# Mariners' Alerting and Reporting Scheme

MARS Report No. 310 August 2018

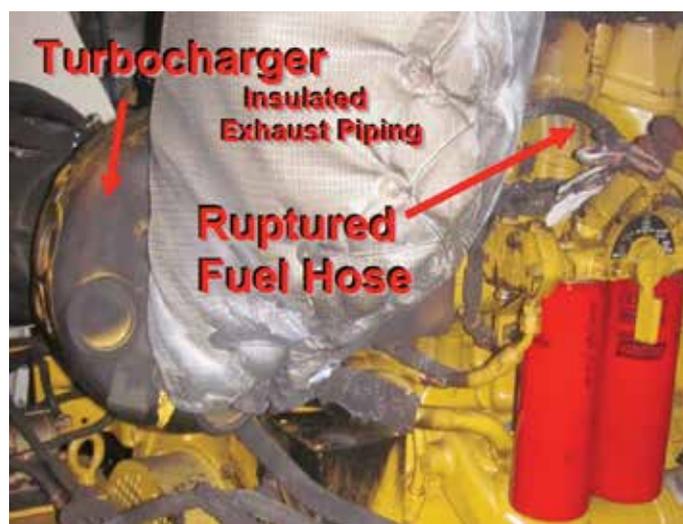
→ While underway a main engine low fuel pressure alarm sounded on the bridge. The crew member on watch entered the unmanned engine room and identified a high-pressure fuel leak spraying on the port engine's turbocharger. There was also a large quantity of diesel fuel in the bilge. The Master arrived on scene just as the fuel ignited and began a fire. He attempted to extinguish the fire using a portable fire extinguisher, but without success. He activated the general alarm, secured the hatches, had crew members secure the ventilation dampers and closed the remote fuel shut-off valves to the engine room. The fire then quickly self-extinguished.

The investigation identified the source of the fuel leak as a rupture on a flexible fuel hose connected to the fuel filter assembly. The fuel filter assembly and its components were installed relatively close to the

turbocharger on the inboard side of the engine. The heat radiating from the turbocharger components was very high and probably led to the degradation of the rubberised hoses nearby. However, the installation was in accordance with the manufacturer's marine engine manual.

- Closely inspect fuel and lubricating systems, from source tanks to system end points. Think about system vulnerabilities such as loose or missing pipe clamps and securing devices, wear or chafing from vibration that is affecting hoses, and pipes or tubes that may be poorly secured. Make sure that plastic piping is not close to hot spots.
- Ensure all insulation, blankets and lagging are maintained and kept tight. Look for areas where released fluids may make contact. Where spray shielding is used, check that it is kept in place; if it is not used, consider adding shielding.
- Minimise the use of non-metallic flexible hoses in systems carrying flammable liquids, particularly around engine areas where leakage or spray may reach hot spots capable of igniting the fluids. Consult with engine representatives if modifications are needed.

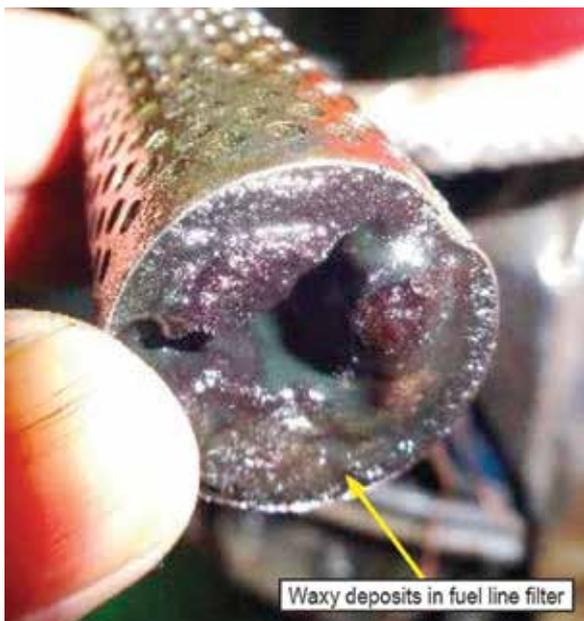
Examination of the boiler fuel system identified a build-up of waxy deposits in the supply filter, sufficient to restrict the fuel flow. Samples of the MGO being burnt at the time of the accident were sent to a laboratory for analysis. The tests found that the fuel had a cold filter plugging point (CFPP) of 14°C and a pour point (PP) of less than -9°C; it therefore required a minimum fuel operating temperature of 15°C. The ambient air temperature at the accident location was about 4°C, low enough for wax to form.

Since the more stringent sulphur emissions limit was introduced, there has been an increased incidence of boiler and marine diesel engine problems in colder waters, industry reports suggest. This has been attributed to the increased paraffin content found in some low-sulphur MGOs, which leads to the formation of waxy deposits or crystals as the fuel temperature falls. Restricted fuel flow due to wax deposits in filters and pipework can cause intermittent and incomplete combustion to the point of flame failure. This could have unintended consequences, as in this case.

- When purchasing low-sulphur MGO bunkers, give careful consideration to the ambient air and sea temperatures likely to be experienced during the voyage. The required cold flow characteristics of the fuel being supplied using cloud point (CP) and CFPP must be appropriate.
- If necessary, the CP and CFPP of the fuels carried on board can be tested through sample testing.

- Closely monitoring the visual appearance of low-sulphur MGO bunkers for signs of wax precipitation
- Conducting regular fuel filter inspections and close monitoring of fuel system pressures.

- Maintaining the temperature of the low-sulphur MGO in the vessel's tanks and pipework above the CP and CFPP temperatures to avoid the possibility of filter blocking.

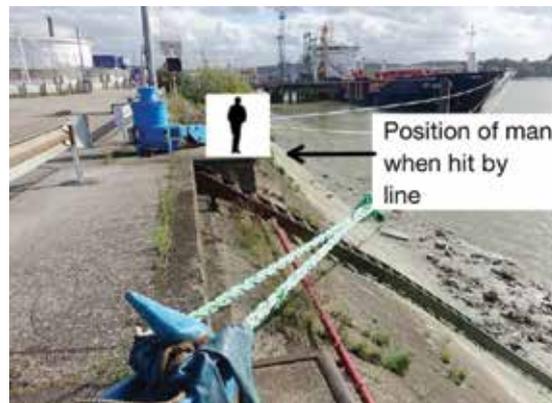
When enough line had been hauled ashore, the linesmen shifted the eye of the rope on the hook. The linesman was in the process of removing the layer on the drum when the slacked rope suddenly moved ahead on the left, hitting the linesman and throwing him down the embankment and into the water.

- When working with mooring lines, always be situationally aware of the forces and direction of tension that are in play – both on board and ashore.
- It is always good practice to keep linesmen in view while they are working your lines. If an accident happens to them, you are well placed to raise the alarm quickly.

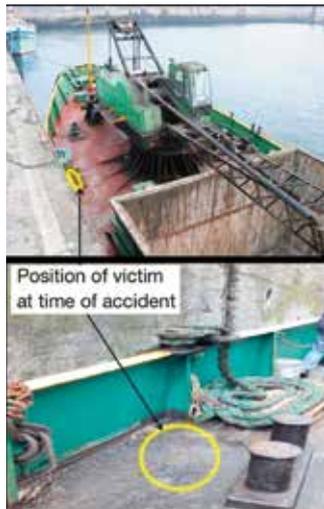
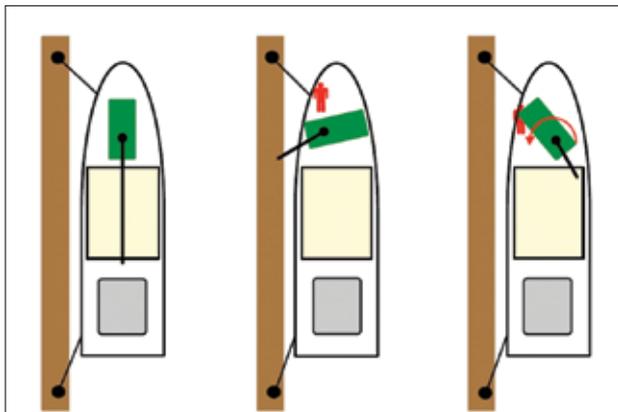
The crew member who was assembling the containers was in a vulnerable position on the port side, where the crane operator could not see him. He was trapped by the counterweight against the ship's bulwark. He collapsed and was quickly attended to but was later declared deceased.

- The victim was relatively inexperienced, and had probably not been made aware of the dangers of the foredeck while the crane was in operation
- The victim was not wearing hi-vis clothing nor a hard hat
- There were no barriers nor indications around the swing radius of the counterweight to warn persons of the danger.

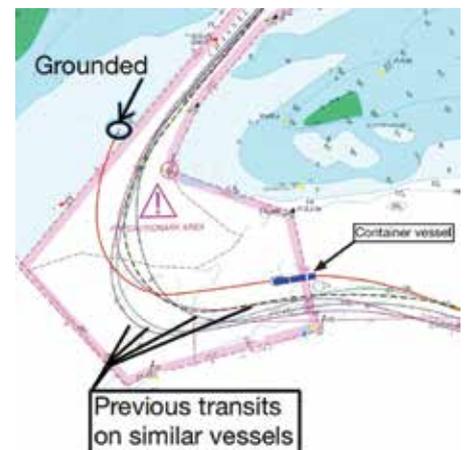
Soon after, the container vessel grounded with the engine at full ahead. The Master implemented the vessel's emergency procedures. The crew's initial inspections and tank soundings indicated that the vessel's hull had not been breached. Tugs quickly freed the vessel on the rising tide.

- The intended route through the precautionary area was not charted, and key decision points, wheel-over points and abort options were not identified.
- The absence of a charted pilotage plan meant that the Master, his bridge team and the assistant pilot were unable to monitor the lead pilot's actions and the vessel's progress during the execution of the turn in the precautionary area.
- The lack of a shared understanding of the pilot's intentions prevented the bridge team from providing the support to challenge or seek to clarify the pilot's actions.
- The bridge team became disengaged from the pilotage process and allowed the lead pilot to become an isolated decision-maker and a single point of failure.

- If you have concerns about the conduct of the vessel, discuss them with the entire bridge team.
- For critical turns or other manoeuvres, have key decision points established in advance. In this case, when compared with past trips, the vessel was obviously too far north as it entered the precautionary area and prior to making the starboard turn. This should have triggered an abort decision.
