## SAFETY INVESTIGATION REPORT

REPORT NO.: 01/2021

### **MV STARA PLANINA** **Two manoverboards** **in position 66° 05.0' N 005° 26.3' E,** **02 January 2020**

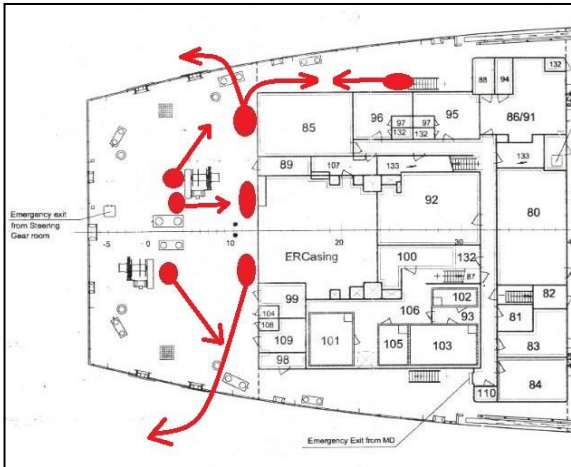
At around 1000, on 02 January 2020, the second engineer observed loose mooring ropes around the poop deck, with some dangling over the vessel's guard rails (Figure 2). He immediately notified the third officer, who was keeping a navigational watch on the bridge, via telephone.

**Figure 2: Poop deck. Red dots indicate the stowed position of the mooring ropes. The arrows indicate the direction that the mooring ropes were scattered**

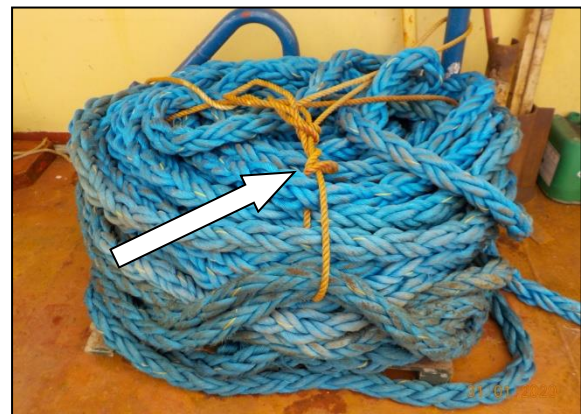
**Figure 3: One of the mooring ropes on the poop deck, secured on a pallet and an adjacent fitting**

The mooring ropes were secured on pallets, using two smaller ropes, and crossed and wound around a fixed structure. It was noted that the smaller ropes did not secure the mooring rope in its entirety, but only the topmost coils (Figure 3).

This procedure may have sufficed in fair weather conditions, when the movements of the vessel would have been limited. However, considering the rolling and pitching movements of the vessel in inclement weather, coupled with the wash of the waves over the poop deck from time to time, may have led to the bottom coils of the mooring ropes to slip out of the securing and scatter around the deck.

It appeared that the approach applied to secure the aft mooring ropes, did not suffice to prevent the mooring ropes from scattering around the poop deck and over the rails in the encountered adverse weather conditions.

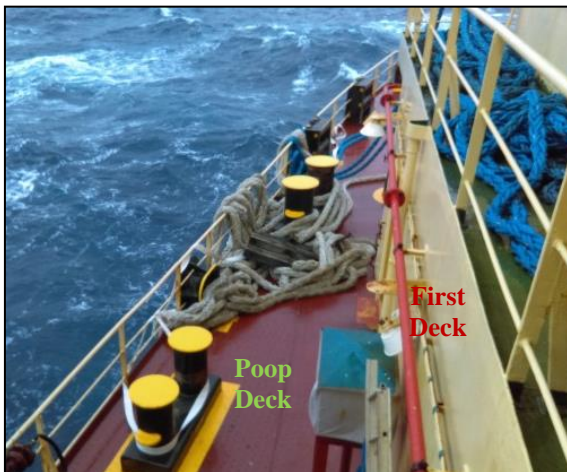
At around 1100, two ABs and the deck trainee arrived on the first deck to assist. The operation moved to the starboard side and, at one point, the deck trainee was seen on the poop deck assisting the chief officer. As the crew could not untangle two of the mooring ropes on the starboard side, the crew members secured them to the guard rails of the poop and first decks (Figure 4).

Figure 4: Situation on starboard side, two ropes secured to the railings of the poop deck, while the end of one of the ropes was hauled onto the first deck

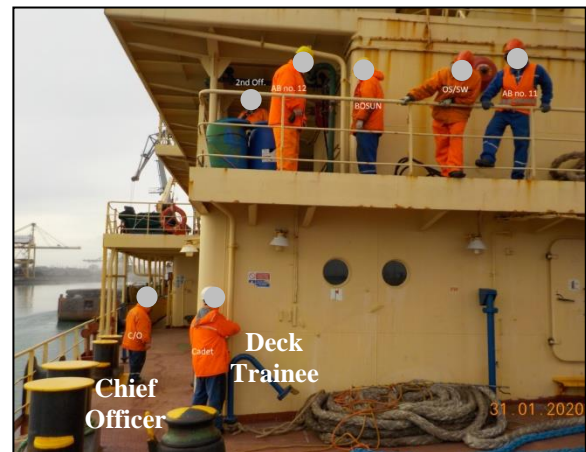
The crew reported that at this moment, a large wave suddenly washed over the poop deck from starboard to port sides. Unexpectedly, a second larger wave washed on board from the same direction and within seconds of the first one. Both the chief officer and the deck trainee were swept overboard. Figure 5 shows the position of the crew members at the time of the accident.

Figure 5: Simulation of the crew's location when the waves washed over the poop deck

Reports from various witnesses indicated that when the first wave struck on board, the deck trainee had proceeded to hold onto a drainpipe, while the chief officer had already made his way to the port side towards the ladder. However, soon after the second wave struck, several crew members noticed orange, winter jackets floating in the water. It soon became clear that both the chief officer and the deck trainee had been washed overboard.

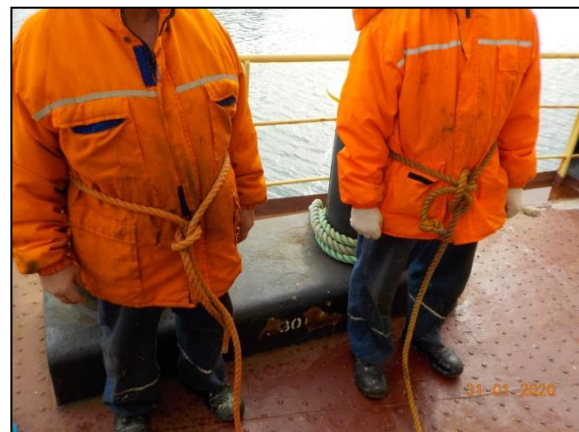
and the deck trainee had ropes tied around their waists (Figure 6). Most of the crew members could not confirm whether the other end of their rope was secured to the vessel during the recovery of the mooring ropes. One of the crew members stated that the rope was not secured to any part of the vessel, as the other end was noticed lying free on deck. Another crew member stated that the chief officer and the deck trainee were tied together with the same rope.

However, all crew members confirmed that when the two large waves washed over the poop deck, both the chief officer and the deck trainee were not secured to any part of the vessel<sup>6</sup>

**Figure 6: Simulation of how the rope was tied around the chief officer's and deck trainee's waists**
