MARINE SAFETY INVESTIGATION REPORT

**Safety investigation into a fatality and serious injuries on board the
Maltese-registered passenger/ro-ro vessel**

Euroferry Malta

MARINE SAFETY INVESTIGATION REPORT NO. 17/2020

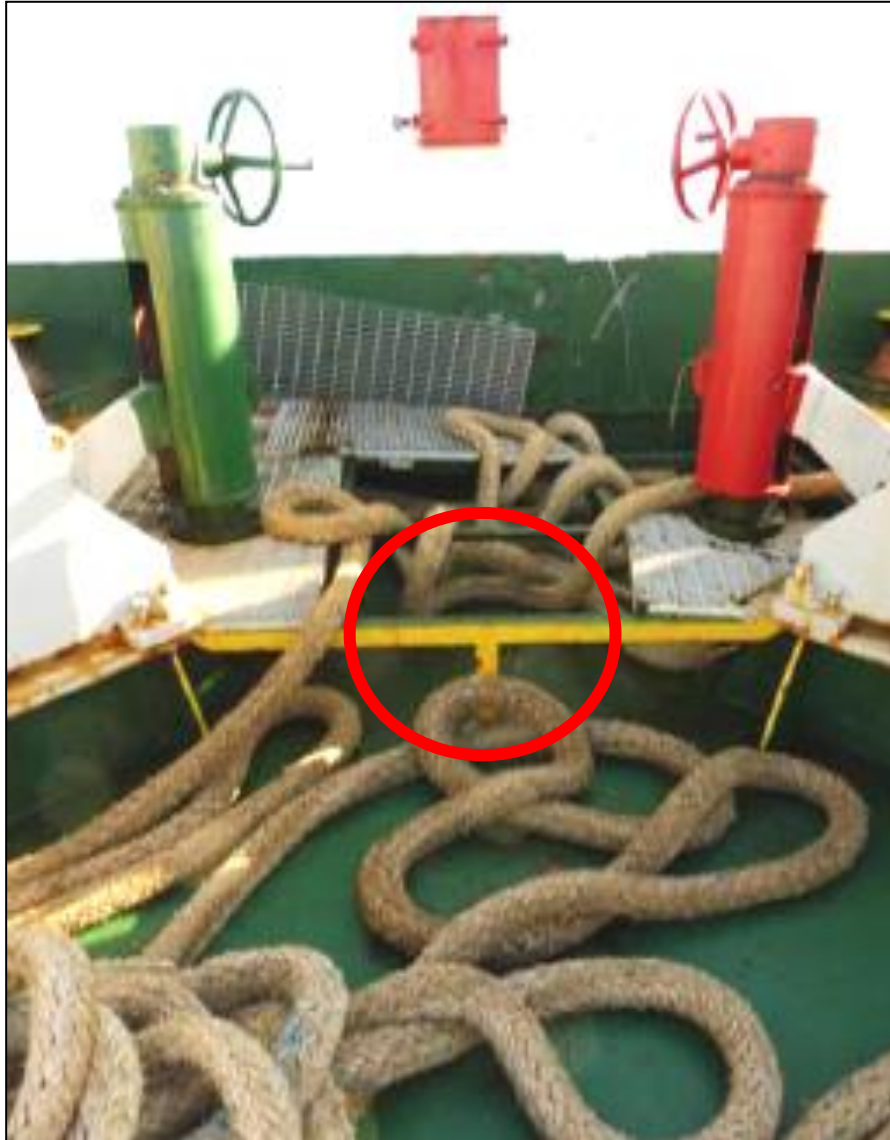
Eventually, the chief officer found AB 1 lying face down and unresponsive between the two windlasses (Figure 12). He checked for vital signs and, on not noticing any, he called for AB 4. The chief officer and AB 4 carried AB 1 towards the accommodation entrance. He then noticed that the bosun and the other two ABs had managed to walk back.

Figure 12: Area (red circle) where the fatally injured crew member was found

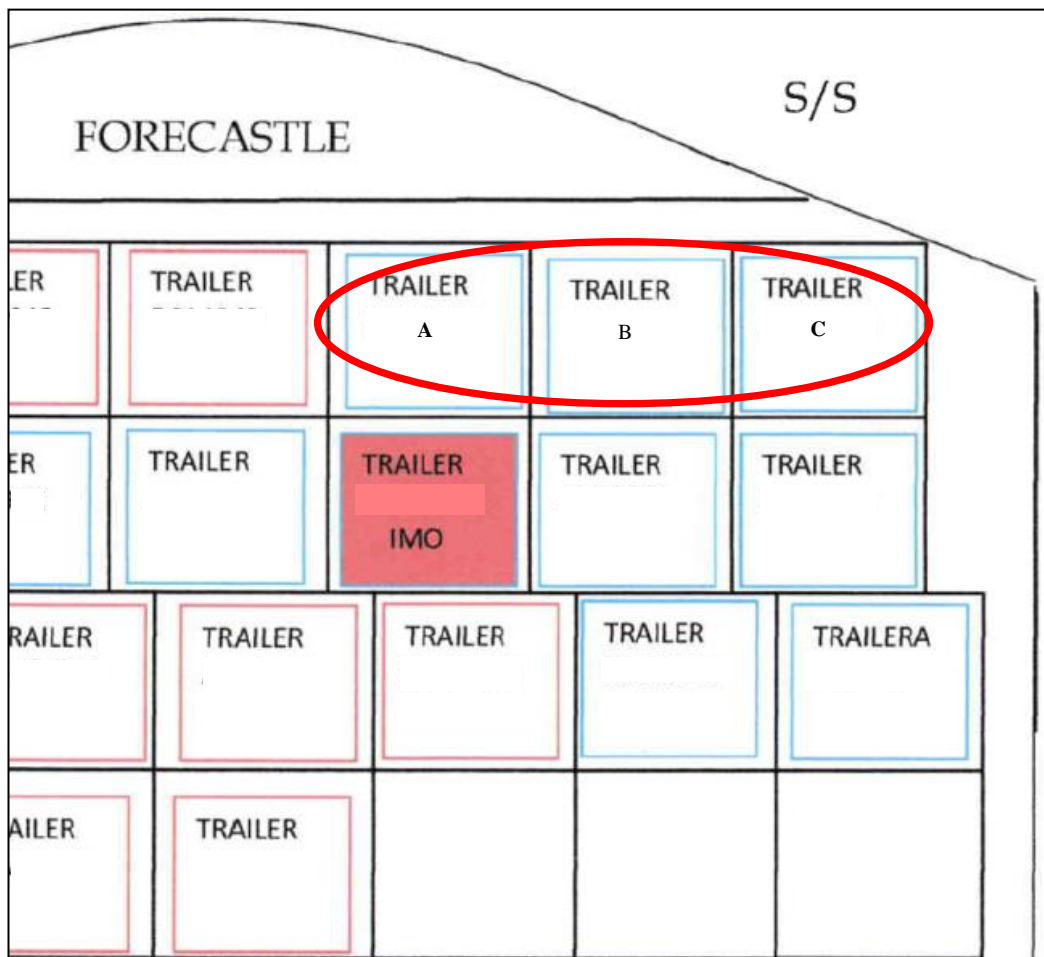
Figure 13: Location of damaged trailers (A, B and C)

Three trailers (Figures 13 to 15), located on the starboard side, just aft of the deckhouse, were found to have sustained substantial damages.

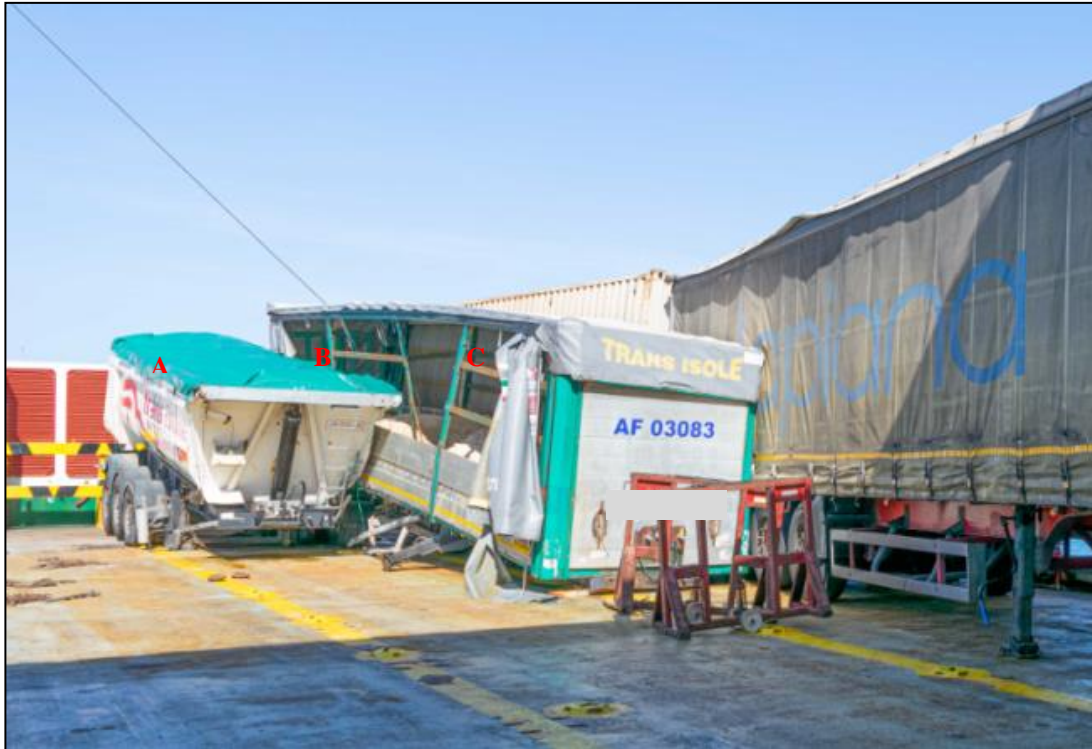
Figure 14: Damaged trailers A, B and C, seen from aft

The trestles and landing gear of trailers A and B had failed, resulting in damages to the two trailers. The damages to trailer B were more pronounced (Figures 16 to 18).

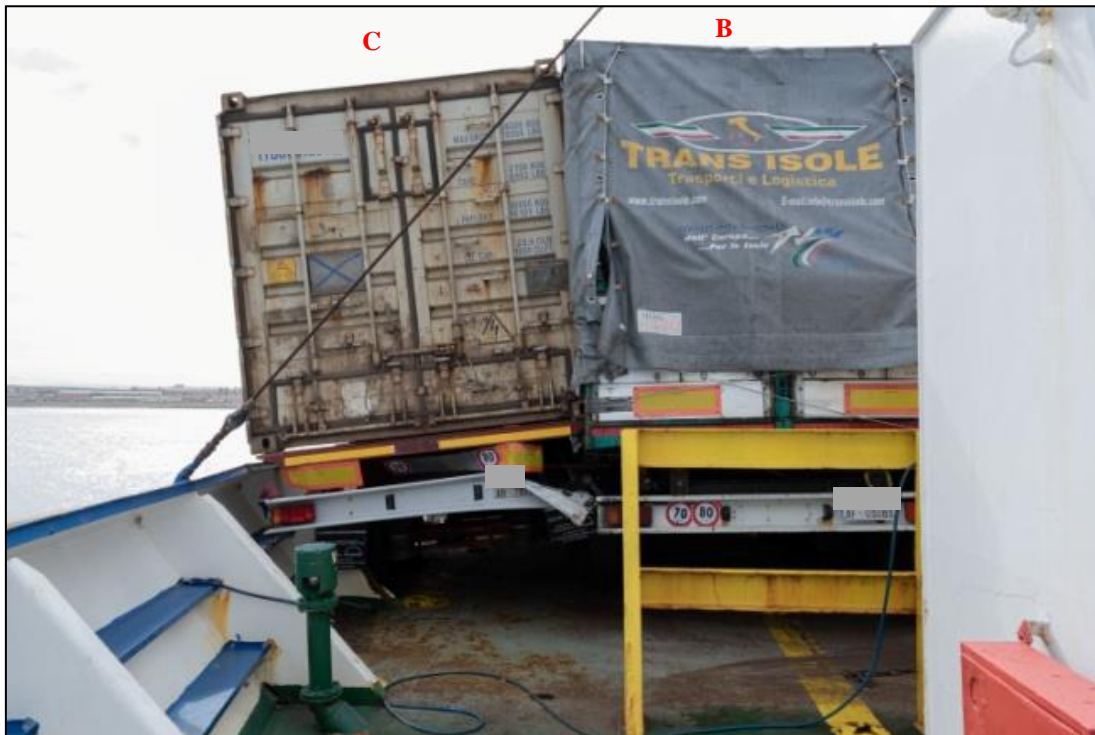
Figure 15: Trailers B and C, seen from forward

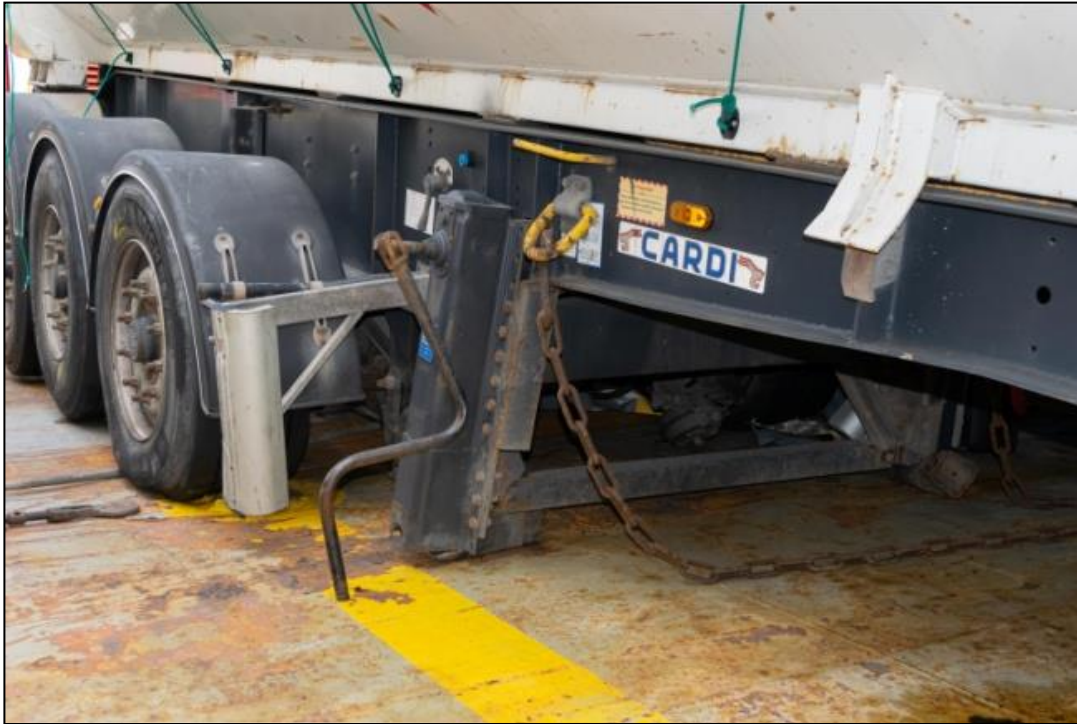
Figure 16: Damaged landing gear of trailer A

The motions of the vessel, shifting of the cargo within the trailers, strain on the cargo securing devices (due to these factors as well as due to some possibly overweight trailers), may have led to the failure of the trestles and landing gear. In turn, this may have led to further cargo shifting and subsequent damages to the trailers, particularly trailers A, B and C.

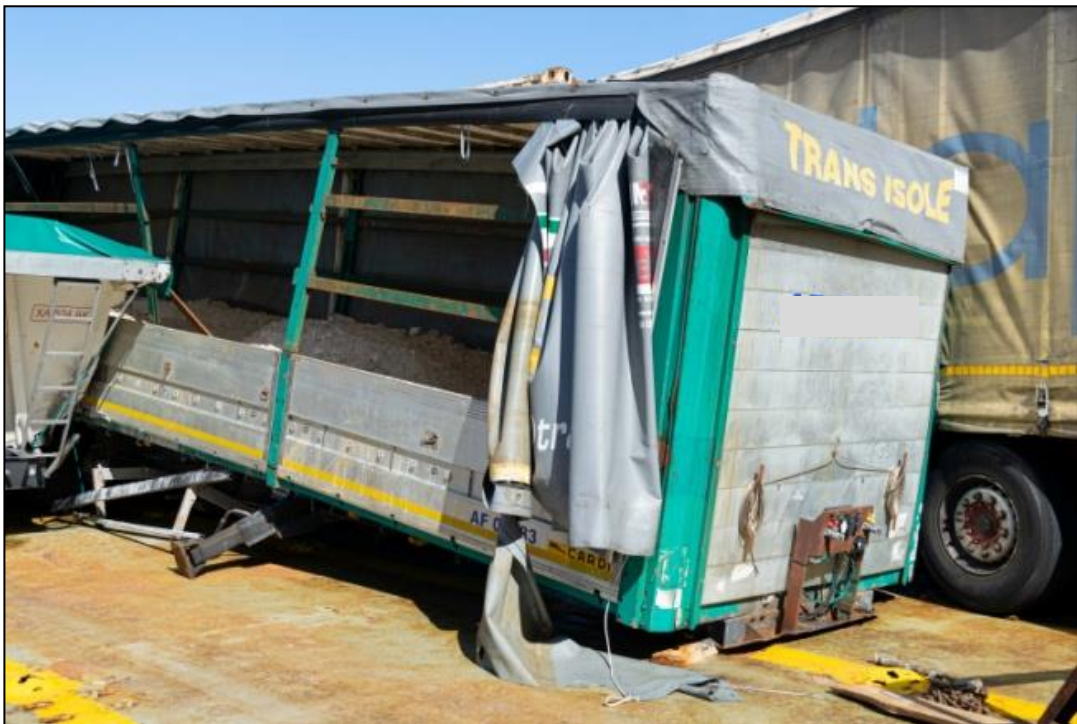
Figure 17: Damaged landing gear of trailer B

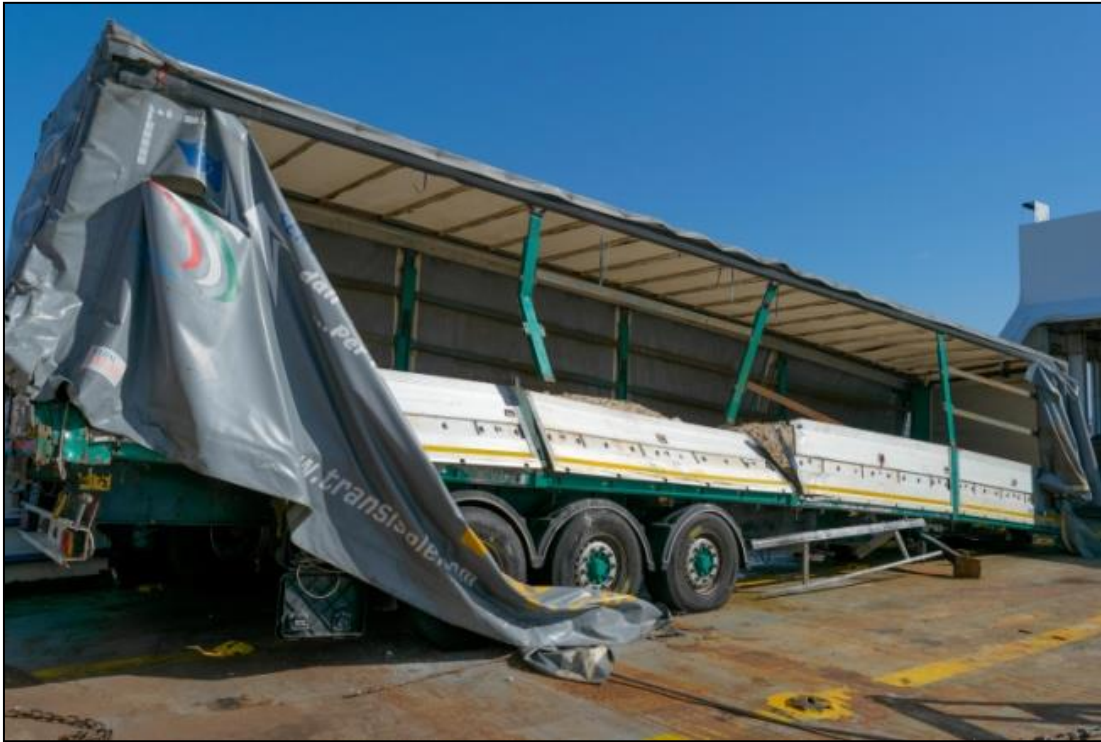
Figure 18: Damaged trailer B

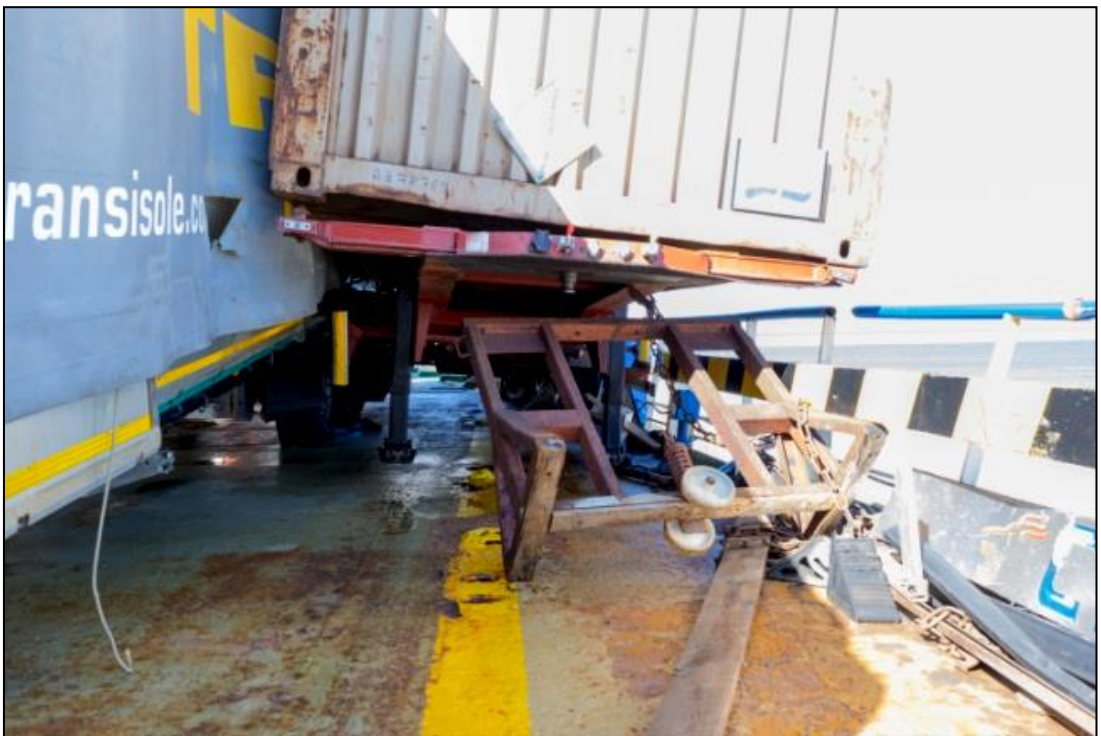
Trailer C was pushed towards the vessel's bulwark and guard rails, causing the container on it to incline over the vessel's side (Figure 19).

Figure 19: Damaged trailer C

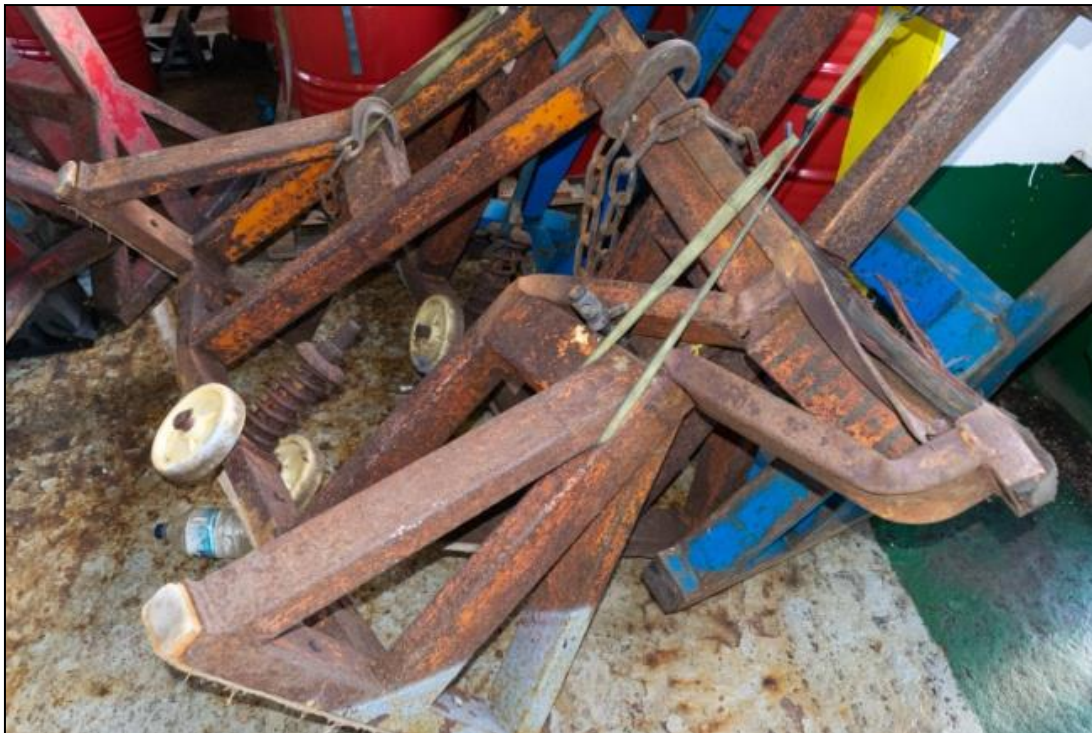
Due to the heavy weather and the subsequent cargo movements, it was reported that two of the vessel's trestles (Figure 20), four securing chains and four shackles were damaged.

Figure 20: A damaged trestle

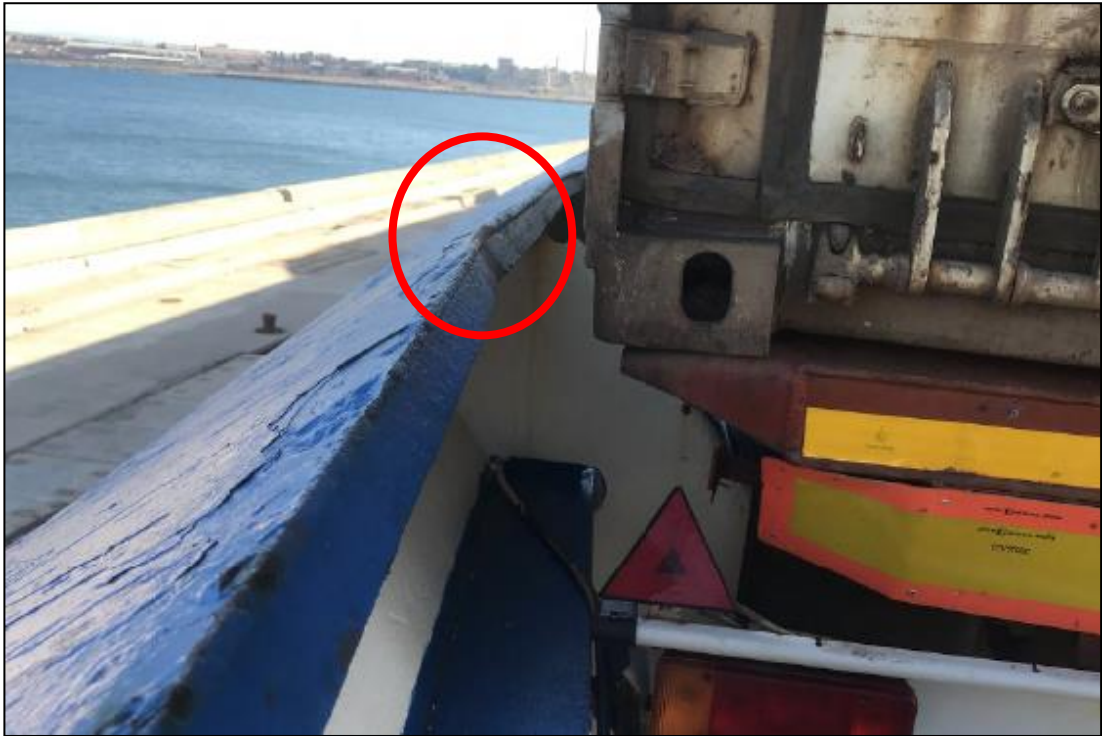
The vessel sustained minor structural damages to her gunwale, bulwark stiffeners, guard rails and an air vent in the vicinity of trailer C (Figures 21 to 24).

Figure 21: Dented gunwale

against the starboard gunwale of the vessel (Figure 21). Trailer C was pushed to the extent that its landing gear was lifted off the deck and the corner socket of the container on the trailer was lifted off the securing twist lock (Figure 19). It is highly likely that the lateral acceleration on this trailer, acting towards the starboard side of the vessel, in addition to its instability after its landing gear was lifted off the deck, resulted in damages to the gunwale, bulwark stiffeners and guard rails around the area of possible contact.

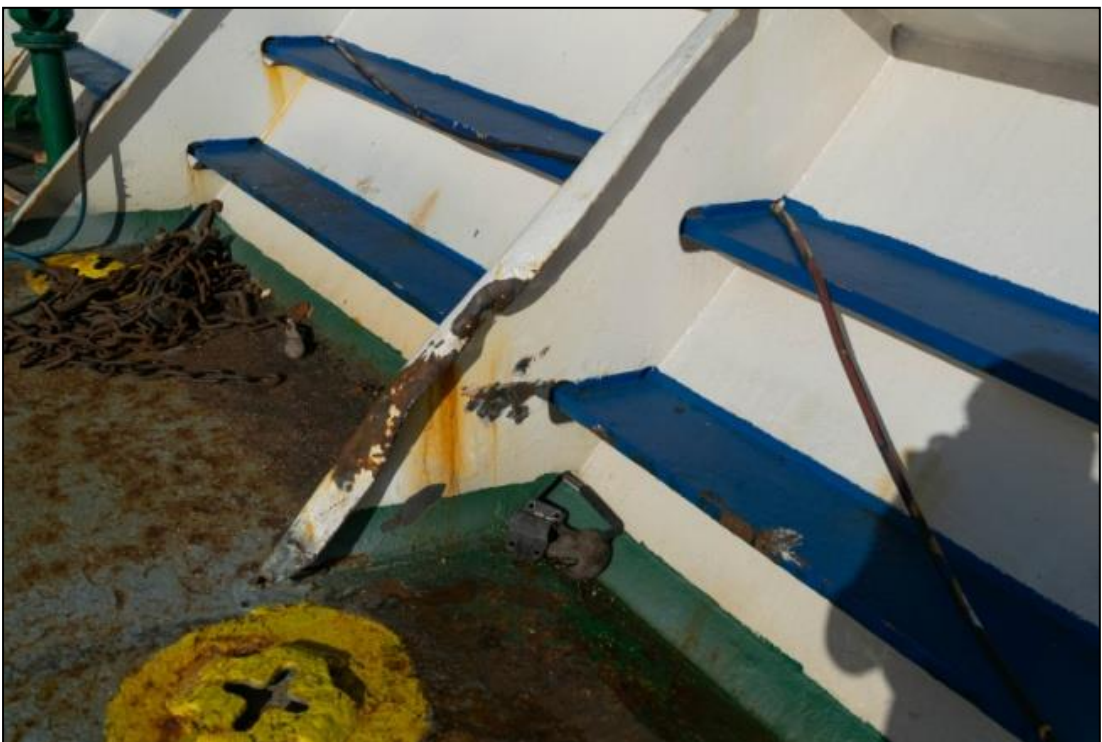
Figure 22: Damaged bulwark stiffener

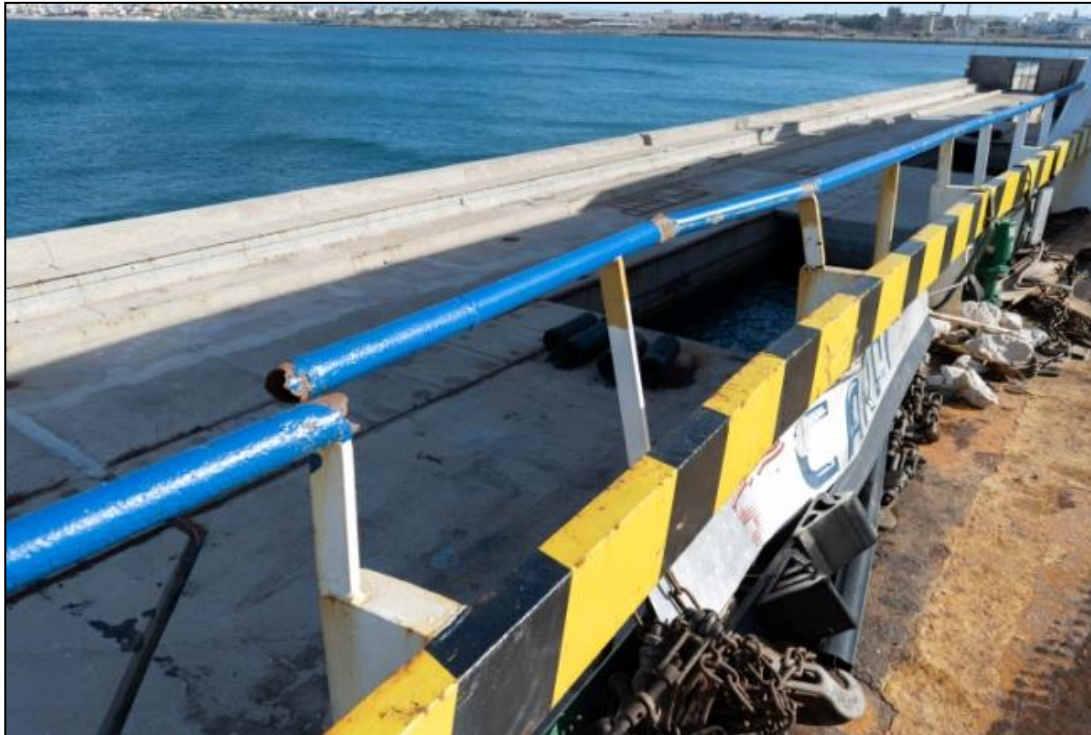
Figure 23: Damaged guard rails

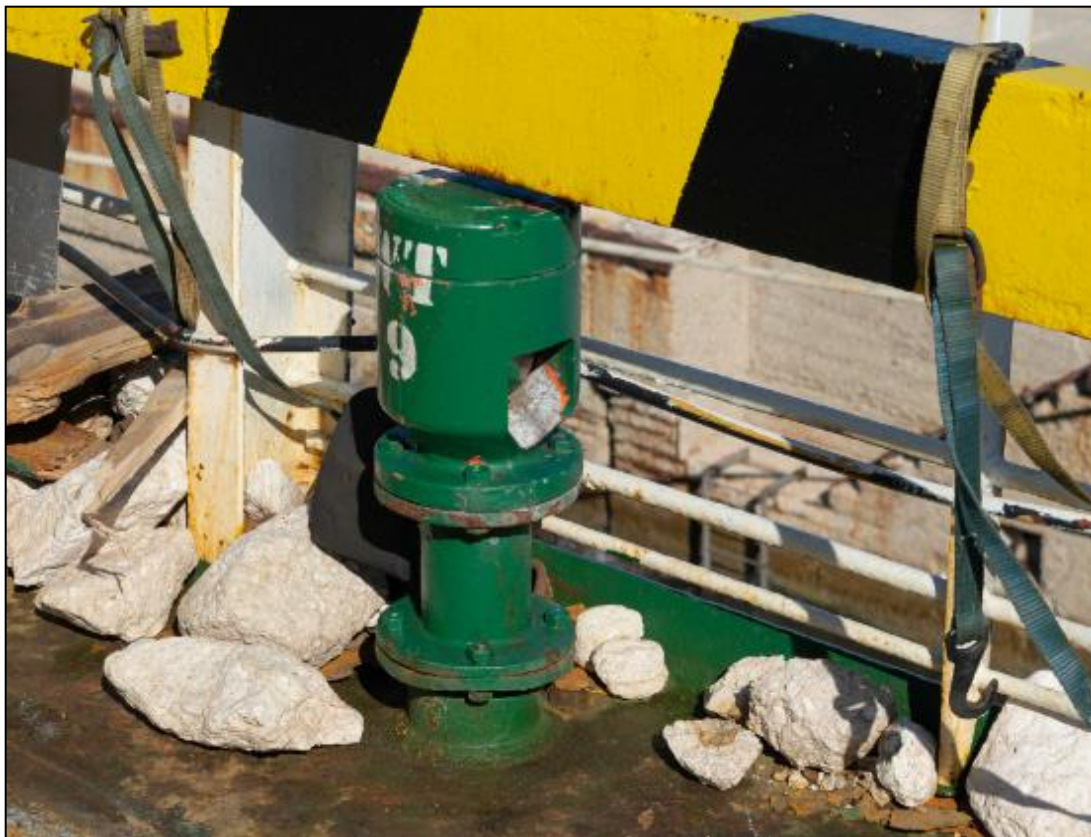
Figure 24: Damaged water ballast tank air vent, and cargo which escaped from trailer B

The damages to the water ballast tank air vent (Figure 24) most likely seemed to be the result of cargo falling out from trailer B and striking this air vent.

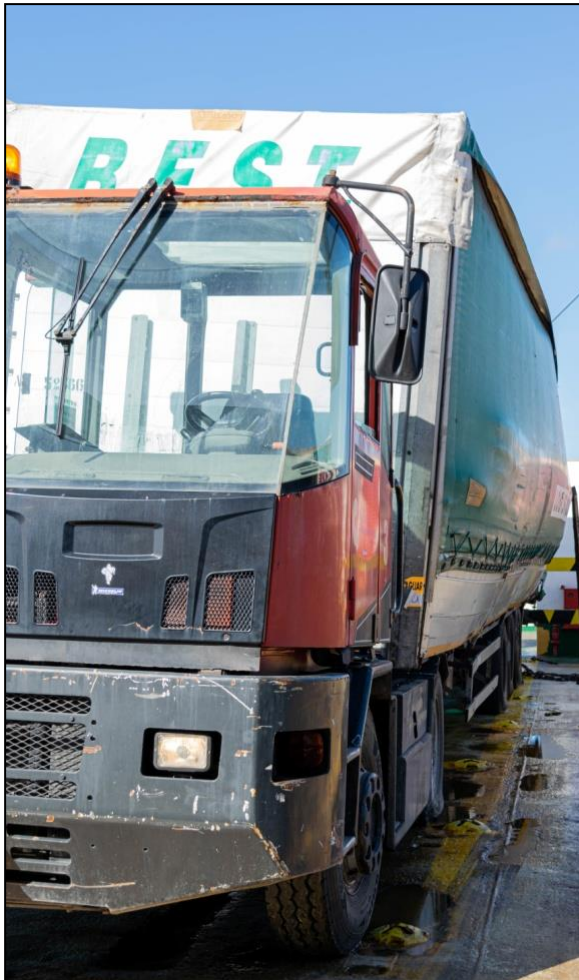
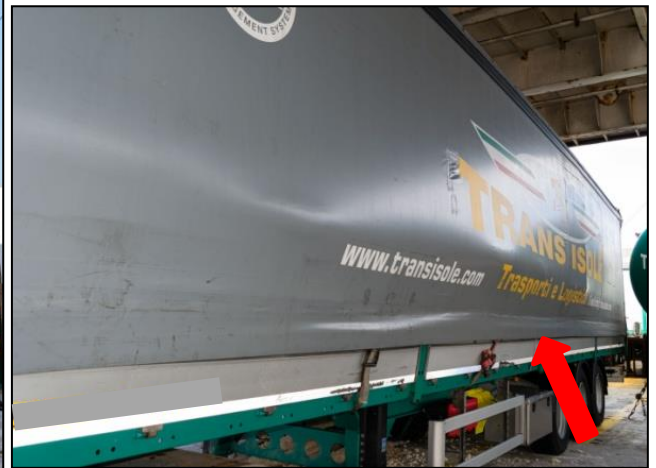
The rolling and the pitching motions of the vessel under the heavy weather conditions caused the cargo within the trailers, especially those loaded on Deck 4, to shift. This resulted in bulging of the sides of some of the trailers (Figures 26a and 26b).

Figures 26a and 26b: Bulging of the sides due to internal cargo shift

Cargo shifts in curtain-sided semi-trailers would lead to a centre of gravity shift towards the bulging side and upward to the side curtain top rail. The MSIU is aware that it is not unusual for vessels to experience problems with curtain-sided units, such as the one in Figures 26a and 26b. Although it is recommended that vehicles with high centres of gravity are stowed in positions of minimal roll, it is not always possible to accommodate this arrangement.
