SAFETY INVESTIGATION REPORT

REPORT NO.: 18/2019

MV MAERSK JAIPUR Fatal accident in the Engine-room in position 54° 18.9' N 164° 26.9' W 08 October 2018

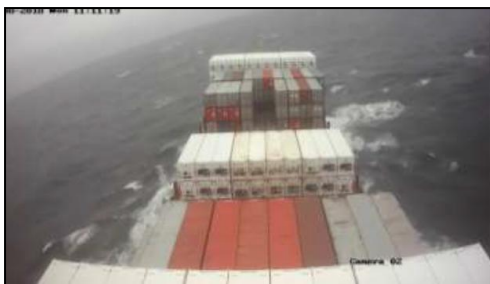
Visibility was moderate to poor and the sky was overcast. The swell was reported to have been coming from a Southeasterly direction, with a height of about 5.0 m, which caused the ship to roll more often and reach angles of 30° to 35° (Figure 1).

Figure 1: Vessel's rolling heavily to starboard – photo taken from the bridge's dome camera

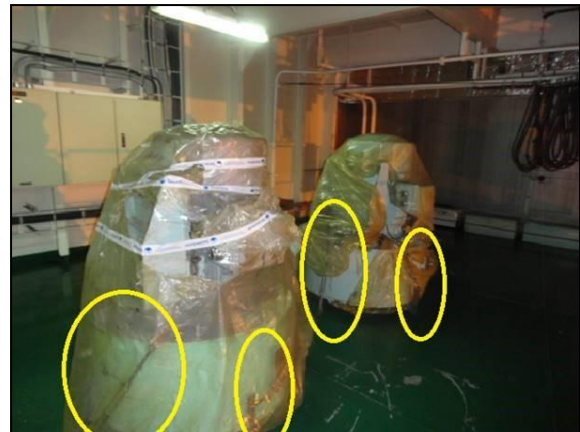
Each blower was placed among four steel angles, each 6.35 mm thick, welded to the deck. In addition, each blower was secured to the deck using four plastic sheathed steel cables, each having 6.35 mm diameter, which were fastened with turnbuckles connected to floor eyebolts. All lashing wires led up at angles of more than 60° from the horizontal. No dunnage was placed under the blowers (Figures 5 and 6).

Figure 5: Lashed spare auxiliary blowers in the engine-room

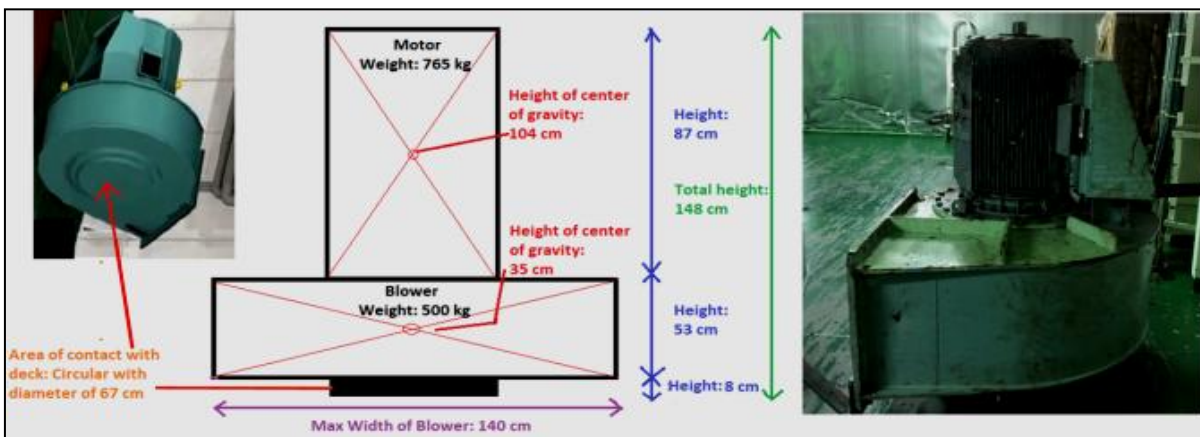
Two spare auxiliary blowers, each weighing approximately 1300 kg, were secured on the upper platform of the engine-room, which was level with the main deck. These units had a circular base, with a diameter of 67 cm, which made contact with the deck and were approximately 148 cm high (Figure 4).

Figure 4: Dimensions of the auxiliary blower

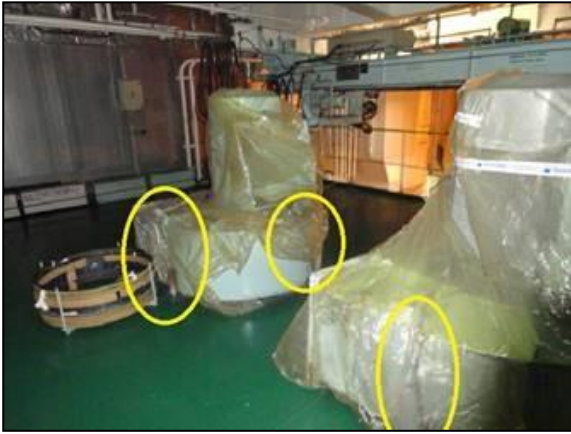
Figure 6: Lashed spare auxiliary blowers in the engine-room

As mentioned in the factual information section of this safety investigation report, dunnage was not placed below the blowers. Apart from the protection from moisture, dunnage provides an increase in friction.

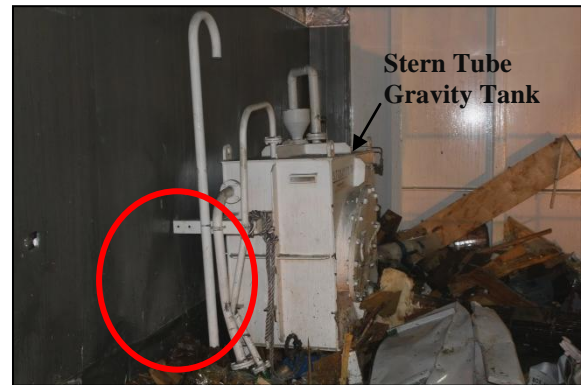
The oiler was pulled by the second engineer who also slipped in the process. The reefer technician pulled both, the second engineer and the oiler, to safety. However, the fitter, who was the furthest away from anyone's reach, was crushed between the bulkhead and one of the blowers, which rolled in his direction (Figure 7).

Figure 7: Location of the accident marked in red

As a result of the blunt blow, the fitter sustained multiple crushing injuries to his trunk and extremities and succumbed to his injuries soon after.

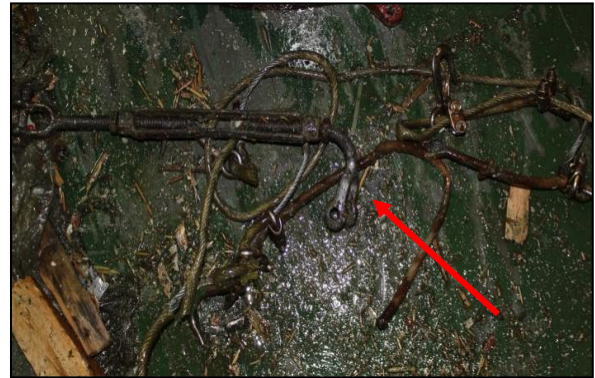
The blowers were secured with wires fastened using turnbuckles, at angles of more than 60° to the horizontal. This did not provide any opposing force to prevent them from sliding in adverse weather conditions. The safety investigation hypothesizes that the blowers broke off from their lashings, during one of the violent rolling motions experienced by the vessel, as the lashing in use at the time did not prevent them from sliding. The turnbuckle, shown in Figure 9,

may give an indication that the physical damage to it was caused due to the sliding movement of the blower, as it broke free.

Figure 9: Damaged lashings of auxiliary blowers. Bent turnbuckle shown by the red arrow. (Photo courtesy of the USCG)

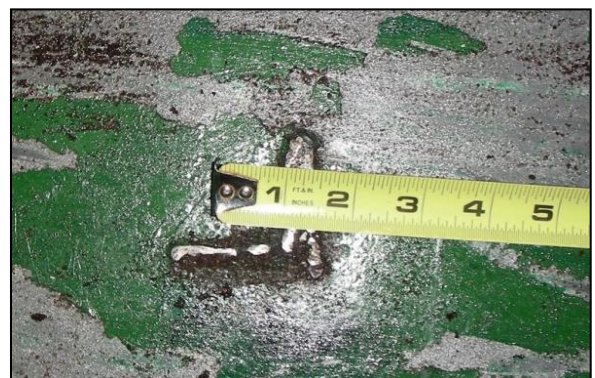
To help prevent sliding, each blower was placed in between four pieces of 6.35 mm thick, steel angles welded to the deck. These angle bars, however, seemed to have failed during one of the violent rolling motions of the vessel (Figure 10), and the first blower broke free from its lashings. The CSS Code recognizes that welded fittings may be used to prevent sliding, when lashings can only be set at large angles. However, the safety investigation was unable to determine which of the lashing equipment / items gave way first.

Figure 10: The base of one of the failed welded angle bars

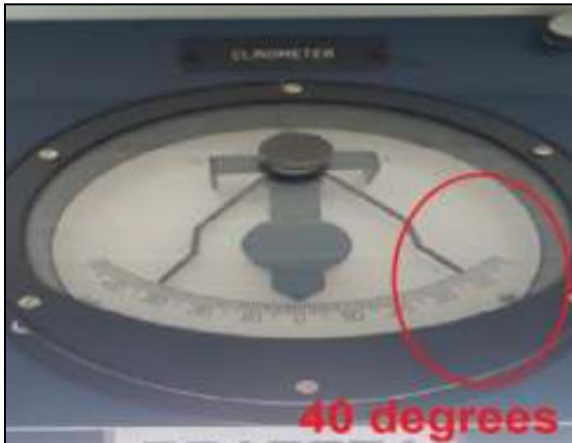
At 0650, the vessel had altered course to 278° in preparation to transit through the Unimak Pass. This was placing the vessel's port quarter open to the oncoming sea and swell. As stated elsewhere in this safety investigation report, the vessel experienced violent rolling motions of between 30° and 35°, at times reaching 40° (Figure 11).

Figure 11: Clinometer on the bridge indicating a roll of almost 40°

The fact that the vessel was exposed to stern quartering seas, and that these violent motions had developed quickly was indicative that the vessel might have experienced parametric rolling.
