## SAFETY INVESTIGATION REPORT

REPORT NO.: 22/2020

### **MV ALMA** **Fatal fall from the** **accommodation stairway** **in position 47° 38.1' N 008° 51.8' W,** **22 November 2019**

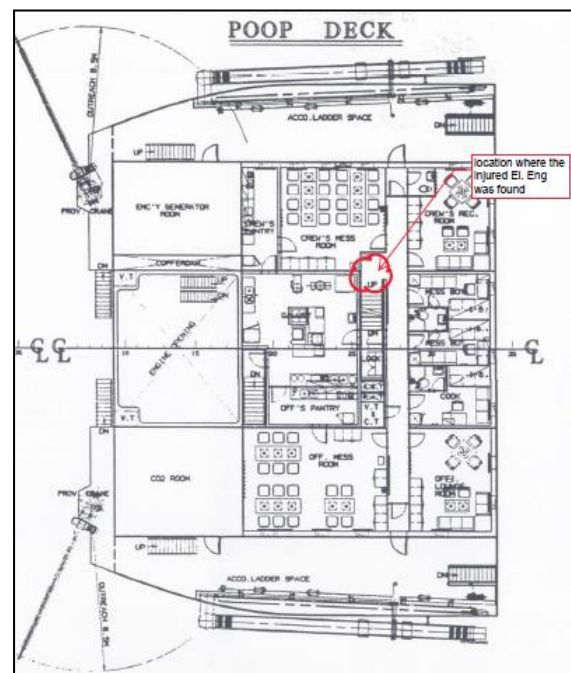
At around 1953, while on his way to the bridge to take over the watch, the third officer met the electrical engineer in the stairway landing of deck 'A', wearing his overalls and safety shoes. Nothing peculiar was observed. However, at about 1955, the bosun, who was in his cabin on deck 'A', heard a sound emanating from the accommodation stairway. On checking, he noticed the electrical engineer on his back, at the bottom of the stairway, on the poop deck (Figure 2).

Figure 2: Location where the electrical engineer was found

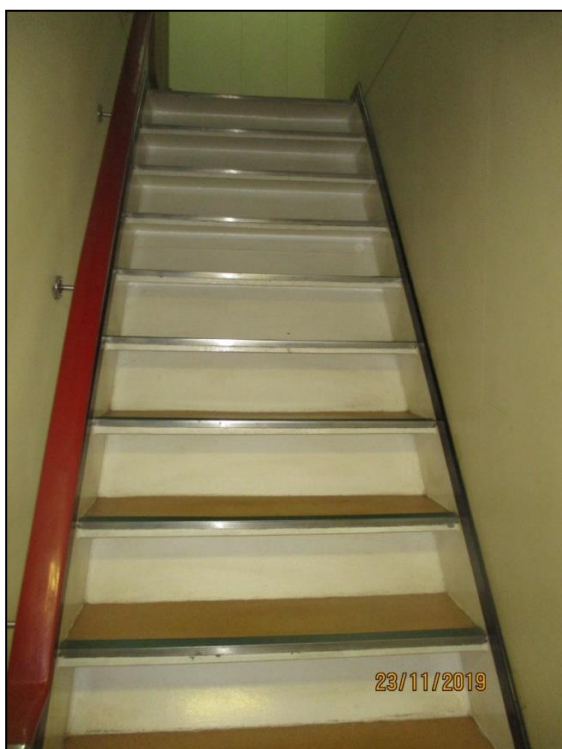
The section of the stairway, at the bottom of which the fatally injured electrical engineer was found, was inclined at an angle of 50° to the horizontal. This section of the stairway consisted of 10 steps, with a riser height of 250 mm and fitted with a handrail on one side (Figures 3).

Figure 3: Section of the stairway, seen from the bottom (poop deck level)

Reportedly, the stairway was well lit and free of defects and slippery substances.

The investigation report emphasised the importance of serving crew members to exercise caution while using the vessel's stairs, especially when the vessel is experiencing rolling and pitching motions, and to hold onto the handrails for support.

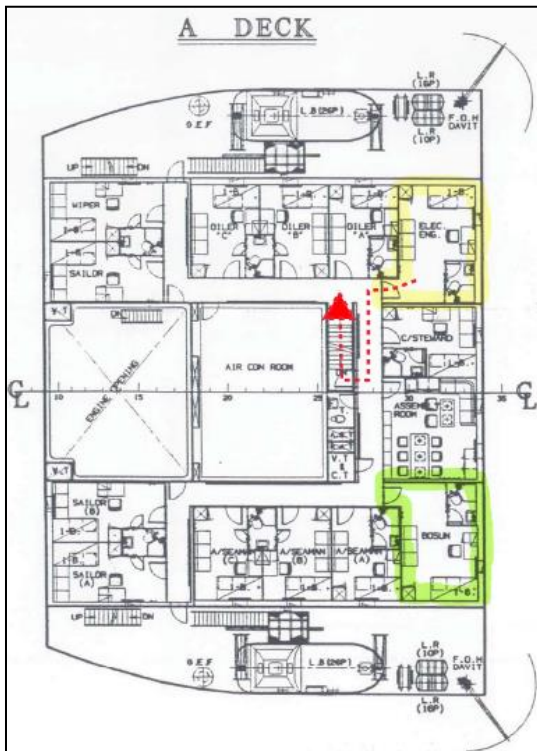
Reportedly, the crew member was walking down the stairway from his cabin on deck 'A' to the poop deck (Figure 4), when the bosun heard him falling down the stairway.

**Figure 4: Reported path followed by the fatally injured crew member**

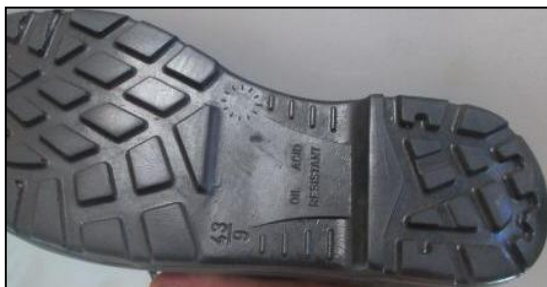
No items were found in the vicinity of the stairway, which could have indicated that the fatally injured crew member was carrying any items in his hand while walking down the stairway. The shoes worn by the fatally injured crew member were in good condition, with the treads on the soles free of wear (Figure 5).

**Figure 5: Sole of the fatally injured crew member's shoe**

The safety investigation hypothesized that the fatally injured crew member either lost his stepping or balance, while walking down the stairway, as a result of the rolling and pitching motions of the vessel. The safety investigation did not rule out the possibility that the crew member was not holding on to the handrail, while going down the stairs. It is highly likely that he subsequently toppled down to the bottom of the stairway, fracturing his skull at some point during this fall.
