Report on the investigation of  
wave damage to the  
passenger cruise ship  
***Oriana***  
in the North Atlantic Ocean  
28 September 2000

**Report No 36/2002  
November 2002**

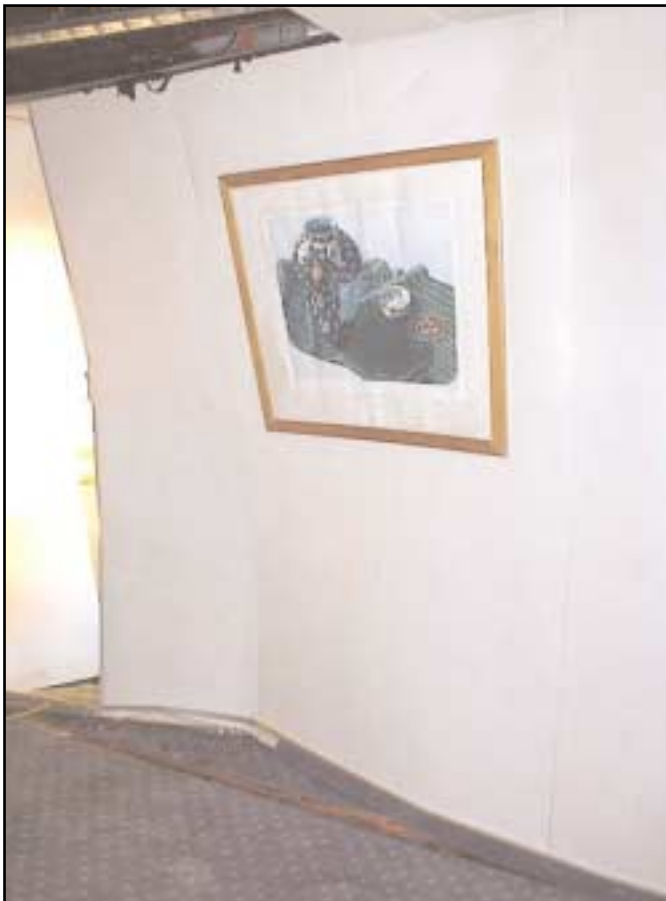
Figure 3

The ingress of seawater caused substantial damage: bulkhead panels were distorted or dislodged (**Figure 3**), ceiling panels were bent with many falling into the cabins (**Figure 4**), and bathroom modules were badly damaged (**Figure 5**). The bulkhead and ceiling panels, and the bathroom modules were of a lightweight construction. Initially, the seawater was retained inside the cabins and, in some cases, the level was nearly up to the windowsill. This caused several of the passengers to have difficulty in opening their cabin doors, and escaping into the corridor because the cabin doors opened inwards. However, because the corridor bulkheads were not watertight, the water slowly drained from the cabins and flowed along the corridors and down the stairway enclosure and integral lift shafts near the damaged cabins. Although some floodwater drained to the bilges and was pumped overboard, most of it either soaked into the carpets or was mopped up by the crew.

Photograph of distorted bulkhead

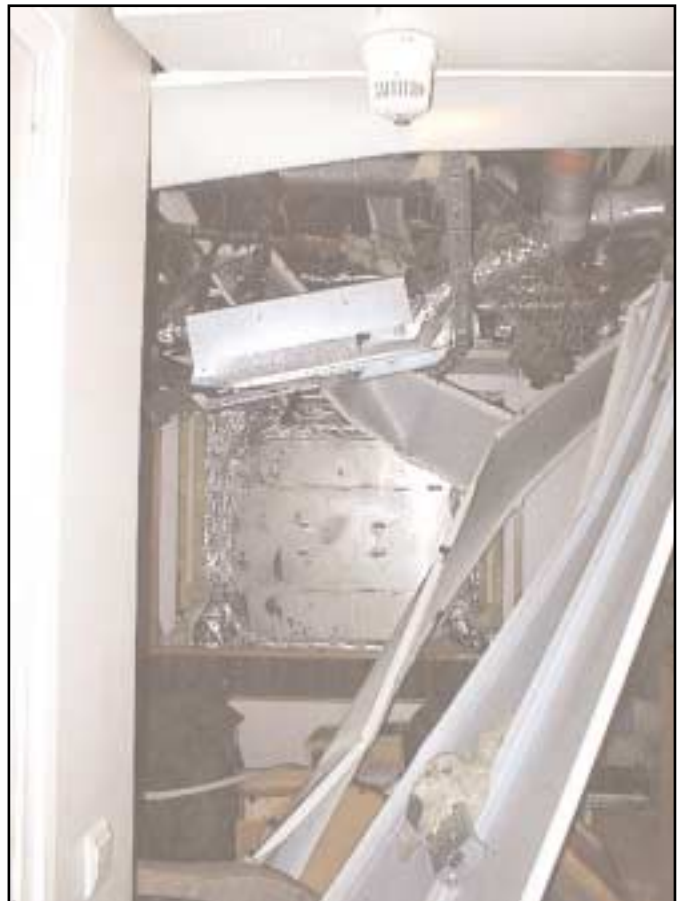
Figure 4

Photograph of damaged ceiling

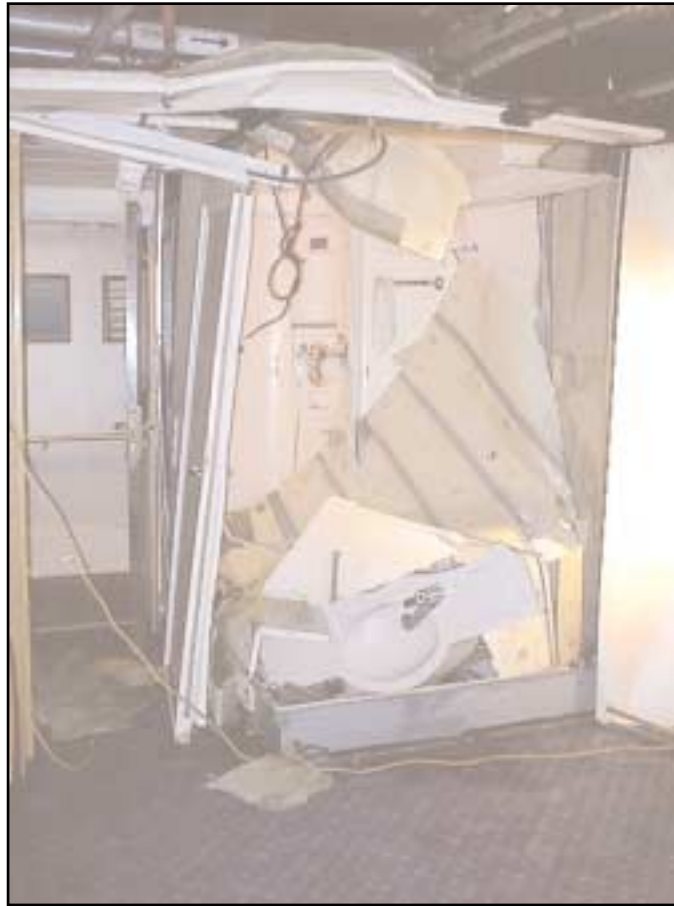
Figure 5

Photograph of damaged bathroom module

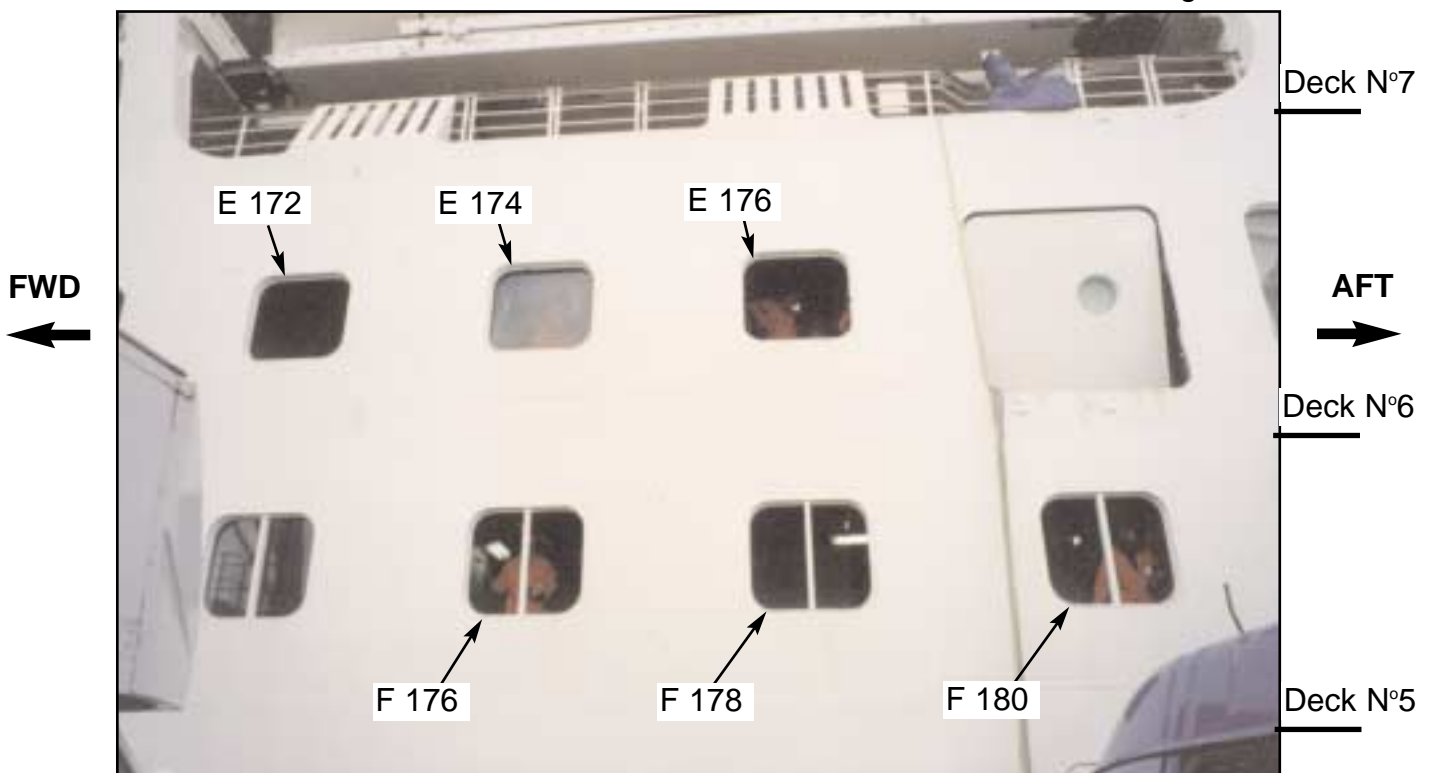
Figure 17

The position of the damaged windows is shown in **Figures 1 & 17**. The cabins affected were F176, F178, F180, E172, E174 and E176, all of which were situated approximately amidships on the port side (**Figure 18**).

Photograph showing position of damaged windows

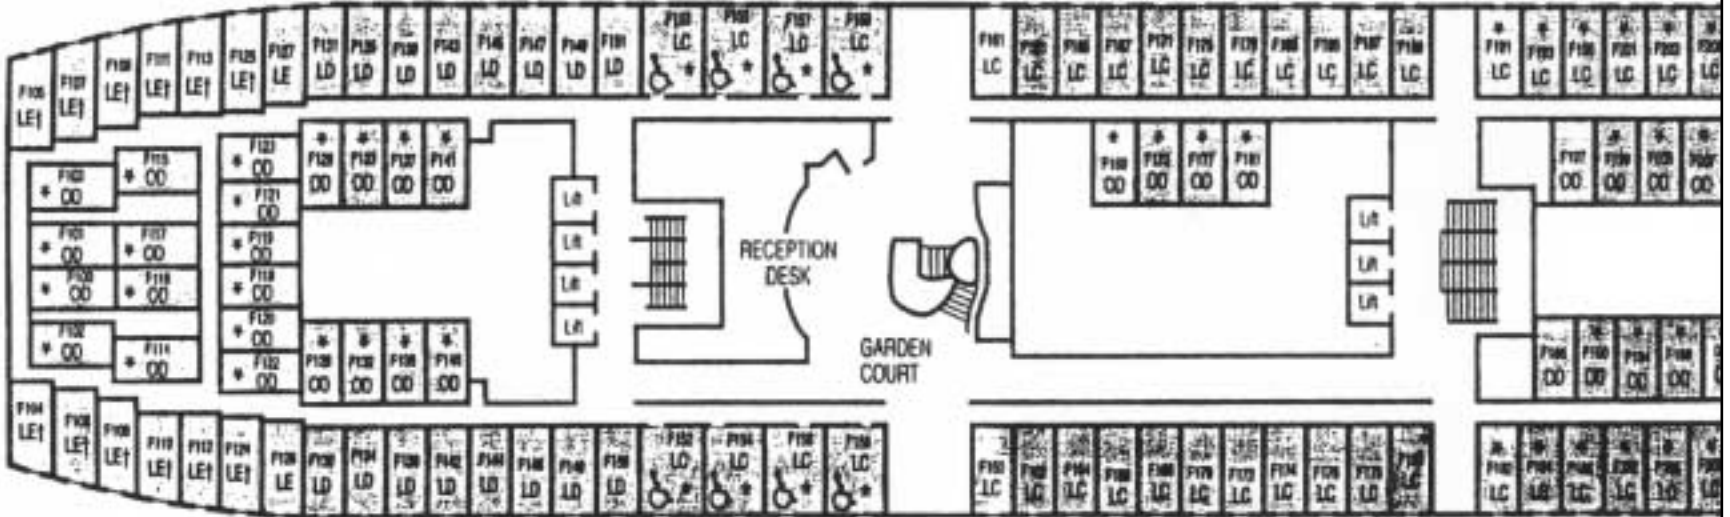
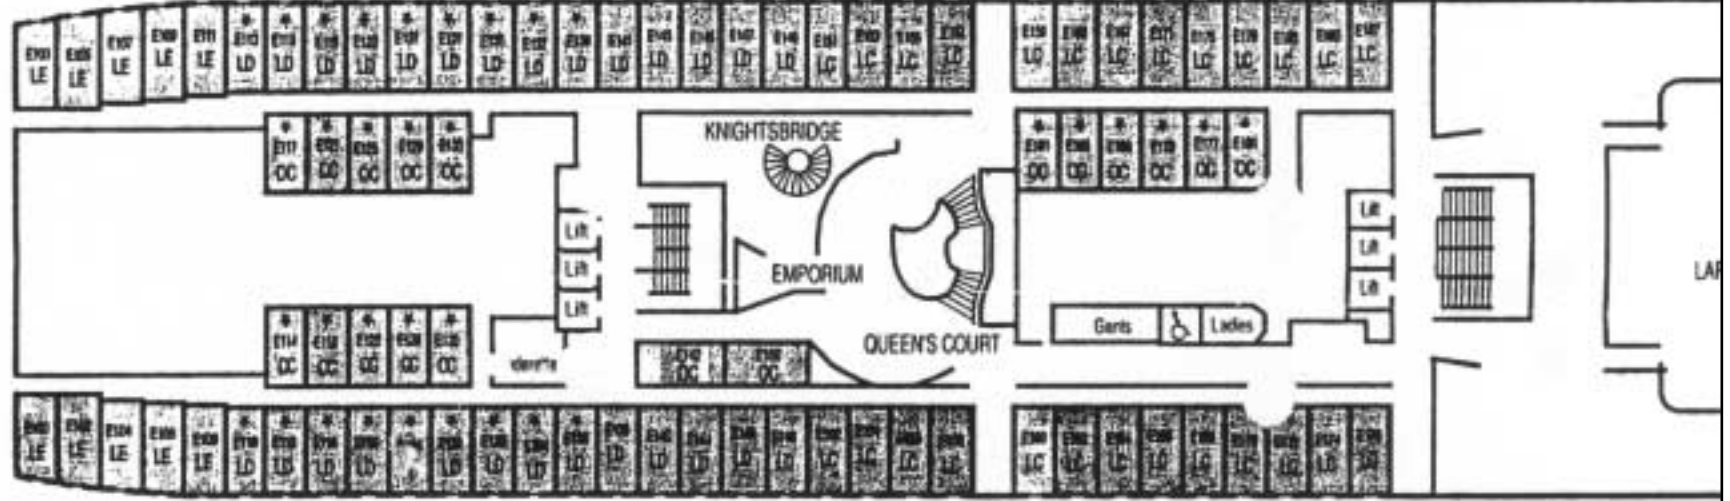
Diagram showing the positions of the damaged cabins

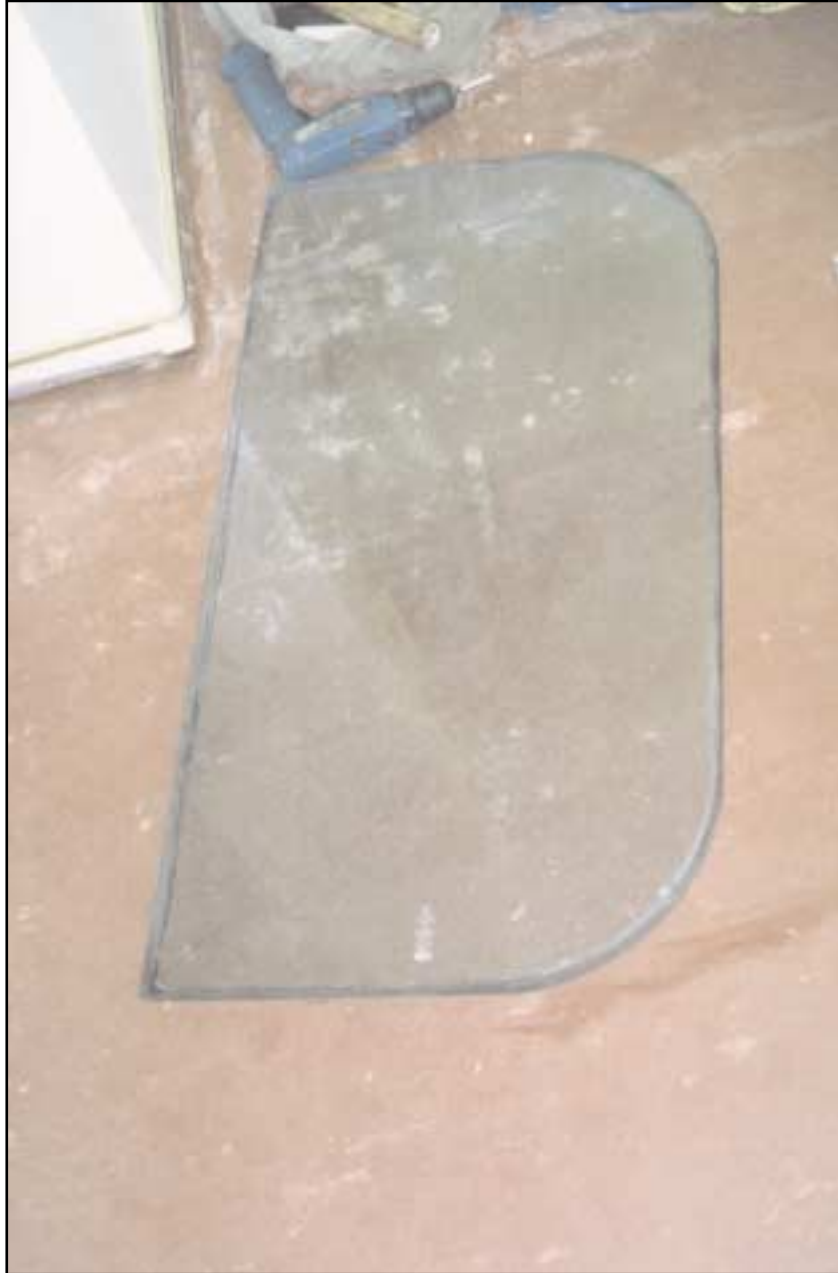
Figure 19

In cabin F180 only the aft pane was breached. In F176 and F178 all four panes were breached; three of these were found intact (**Figure 19**), of which two were found to have chipped or splintered edges. These marks appear to have been made by the glazing strip, and the marks on the edge of the glass, next to the mullion, extended further across the pane than those on the opposite vertical edge.

Photograph of glass pane found intact

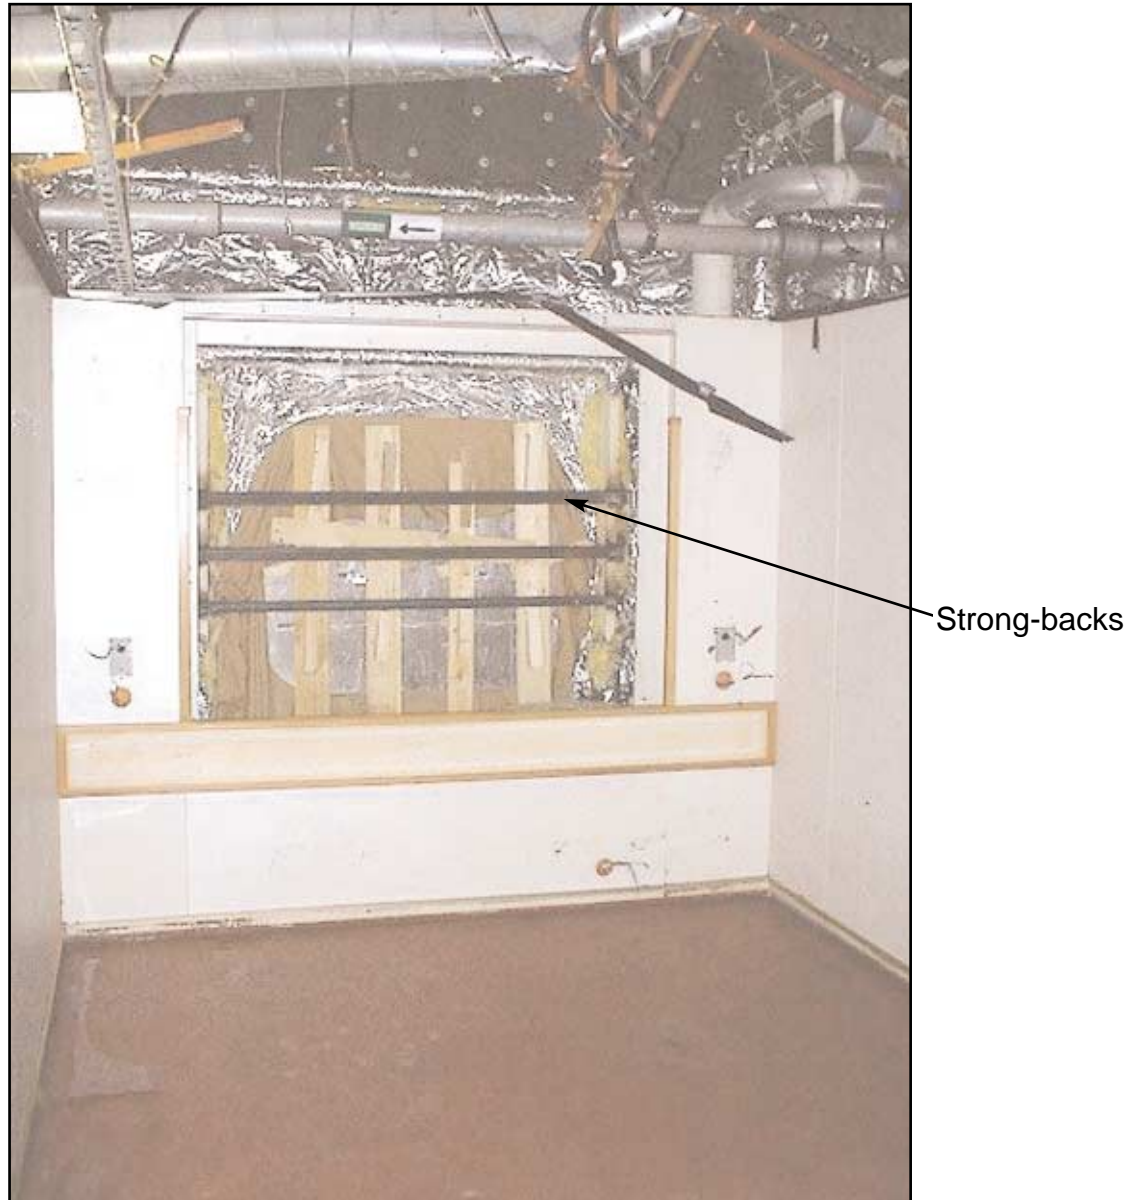
Photograph of temporary repair to a damaged window

Initially, the damage repair teams fitted strong-backs which were placed in sockets cut into the fairings surrounding the windows, but it was soon evident this would not provide sufficient support. However, after discovering that the fairings were attached by screws concealed by small plastic caps, these were removed and the fairings taken down to expose the steel structure surrounding the window frames. Three horizontal strong-backs were then fitted across each opening, with the ends welded to steel stiffeners on the ship's side (**Figure 20**). The strong-backs were either square or angle steel sections obtained from the ship's stores. The windows were then blanked off by either storm covers or plywood sheets. Wooden wedges were then driven into the gap between the strong-backs and the covers, to secure the covers in place. The materials used by the repair teams were prepared in the ship's workshops.

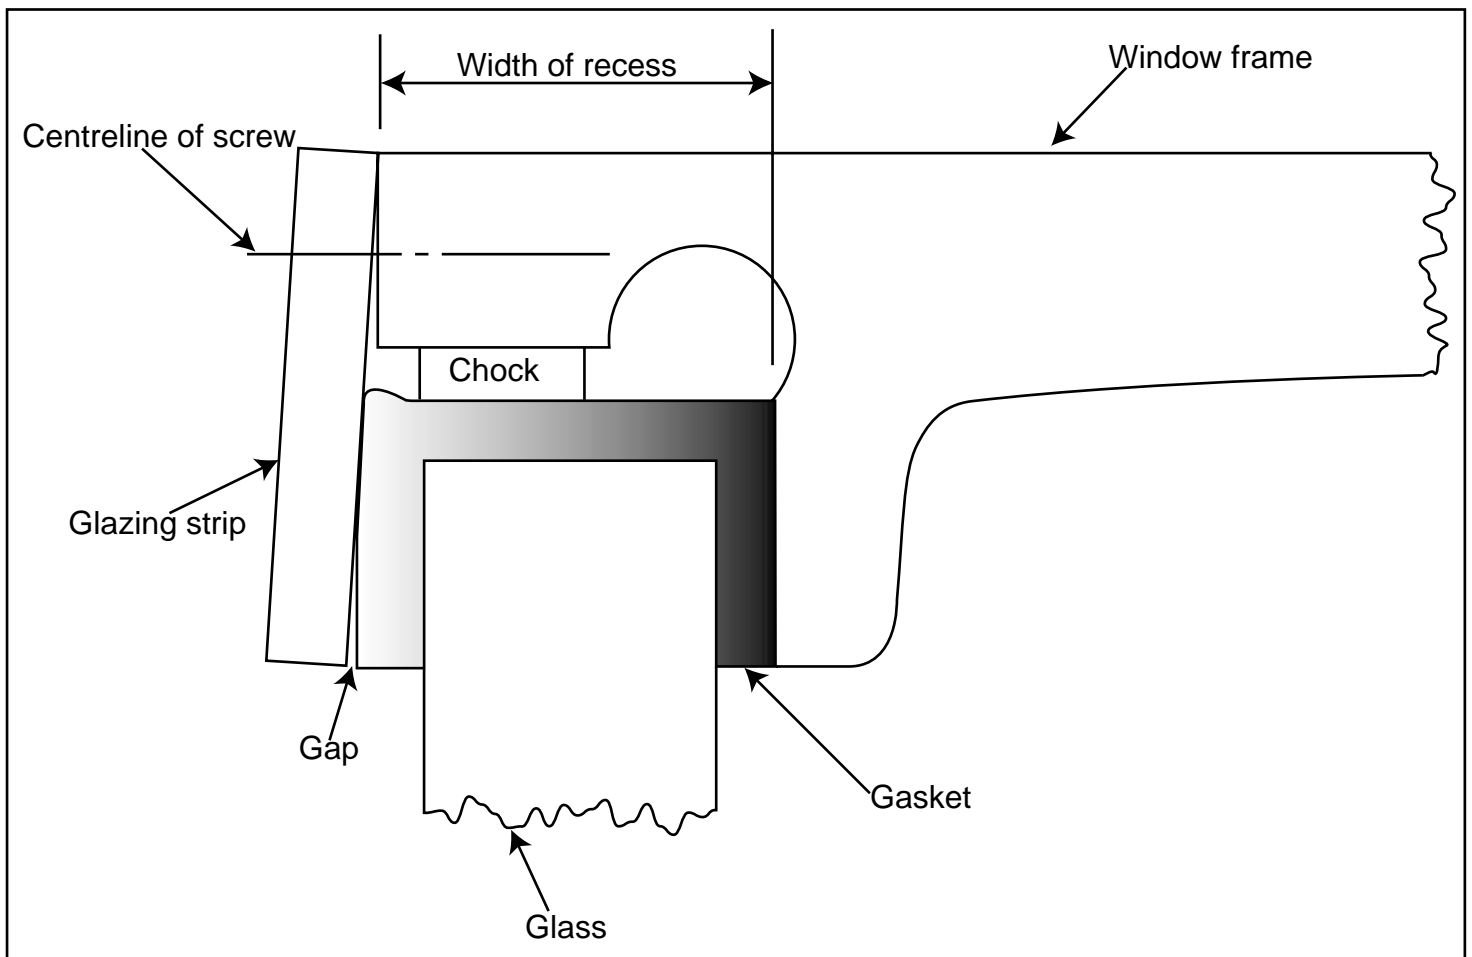
Figure 21

- f. Some gaskets looked different to others, and the hardness appeared to differ. Some windows were fitted with plastic chocks and some were not. It was assumed that the chocks were made from Promasil 850.
- g. Some stainless steel glazing strips were deformed. Where the gasket was too thick for the recess, tightening the screws tended to deform the strip, leading to a gap opening up on the inner edge (**Figure 21**). Consequently, with a gap at the inner edge of the strip, the glass was not clamped properly on the frame.

Diagram showing gap caused by poor fitting gasket

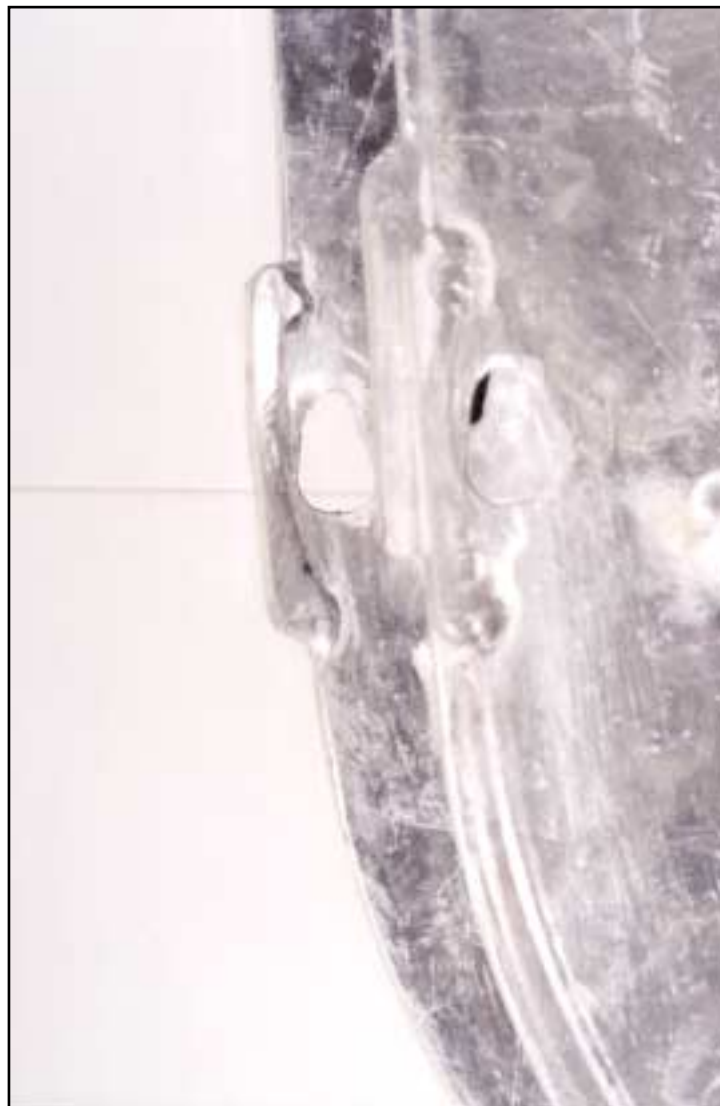
Figure 24

When the windows fitted with storm covers on deck 5 were breached, the storm covers were forced off their mountings by the pressure of the water. The sockets cut in the sides of the storm covers were ruptured as they were pushed off the lugs (**Figure 24**). The storm covers were also bowed.

Photograph of ruptured sockets

Following the fitting of retaining plates to the windows, the arrangements for securing storm covers were also modified. To fit the covers, the old lugs are unscrewed, as these are only retained for cosmetic reasons, and replaced with longer studs. Four spacers, the same depth as the retaining plates, are then fitted. The storm cover is then hung on the studs and secured in position by nuts. The new studs, spacers and nuts, are kept with the storm covers, which are generally stowed in crew stairways.

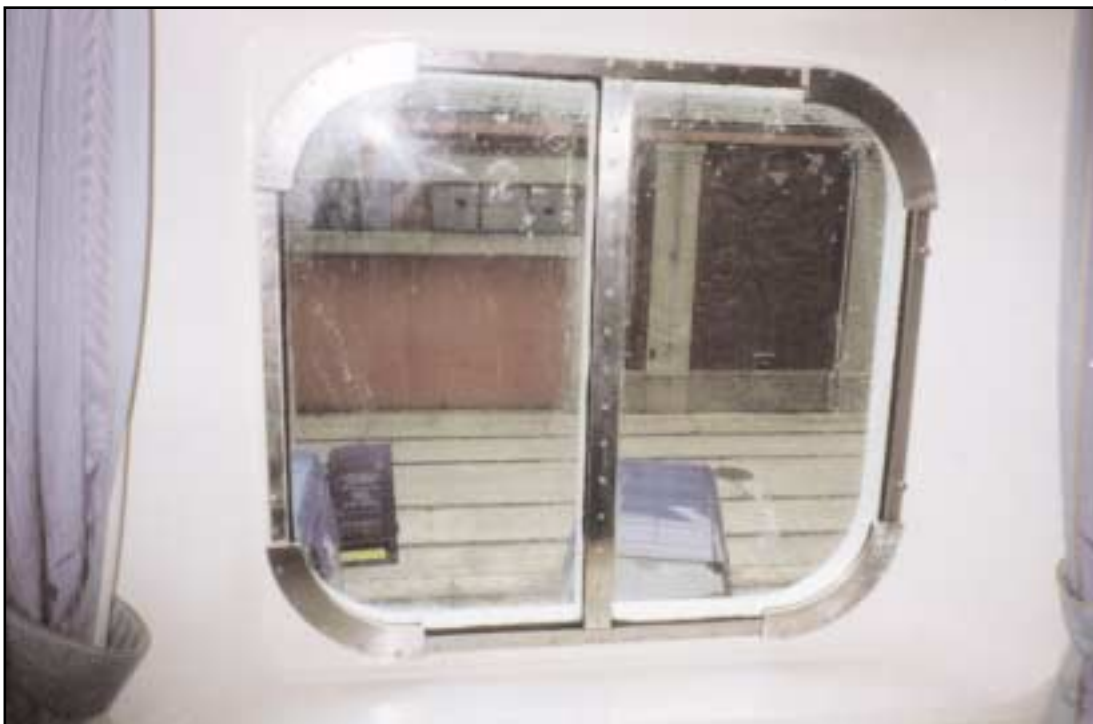
Figure 25

Photograph of window fitted with retaining plates

After the accident, P&O repositioned all window-panes on decks 5 and 6 which were not properly centred, and fitted steel retaining plates to the corners of all windows on decks 5 and 6 (**Figures 25 and 26**). These plates were fitted on top of the existing glazing strip, with the intention of increasing the overlap and the grip of the frame on the glass. No retaining plates were fitted at the junctions between the mullion and the main part of the frame. This work was proposed by Lloyd's Register as a temporary measure, and carried out by P&O to standards approved by Lloyd's Register.
