Report on the investigation of heavy weather
encountered by the cruise ship

Pacific Sun

resulting in injuries to 77 passengers and crew

Report No 14/2009
June 2009

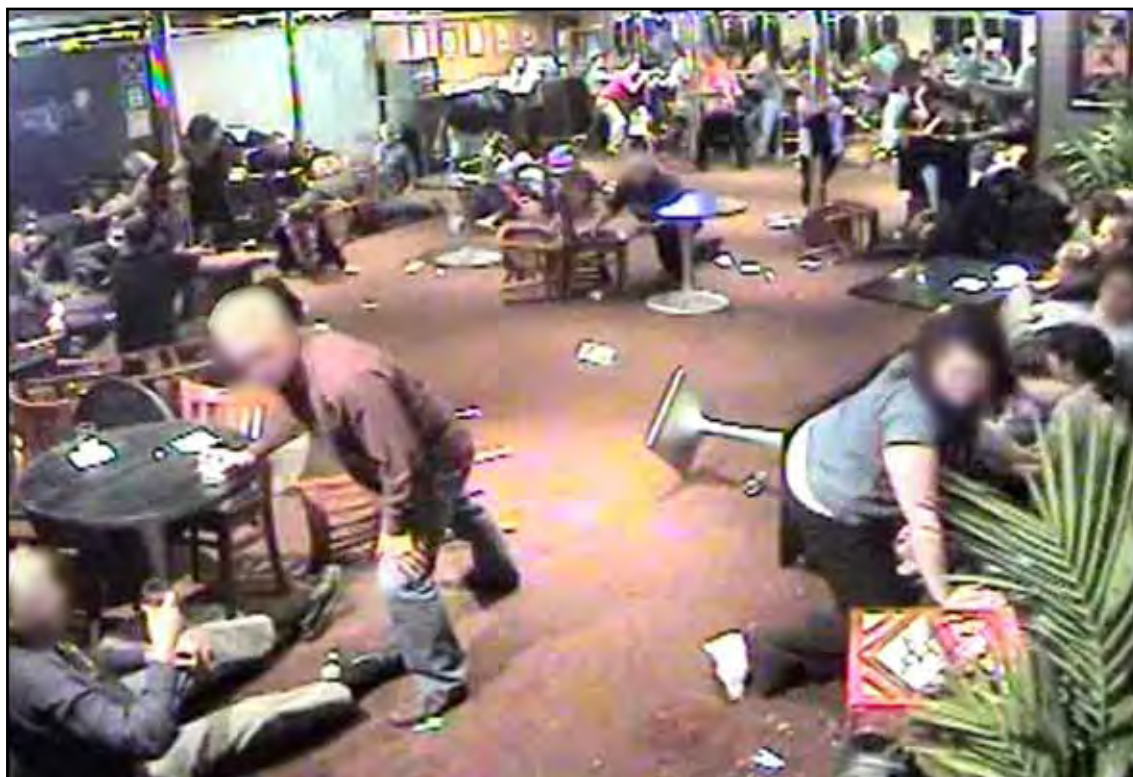
The heavy rolling caused passengers and crew, together with unsecured and insufficiently secured furniture, to move across the ship. The greatest disruption was in the upper deck large public rooms and restaurants where the majority of passengers were located. The accident caused fear and great anxiety among many of the passengers.

Legends Bar, Deck 9, prior to the three large rolls

Legends Bar, Deck 9, following the three large rolls

In the Legends Bar, where bar service was being provided, the effect of the roll can be seen in the 'before' and 'after' pictures at **Figure 4**. The settees, tables and chairs were all able to move freely, and the CCTV footage showed passengers attempting to regain their balance by grabbing at heavy unsecured tables and other unsecured furnishings as they were thrown and fell across the deck. The broken glass, liquids and fallen plant pots added to the hazards the passengers and crew faced, and at least seven injuries were reported from this area.

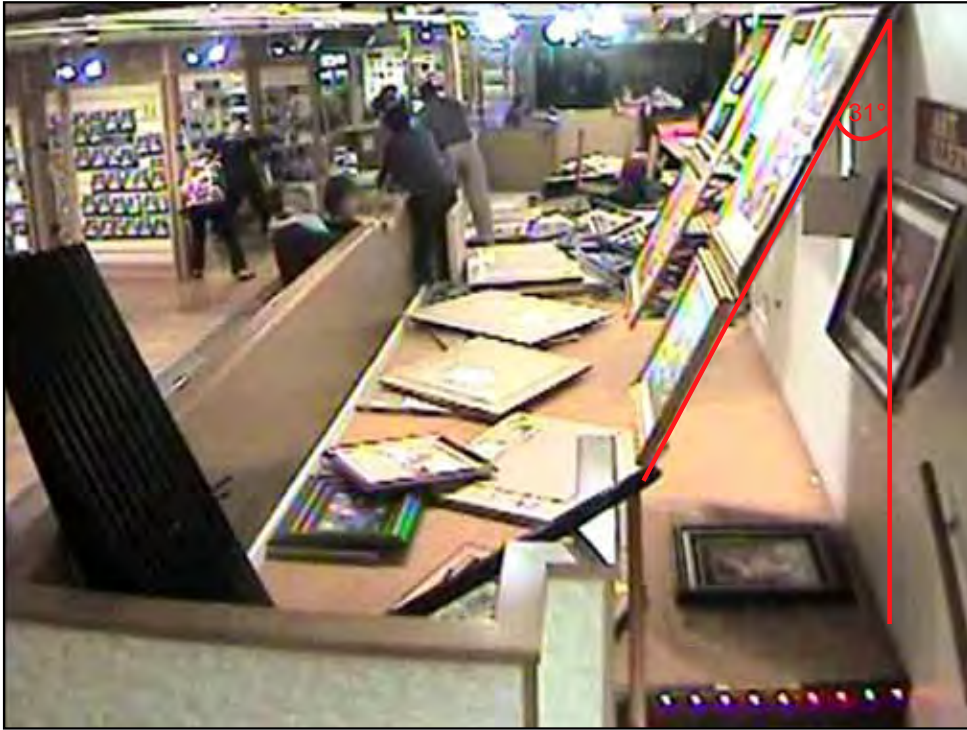
Art Gallery and Photo Gallery, Deck 9, at the largest recorded roll angle

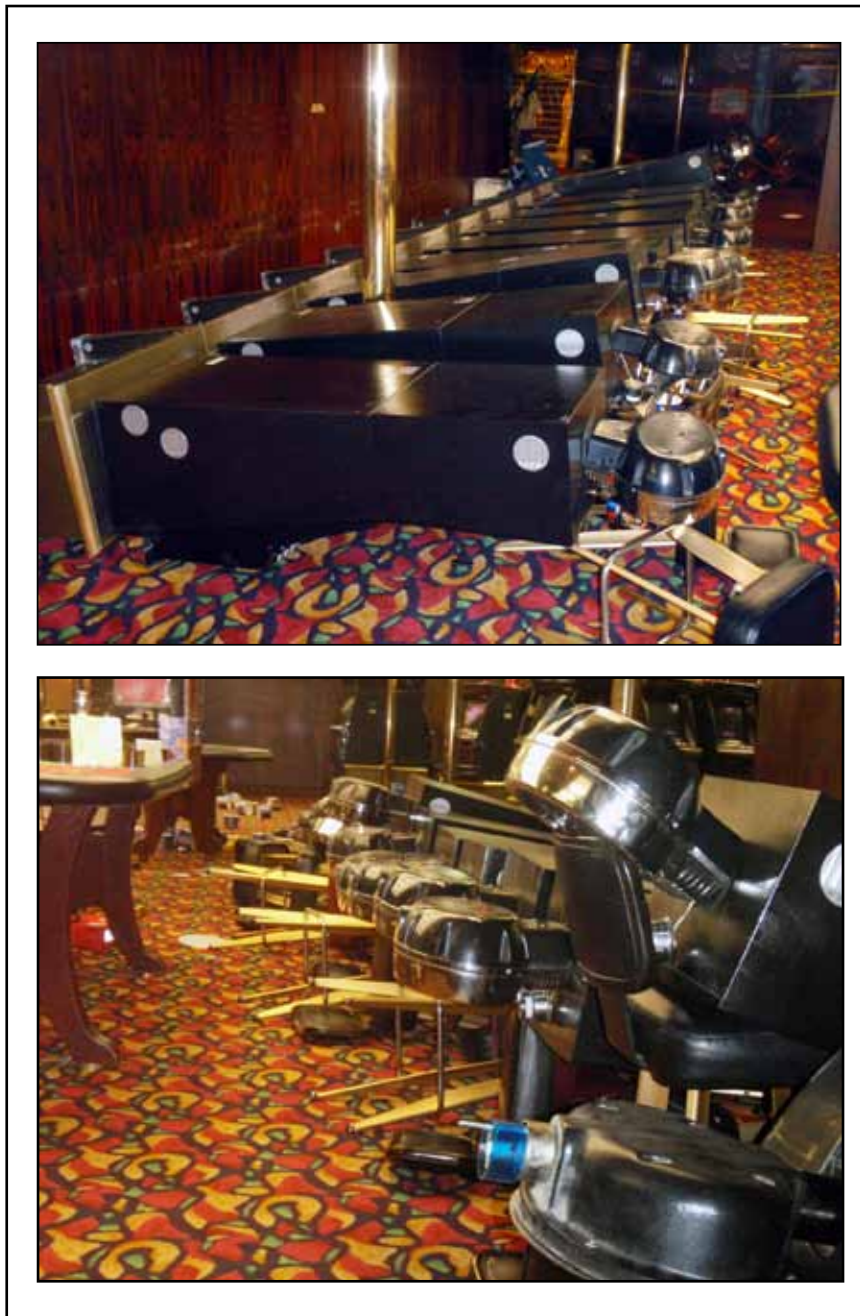
Figure 9

This muster station combined two areas of deck 9. The effect of the rolling in the casino area caused large secured items to move, including a bank of gaming machines to fall from the bulkhead (**Figure 9**). Some passengers only avoided injury because the adjacent chairs prevented the gaming machines from collapsing directly on to the deck. The electronic poker machine (**Figure 10**) came adrift and travelled across the casino deck, causing several reported injuries.

Collapsed casino gaming machines, Casino, Deck 9

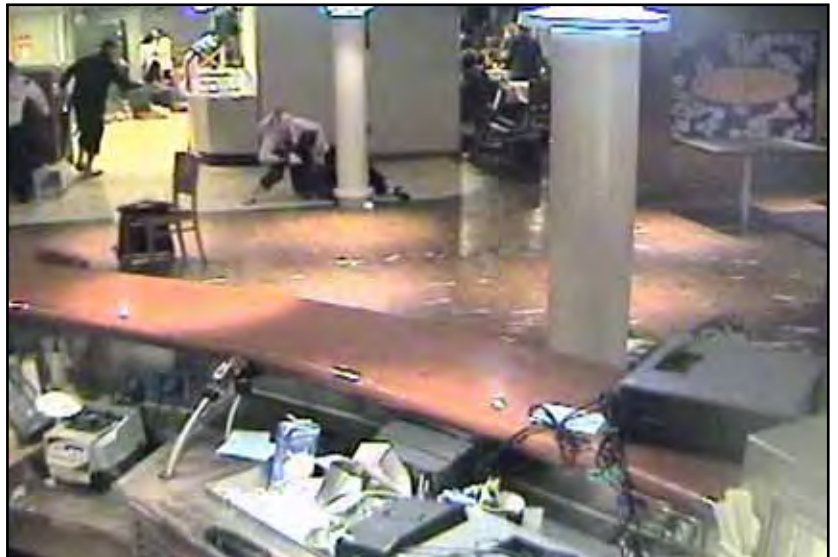
Outlook Bar and Grill - Deck 10, Muster Station C, during the large rolls

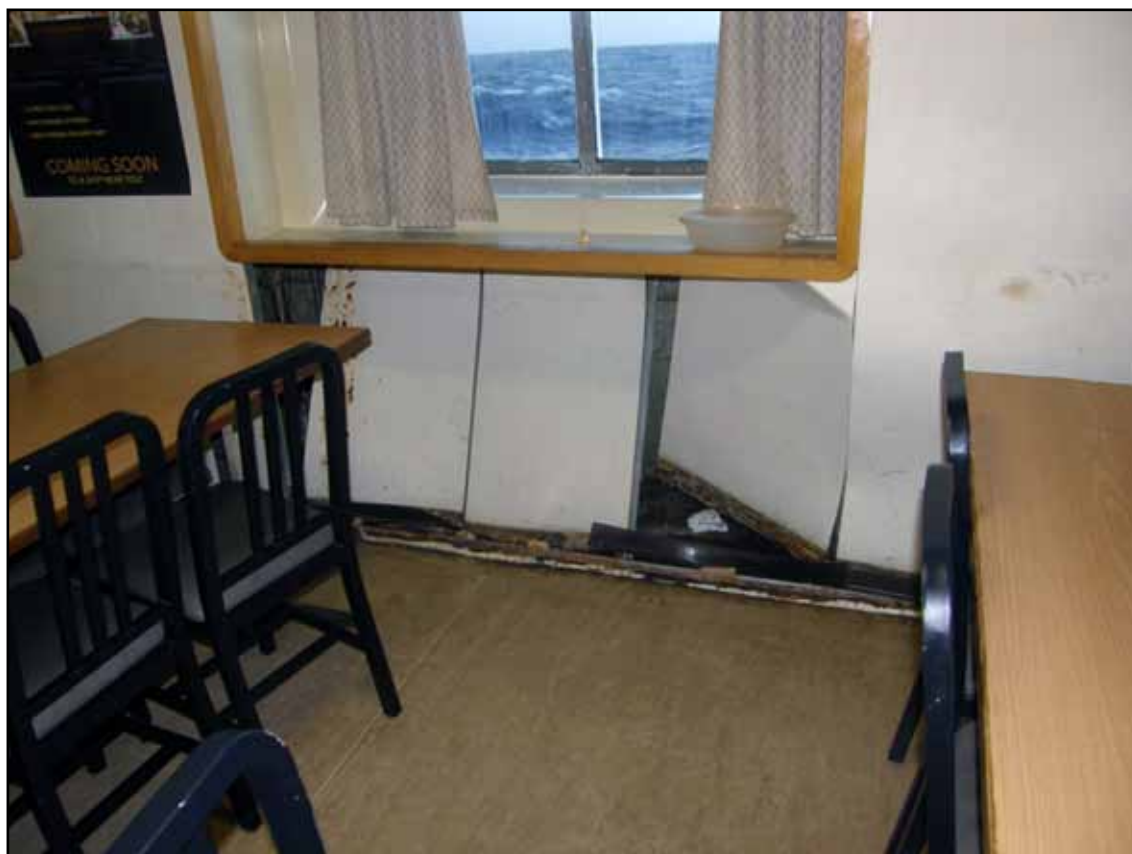
Figure 12

In the officers, staff and crew mess rooms (**Figure 12**), all of which were in use at the time of the accident, no tables or chairs were secured to the deck and all of these moved as the ship rolled.

Damage to crew mess room, Deck 3

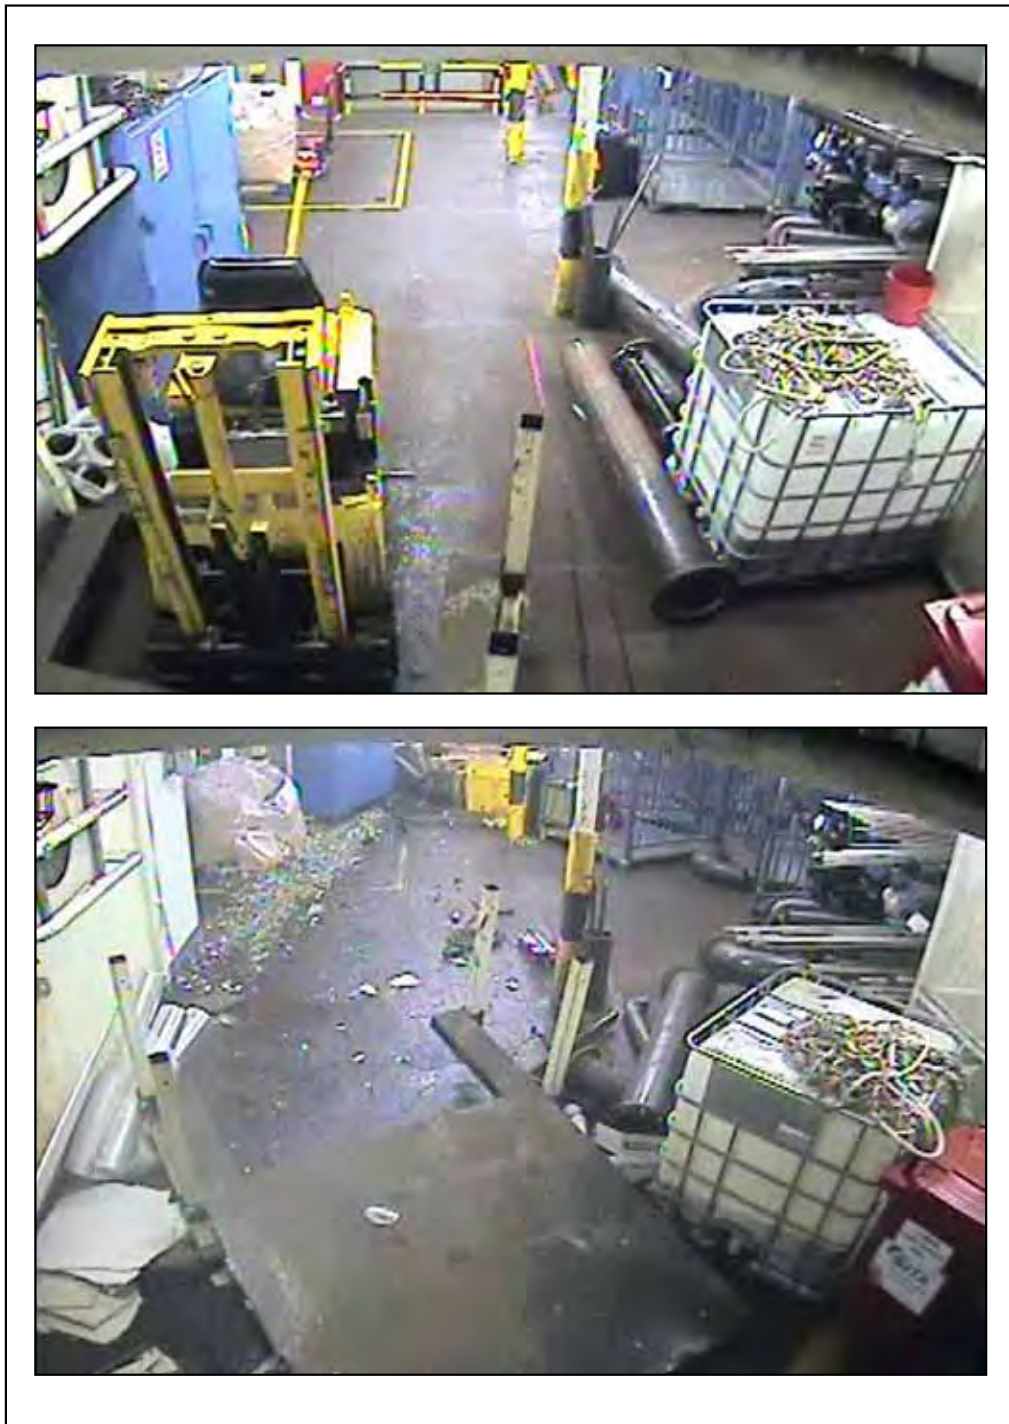
Figure 13

The stores handling area on deck 3 was a busy thoroughfare and served as a storage area for engineering equipment and baggage handling cages. As the ship rolled, a forklift truck which was stowed in this area, several heavy pipes and a number of storage boxes were able to move across the full width of the deck (**Figure 13**). In addition, at the extremities of the rolls the deck 3 shell doors were partly submerged and, as these were not watertight, seawater entered the deck, making it slippery.

Deck 3 handling area and crew main access, before and after the large rolls

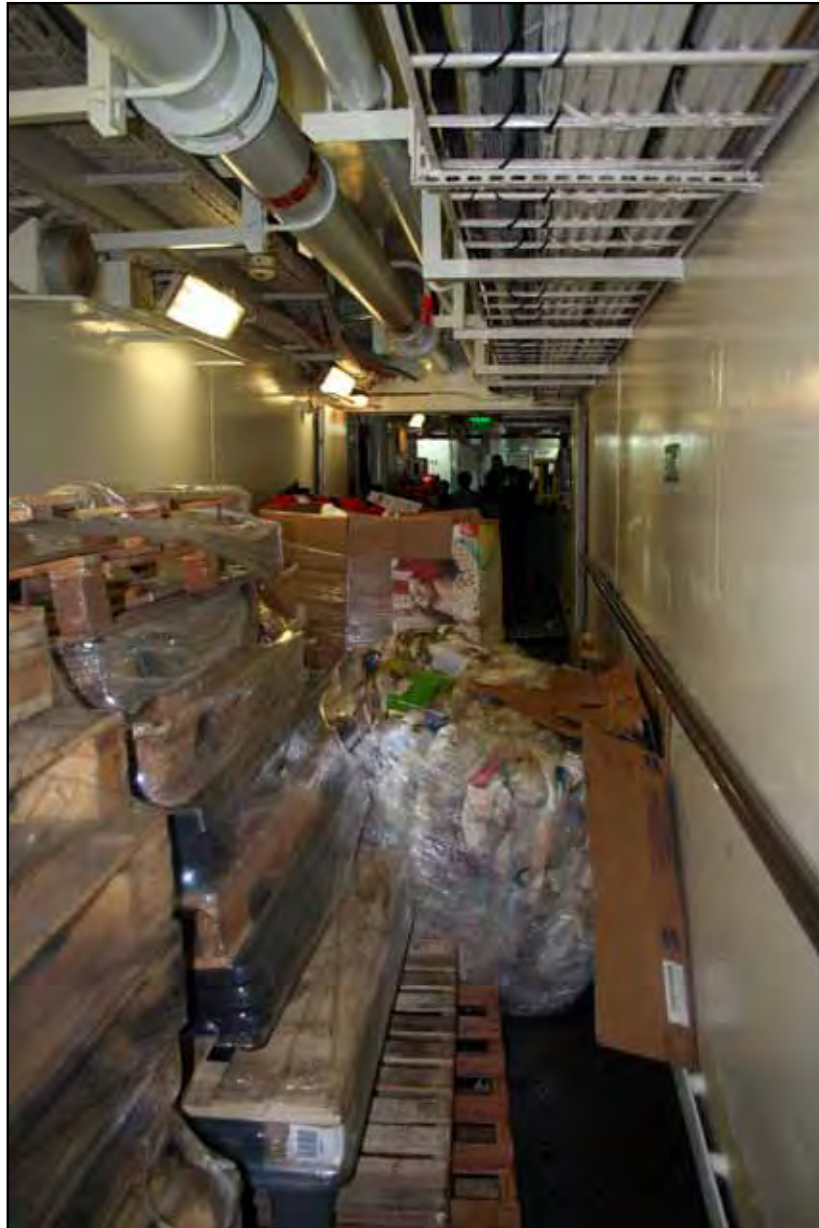
Figure 14

In preparation for arrival in Auckland the next day, the crew had started to place on deck 3 the garbage and other equipment for landing, and some of these stows collapsed, blocking alleyways (**Figure 14**).

Deck 3 - main crew alleyway after accident
