Fatal man overboard from *Apollo* (INS 179) 30nm north-west of the Orkney Islands 18 April 2016

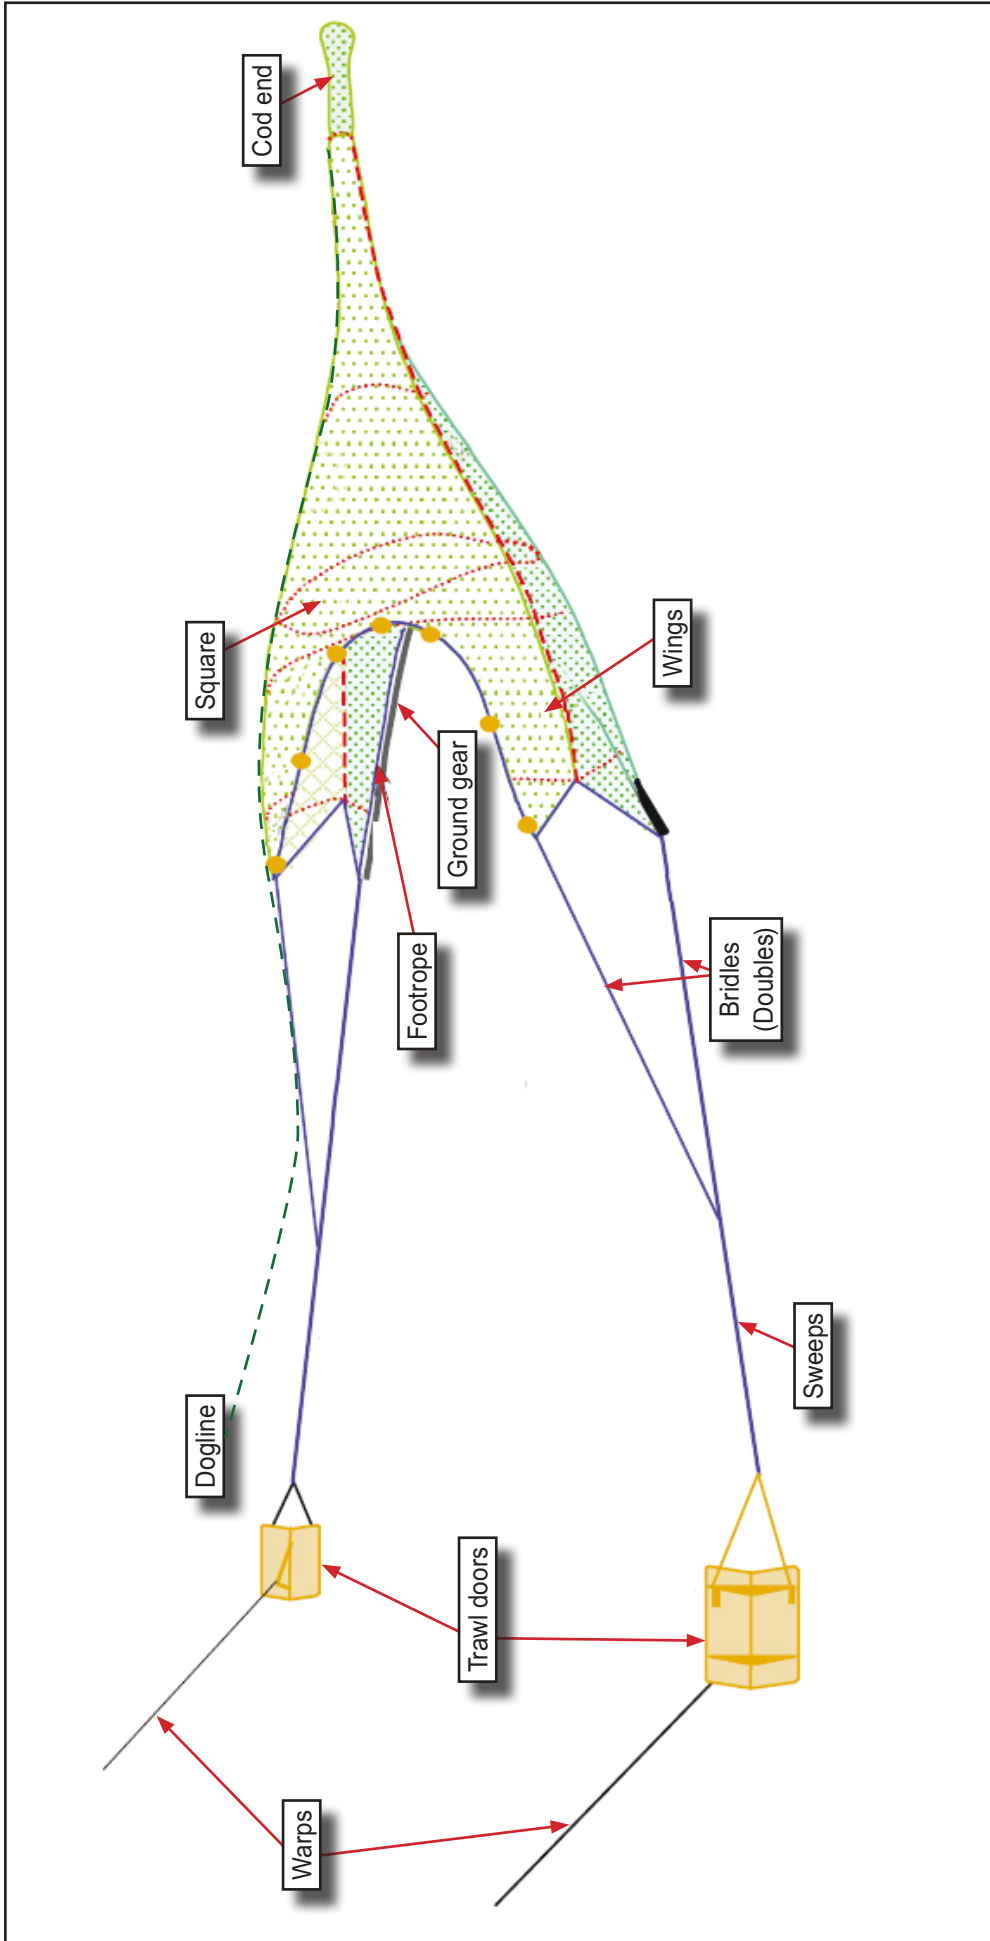
Figure 2: Trawl gear in use on Apollo

At 0620 the trawl doors were recovered and secured, and the sweeps and bridles³ (**Figure 2**) were then transferred onto the forward starboard net drum (**Figure 3**).

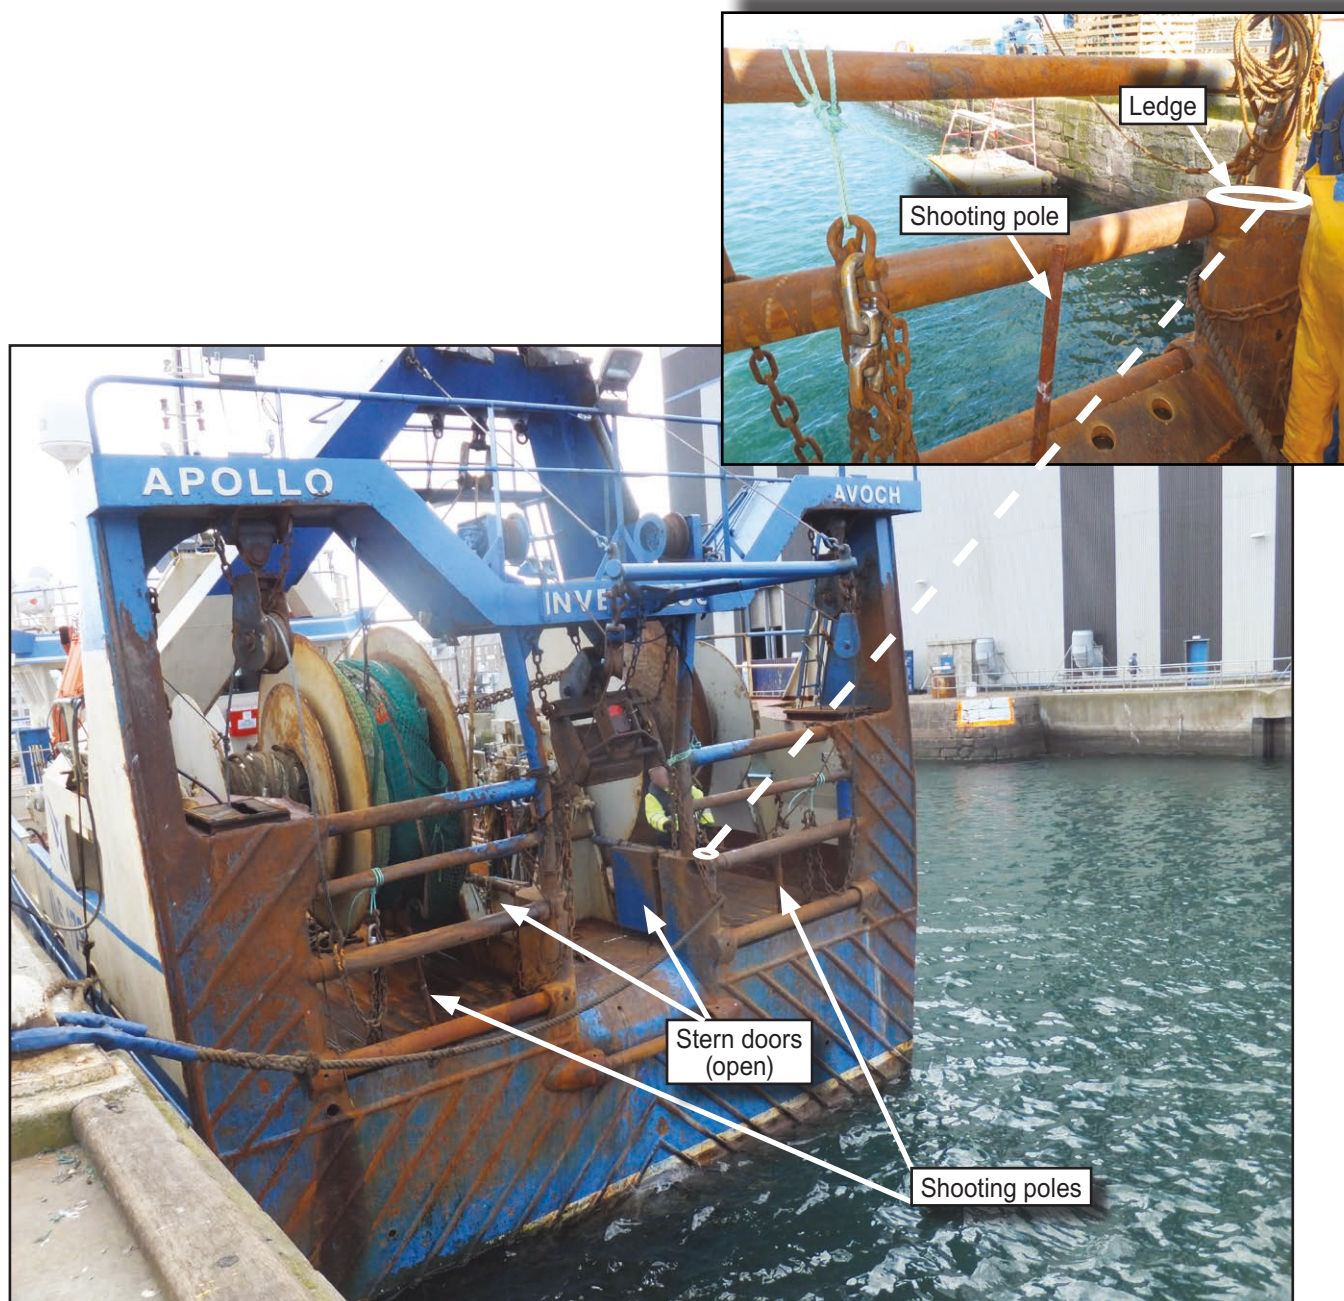
Craig had been standing on a narrow ledge at the stern (**Figure 4 inset**), 1m above deck level, when the shooting pole was pulled out. He was then seen to fall and land on his side in the unguarded area aft of the bagging hatch, the stern doors having already been opened in preparation for the recovery of the cod end of the net.

Figure 4: *Apollo* – stern doors and shooting poles
(inset: shows the ledge where Craig was standing at the time of the accident)

When the shooting pole was dislodged, Craig was standing on a narrow ledge at *Apollo*'s stern, 1.0m above deck level, and he was holding onto a section of the stern gantry.

The ledge was not designed to be used as a platform and there were no dedicated hand-holds or protective barriers. However, crew members had regularly used this ledge when hauling nets, particularly in rough weather, to avoid getting their feet wet when waves were washing over the deck, as on this occasion.

It is known that there was a loud noise when the pole was violently dislodged, and that this occurred just before Craig was seen to fall from the ledge. There is no evidence to suggest that the pole hit Craig but it is thought probable that the sudden noise of the pole being pulled out and falling to the deck, combined with the movement of the vessel, caused him to lose his grip and fall to the deck.

Following the accident, the task of lifting out the shooting poles on *Apollo* was reviewed and mechanised by the installation of a remotely controlled winch that lifted a wire attached to the top of the pole. Substituting a winch mechanism for the manual method of removing the shooting poles was a more effective control measure than requiring the crew to wear PPE for the task as it has removed the need for a crewman to stand at the stern while hauling nets.

- Introduced a mechanical system for lifting the shooting pole to avoid the need for a crewman to lift it from its housing.
- Issued each crewman with an ISO 12402 PFD and mandated that the crew wear their PFD and hard hat when working on deck.
- Purchased and trained the crew in the use of a new man overboard recovery system.
- Re-emphasised to the crew that safety harnesses and lanyards must be worn when working in elevated or exposed locations on board.
