Securing of RORO Cargo

Introduction

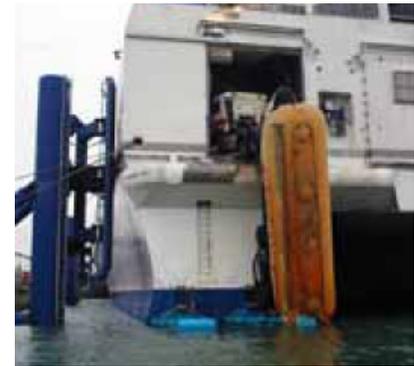
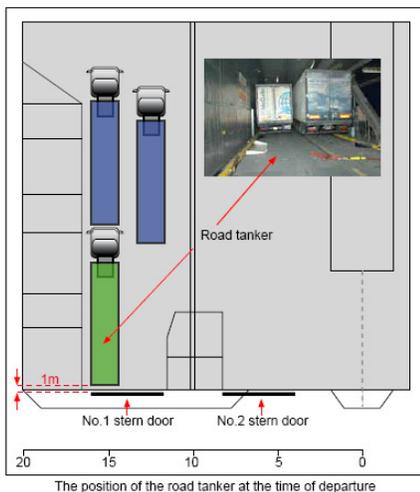
shell door was missing, a HGV tractor unit was wedged up against the internal insulation at the top of the door opening, and the trailer unit was hanging vertically over the stern. The tractor unit subsequently returned towards deck level where it was secured in position, and the trailer unit rested vertically on top of no.2 waterjet.

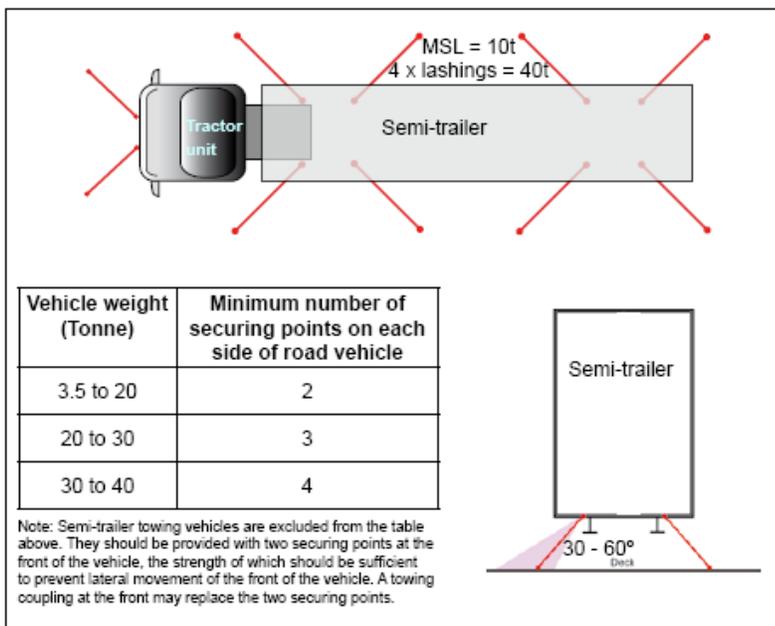
CSS Code ferry securing ring guidance

3. The two ferry securing rings fitted on each side of the forward end of the trailer unit and the absence of any rings on the tractor unit did not comply with the guidance contained in the CSS Code or the International Organisation for Standardization (ISO) standards: Lashing and securing arrangements on road vehicles for sea transportation on Ro/Ro ships – General requirements – ; ISO 9367-1; Part 1: Commercial vehicles and combination vehicles, semi-trailers excluded, or ISO 9367-2; Part 2: Semi trailers.

4. Haulage contractors should be encouraged to fit ferry securing rings to both their tractor units and trailers, in line with the requirements of the ISO standards.
