# Crew member fatality on board the bulk carrier *Polska Walczaca* at sea off Queensland 15 November 2010

## Abstract

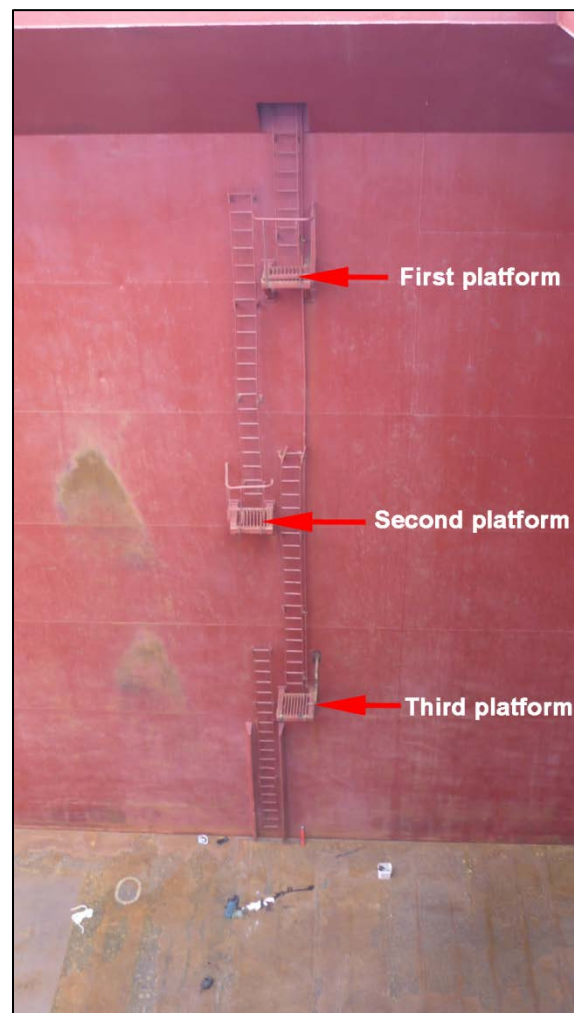
When the cargo hold cleaning was completed, the chief mate inspected the holds to check that they were ready for loading. He noted that there was some water in the hold bilge wells and that the handrail around the third platform of the number five cargo hold ladder was damaged and would need to be repaired (Figure 2).

**Figure 2: Number five cargo hold ladder: note that the handrails have been removed from around the third platform**

The dimensions of the ladder platforms were about 810 mm x 900 mm. They were designed as a landing to hold a single person while moving from one section of ladder to the next. The third platform was about 5 m above the tank top and its hand railings had been removed. It is also likely that the storekeeper, a welding machine and its power cables, a bucket of tools, a safety harness and sections of hand railing were all on the platform at the time. Furthermore, the fitter had rigged a light about 1 m above the platform and this would have added to the congestion on the platform.

As a result, the platform would have been very congested and a dangerous place to stand and work.

There is no evidence that indicates why the storekeeper fell. However, it is possible that he had started working on the third platform and that he tripped over one of the many items on the platform and, with no barrier to prevent a fall, fell to the tank top below.

- It is likely that, when he fell, the storekeeper was working on the third platform of *Polska Walczaca*'s number five cargo hold ladder, about 5 m above the tank top.
- The third platform did not have any hand railings. The storekeeper had removed the hand railings and was in the process of re-fitting them when he fell.
- The storekeeper was not wearing an appropriately fitted and tethered safety harness when he fell.
- The storekeeper was wearing a hardhat when he fell, but its chinstrap was probably not properly fastened. As a result, the hardhat did not offer the protection it may have had it been properly secured.
