# Risk Alert

## RA74 - Containerised Cargo – Stowage and Securing

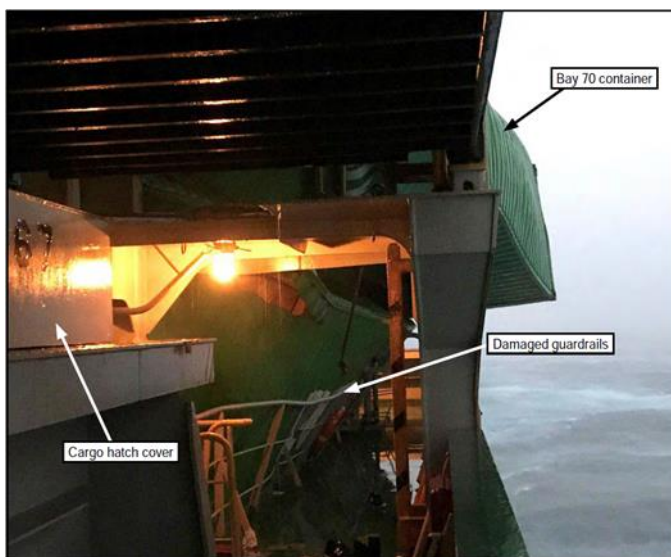
Once the weather had abated, the crew discovered that the container stacks on the aft most bay had collapsed

and toppled to port. Of the 151 containers in the stow, 42 were lost overboard and 34 were damaged. Superficial damage was caused to the ship.

View from main deck. Ref: [MAIB report no 14/2020](#)

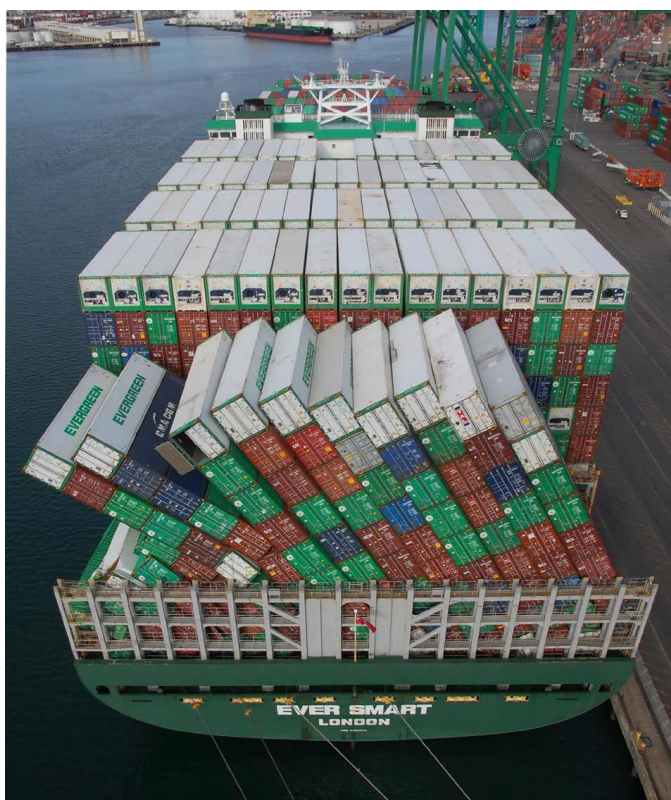
Stern. Ref: [MAIB report no 14/2020](#)

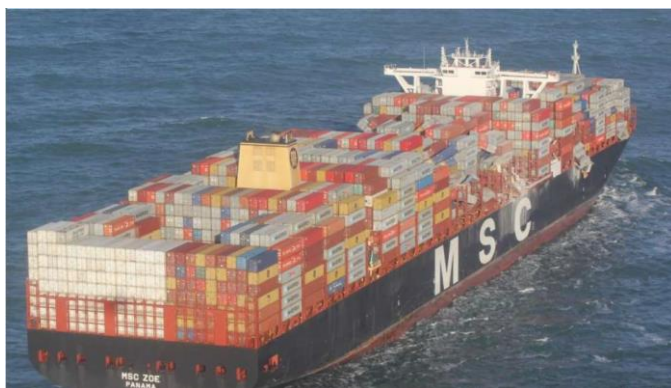
On passage from Sines, Portugal to Bremerhaven, Germany - While sailing along the North Sea Traffic separation scheme (TSS) Terschelling – German Bight January 1 & 2 2019 vessel lost 342 containers overboard.

Starboard side: Ref: [Joint investigation report - MSC Zoe 01 - 02 Jan 2019](#)

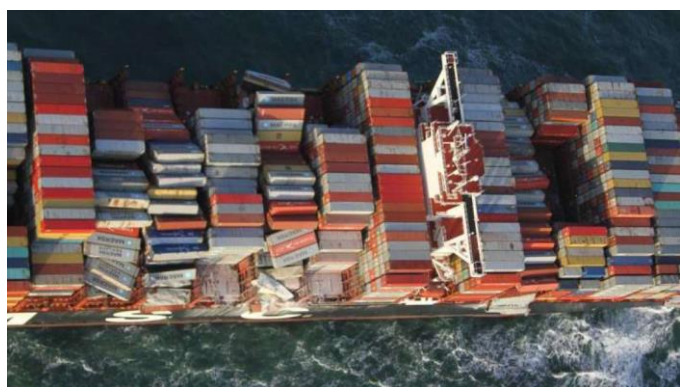
View from top: Ref: [Joint investigation report - MSC Zoe 01 - 02 Jan 2019](#)

Attempts to assess the damage was difficult due to the darkness and fallen containers on deck obstructing access. Containers in bay 58 were noted to have collapsed and were hanging overboard and a similar situation was noted in bays 10 and 26.

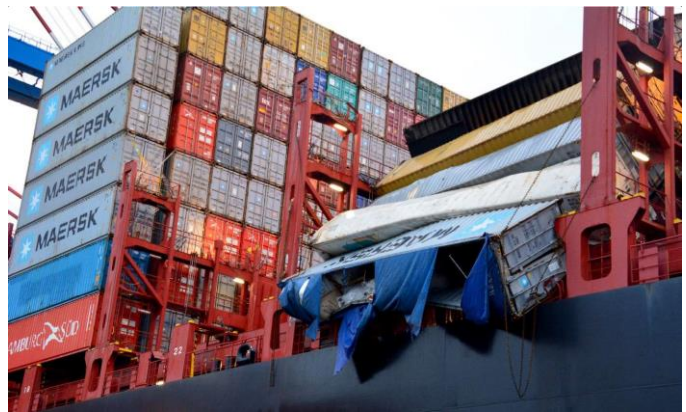
Container with polystyrene balls hanging overside Bay 26: Ref: [Joint investigation report - MSC Zoe 01 - 02 Jan 2019](#)

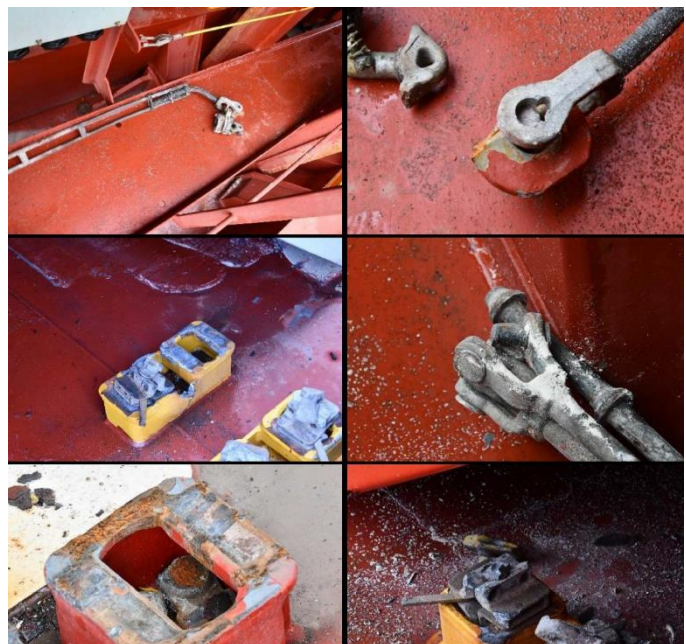
Crew retightened loose lashings. Various loose parts of the lashings were noted, including tensioners from the lashing rods, hooks and locking pins, some twistlocks were noted broken in two.

Broken lashings (Source: German water police) : Ref: [Joint investigation report - MSC Zoe 01 - 02 Jan 2019](#)

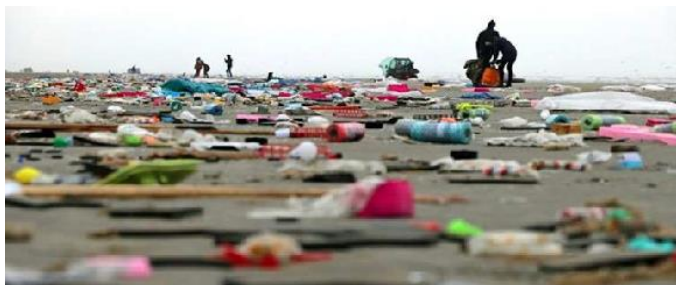
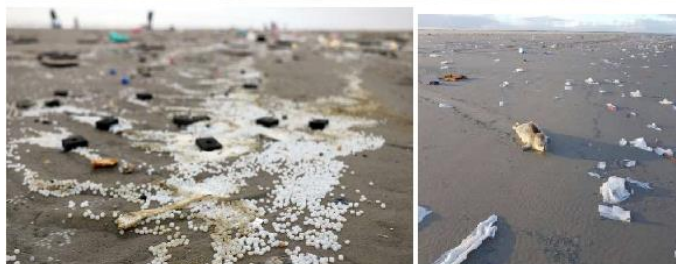
Cargo Debris on Wadden Island: Ref: [Joint investigation report - MSC Zoe 01 - 02 Jan 2019](#)

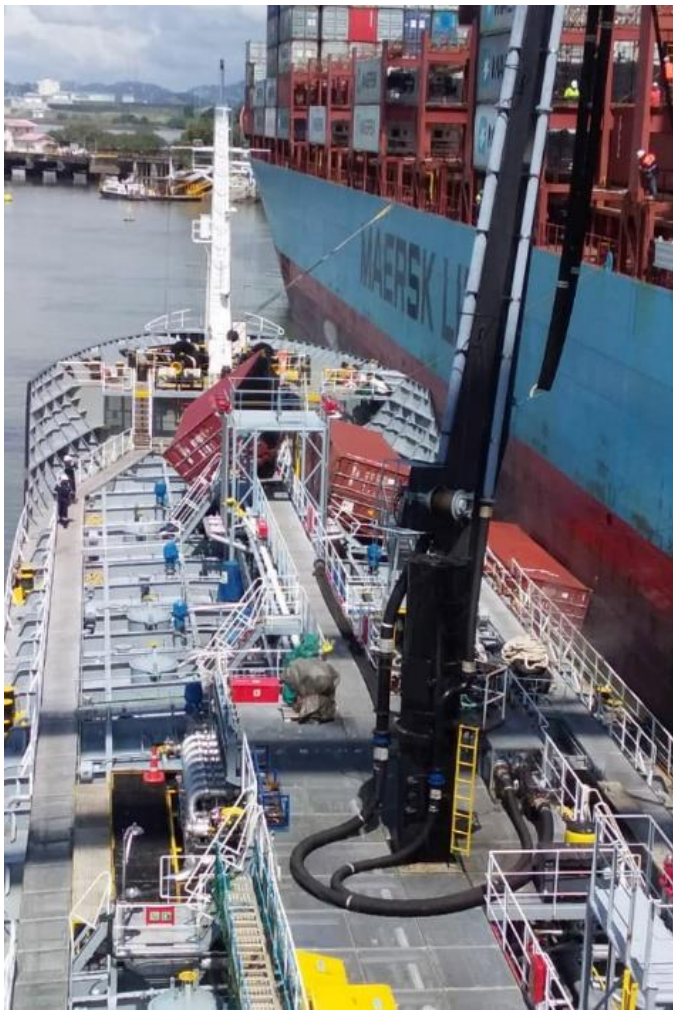
2 containers on deck / 1 container between the vessels Source: 'Marine Traffic Maritime News' - [Containers crashed on bunker tanker from MAERSK container ship](#)

Stack collapse or falling containers when alongside a berth during cargo operations is possible since during this period (loading discharging of containers) the twistlocks/base locks of the bays being worked would ordinarily be in an unlocked position and the cargo lashings removed.

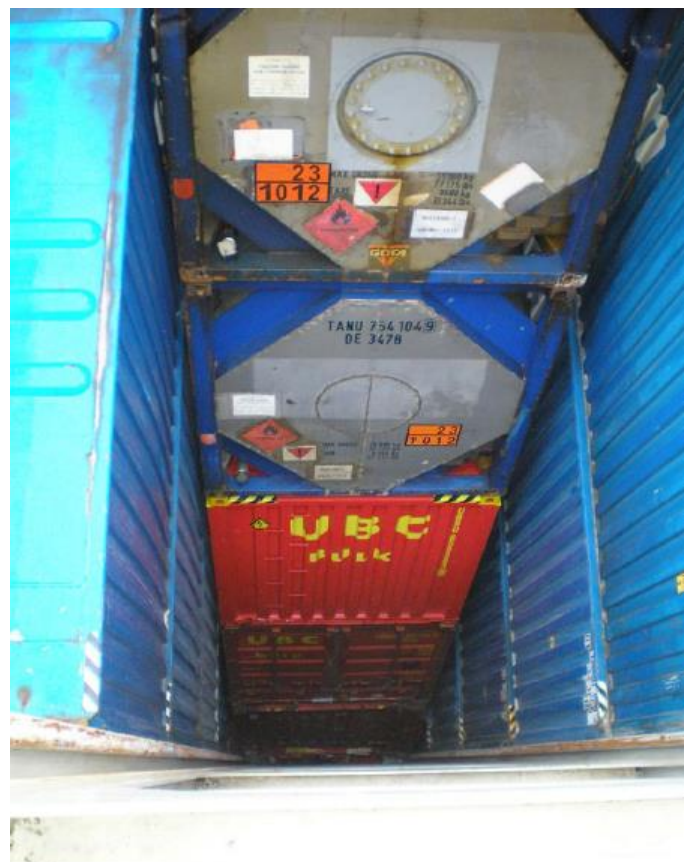
The collapse of cargo containers occurred as a result of downward compression and racking forces acting on the lower containers of the stack, which were not strong enough to support the stack as their maximum allowable stack weight had been exceeded.

The total weight of the seven containers in the stack was 225 tonnes. The cargo securing manual indicated that the maximum permissible stack weight for 30 foot containers loaded in this location was 150 tonnes. Furthermore, the lower four containers in the stack each had a maximum allowable stacking weight of approximately 100 tonnes.

Looking down on the aft end of the collapsed stack of containers, Ref: [MAIB Report No 21/2007](#)

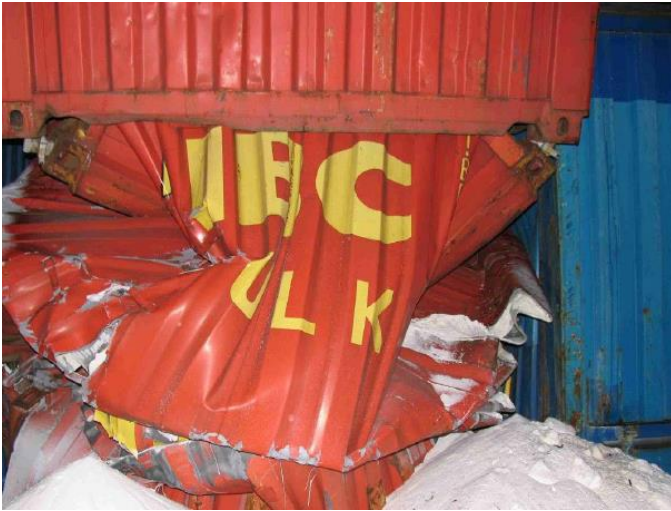
Crushed container at the bottom of the stack. Ref: [MAIB Report No 21/2007](#)

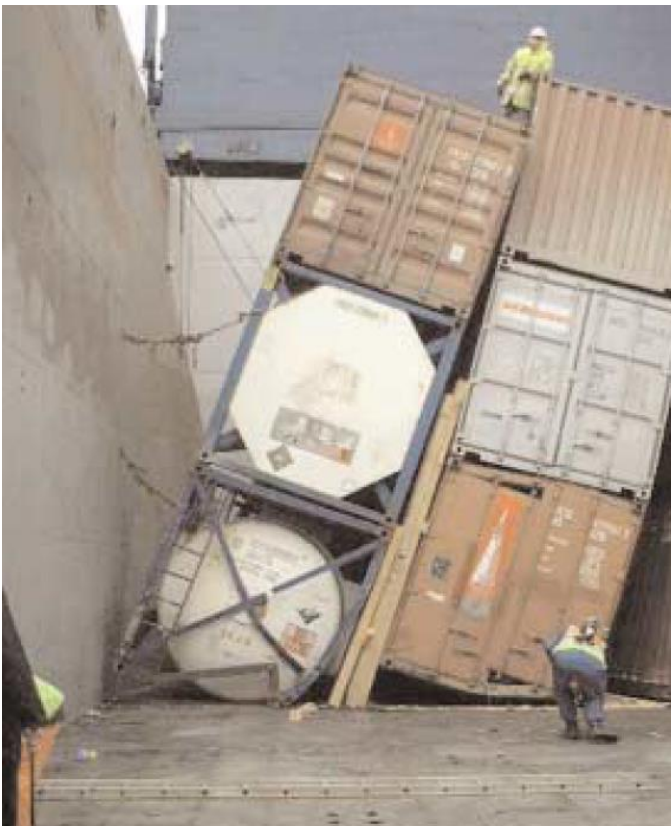
The investigation found that the masses of each of the three stacks of containers in Bay 1 of Dutch Navigator exceeded the limits set out in the vessel's cargo securing manual. This resulted in the lower containers being subjected to racking loads, greater than their design value, while the vessel was on passage. A damaged tank container was one of these at the bottom of a stack and was severely damaged. Further, both tank containers were over-stowed, which is not in compliance with the International Maritime Goods Code and UK Regulations.

Stow in Bay 1 looking forward - Ref: [MAIB report no 37/2002](#)

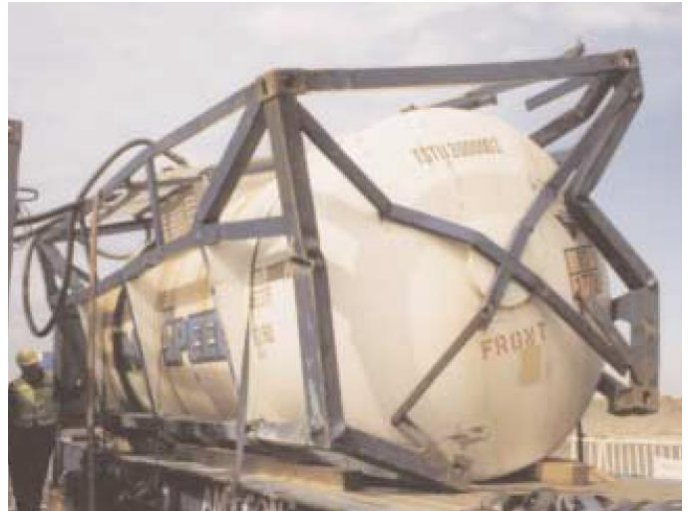
Damaged front end frame - Ref: [MAIB report no 37/2002](#)

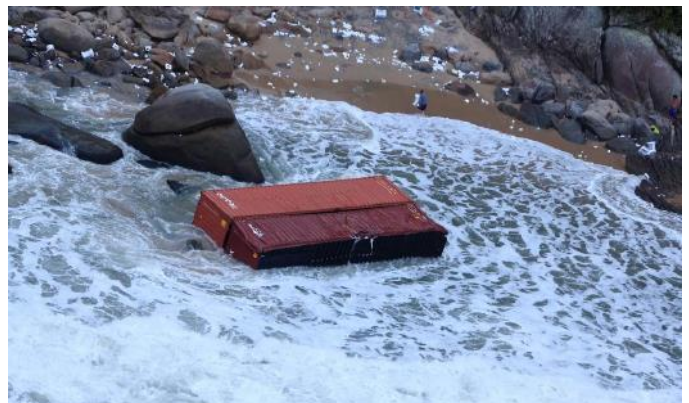
Containers washed up on remote beach
