The Bahamas
Maritime Authority

“M.V Bulk Jupiter”

Report of the marine safety investigation into the loss of a bulk carrier in the South China Sea on January 2nd 2015

Date of Issue: 18th August 2015

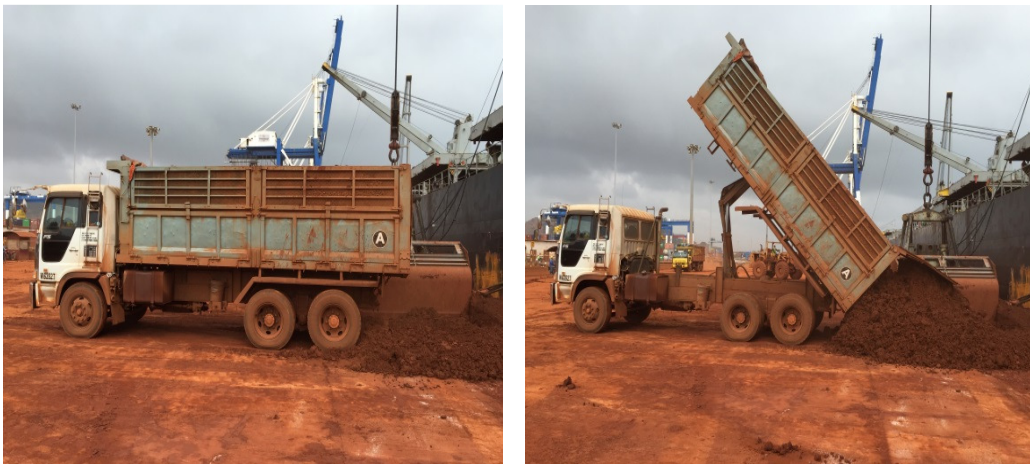
2.4.9 The loaded trucks, which are generally not covered as shown in figure 6, if coming from within the port or nearby stockpiles, dump the cargo on to the quayside (Figure 6).

Figure 6: Truck unloading Bauxite on quayside

2.4.11 During periods of rain vessels generally close their hatch covers to prevent any moisture from entering cargo holds and maintain the cargo in a dry condition. However, any cargo left on the quayside is left uncovered and therefore exposed to the elements.

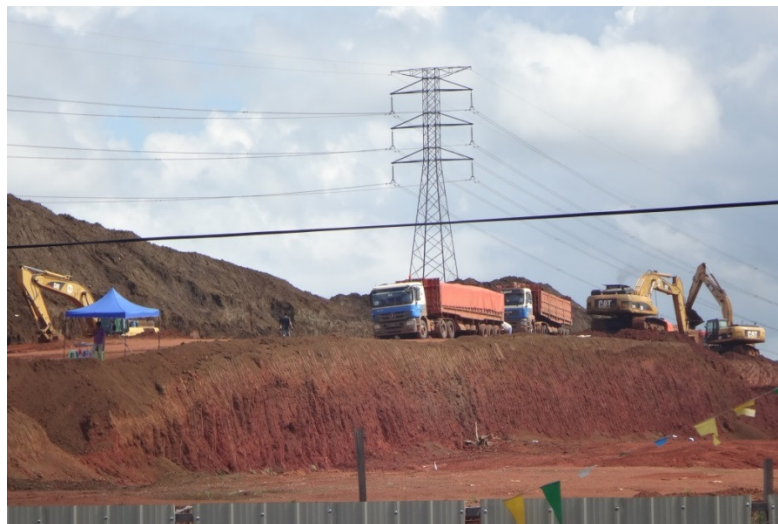
2.5.5 There are a number of mines dotted around Kuantan Port with varying sizes of operations. Some mines simply excavate bauxite and transport the product via trucks while other, typically larger, mines both excavate and process the mineral. In either case, there is no covered storage facility that affords any protection from the rain or surface water runoff. Occasionally protection was provided to the bauxite when it was transported by truck from outside the port; it was covered by a tarpaulin (Figure 9).

Figure 9: Truck transporting Bauxite covered by tarpaulin

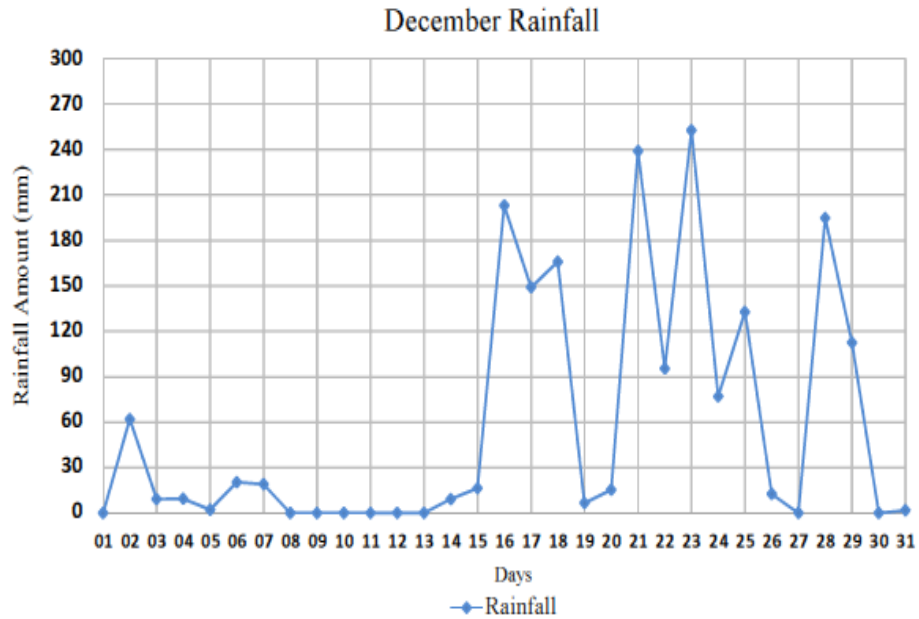
4.3.3 The signed declaration¹⁶ provided by OXY PTE LTD (shippers) on 11th December in Kuantan concludes two vital pieces of information which may have been early indicators as to the condition of the cargo prior to loading bauxite. The date at which the declaration was made was 6 days prior to the vessel commencing loading and was signed by the shipper when the Bulk Jupiter was still on passage to Kuantan anchorage from Thailand. Rainfall figures (Figure 22)¹⁷ for the days preceding the 11th December indicate that 122.2mm of rainfall had fallen in Kuantan. However, 377.6mm of rain had fallen in the same region between the signature of the declaration and the vessel commencing loading (6 days later).

Figure 22: December rainfall in Kuantan

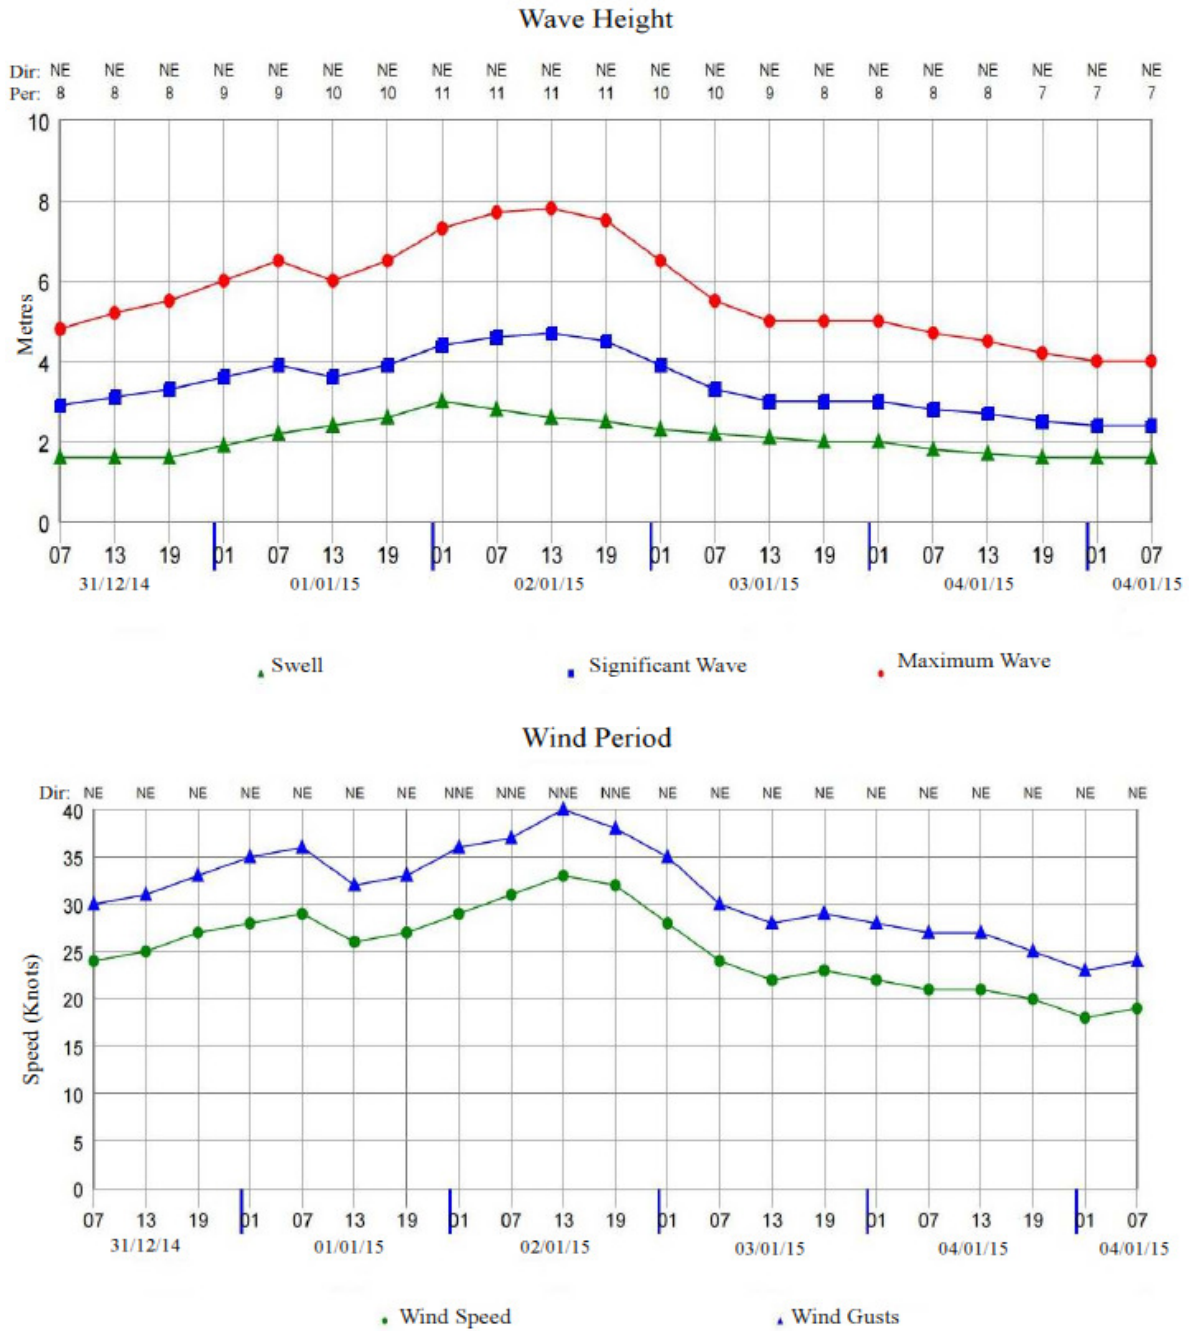
- 4.5.1 The statement provided by the Chief Cook contains several factors that are possible indications of an unstable cargo. However the downgraded tropical depression delivering gale force winds and very rough seas apparent from the description of the vessel's motion are also worthy of consideration as a contributory factor.
- 4.5.2 A weather report produced by 'm.v Toisa Dauntless' at 1000 on the 3rd January descibed the conditions as North Easterly wind 30kts, wave height of 5m. The recorded weather experienced over the period (see Figure 27) provides data on wave height and wind periodicity for the duration of the SAR operation. The data provided by 'm.v Toisa Dauntless' is considered an accurate reflection of the experienced conditions, particulalry when aligned with that of the recorded data from other sources.

Figure 27: Actual recorded data for wave height and wind strength for the region

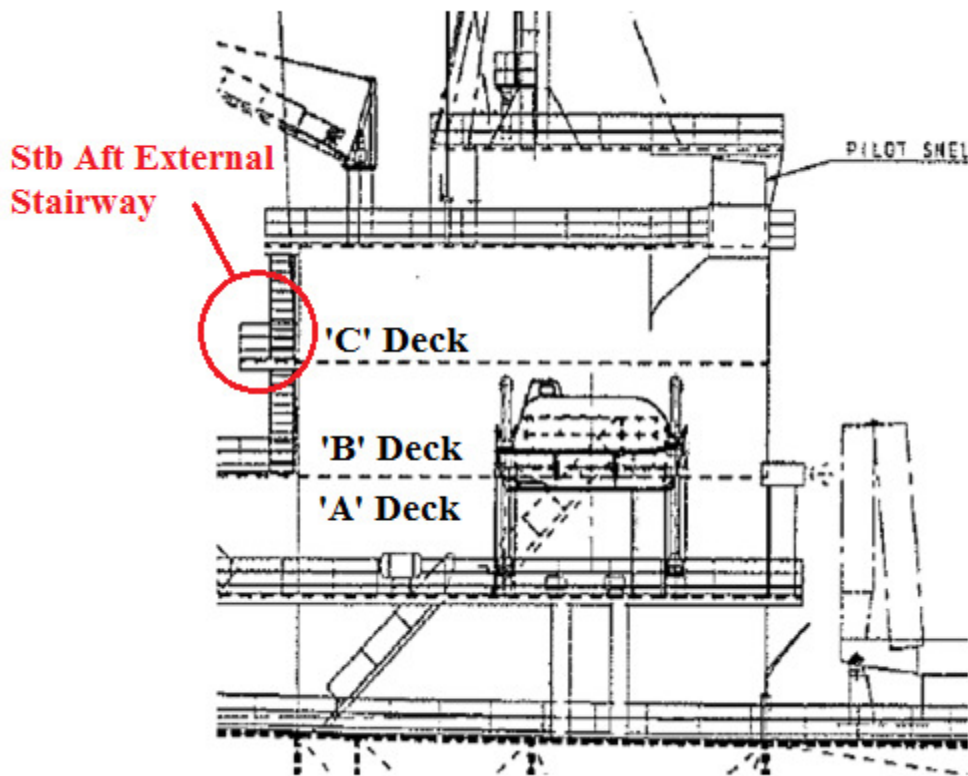
- 4.6.8 It is known that the Master and Chief Cook proceeded to the starboard aft ladder platform on 'C' deck prior to abandoning ship (see figure 28); it was observed by the Chief Cook that he suspects that the vessel was "*at an angle of heel of approximately 45°*" as the platform edge was at sea level. The vessel quickly reached the point of vanishing stability which is a point of unstable equilibrium. Any heel smaller than this angle will allow the vessel to right itself, while any heel greater than this angle will cause a negative righting moment (or heeling moment) and force the vessel to continue to roll over. When a vessel reaches a heel equal to its point of vanishing stability, any external or internal force can cause the vessel to capsize. Therefore at the point where the deck was submerged, an internal factor, such as unstable cargo, cargo displaced to starboard or a free surface water effect generating enough momentum to initiate a heavy roll to starboard, when combined with the effects of the shifting of the cargo would lead to the vessel exceeding the vanishing point.

Figure 28: Master and Chief Cook disembarkation location

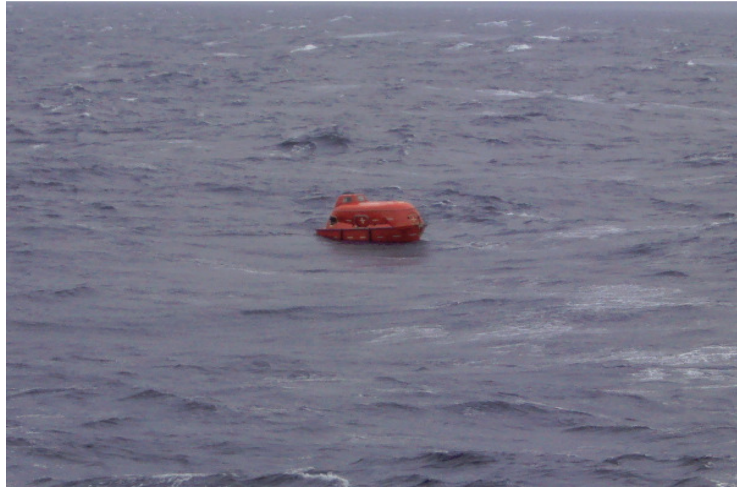
Figure 29: Bulk Jupiter lifeboat as seen from 'm.v Zim Asia'

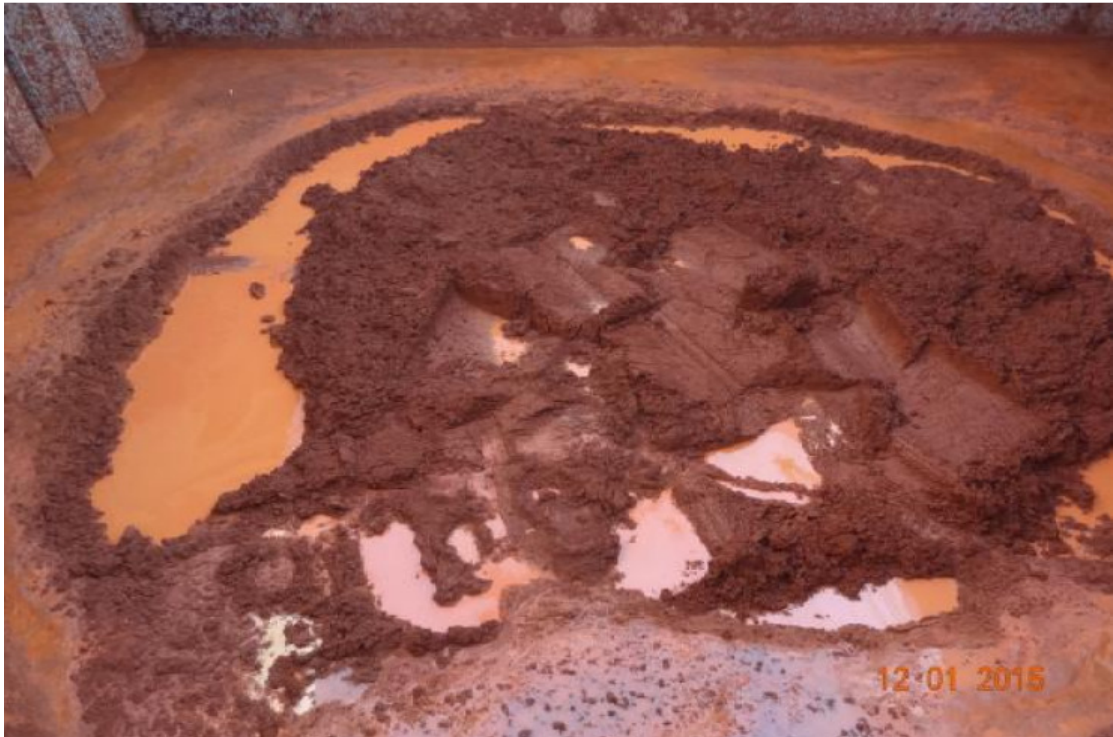
Figure 33: General view of hold No. 4 on board 'm.v Orchid Island' at Qingdao, China

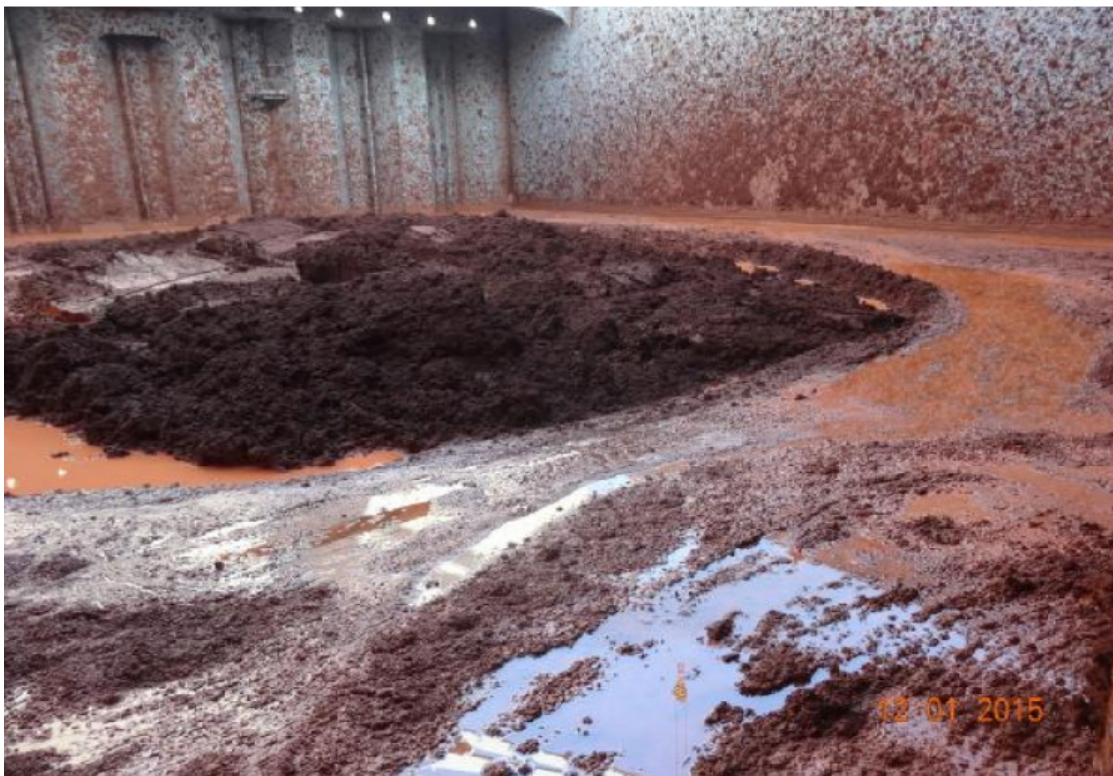
Figure 34: General view across hold No. 4 on board 'm.v Orchid Island', note extensive splatter on bulk head
