Crew member fatality following a fall on board the bulk carrier *Hanjin Sydney* at sea 2 February 2011

Abstract

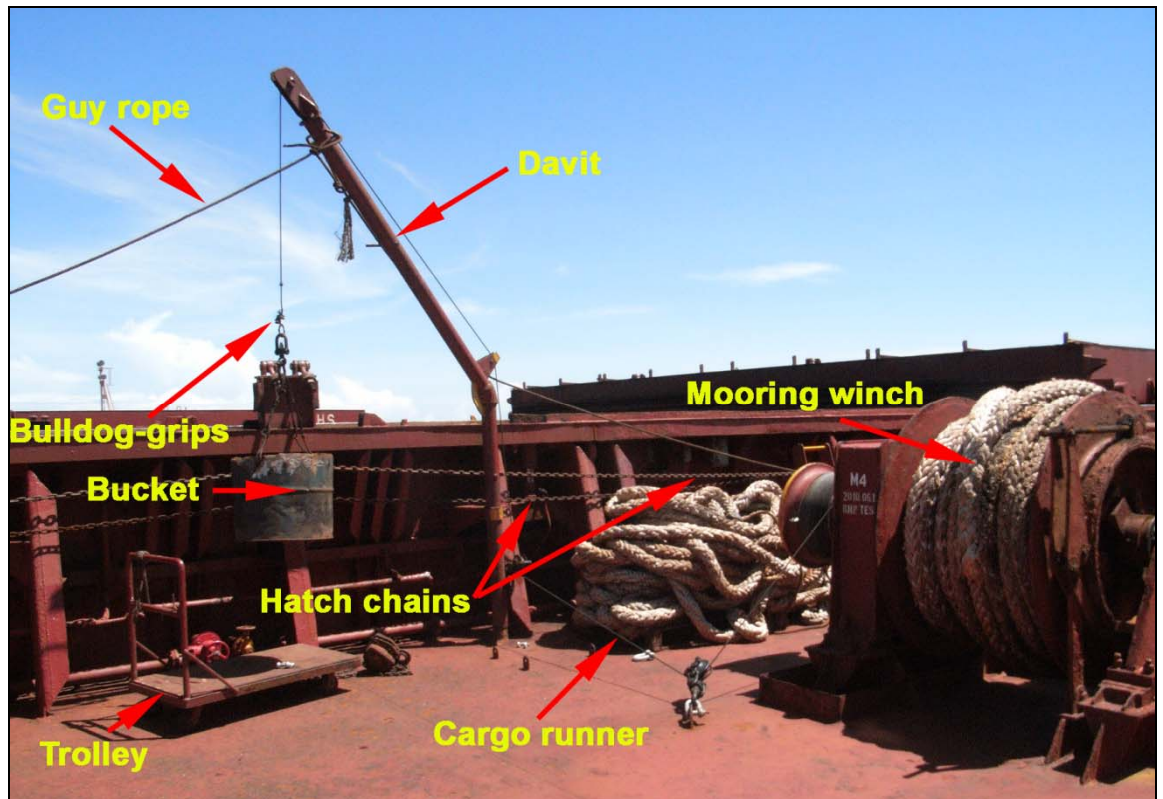
Figure 2: Portable cargo hold davit in position alongside *Hanjin Sydney*'s number eight cargo hold

While the bucket was being lowered, the bosun climbed up the side of the hatch coaming and stood on the hatch lid drive chains (Figure 2) so that he could look over the hatch coaming into the hold and give directions to the cadet.

The crew did not identify falling from a cargo hold hatch coaming into an empty cargo hold as a risk that required mitigation. They did not think that anyone would have a need to climb onto the top of a hatch coaming while they were removing the cargo residue from the holds. They probably also thought that the hatch coaming would provide a safety barrier between them and the open cargo hold.

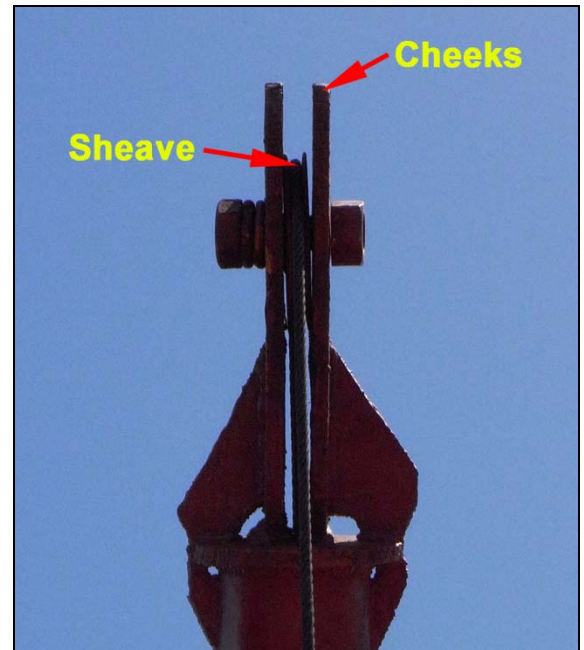
Figure 3: Davit head

The bosun swung the davit back over the hatch coaming. He then told the cadet to lower the bucket. When the cadet tried to lower the bucket, it did not move. The cargo runner went slack, but the bucket did not lower because the bulldog grips attaching the shackle to the wire had jammed at

the head of the davit in between the sheave and the davit head cheeks (Figure 3).

While the crew had not experienced an incident when using the davits, they had encountered some problems. On previous occasions, the cargo runner had jammed in the head of the davit when the bucket was hoisted too high, as it did on 2 February 2011. However, on these occasions the crew had swung the davit over the deck and either climbed up the davit or used a ladder to reach the davit head to resolve the problem.

On each of these occasions, the crew were presented with an opportunity to learn from their experience and to take action that would improve future operations and safety. They could have put a mark on the cargo runner to indicate to the winch operator when to stop hoisting or modified the lifting arrangement by fitting a preventer (a ball or a plate) to the cargo runner to prevent it from jamming in the head of the davit. However, they did not. They simply kept using the davit, knowing that the wire would probably jam again sometime in the future.

- On 2 February 2011, the davit cargo runner jammed in the head of the cargo hold davit when the bucket was hoisted too high.
- The bosun climbed onto the hatch coaming of the open number eight cargo hold to free the jammed davit cargo runner.

The ATSB has been advised by Hanjin Ship Management that because the problem of jamming was not reported to the chief mate, neither he nor Hanjin Ship Management were aware of it. As a result of the accident, it is now a requirement for the ship's safety officer to be more proactive during tool box meetings and safety 'walk arounds' in questioning the crew about problems they are encountering during routine operations.
