SAFETY INVESTIGATION REPORT

REPORT NO.: 05/2016

April 2016

MV POLYNESIA **Fatal fall overboard during** **cargo operations at** **Pago Pago, American Samoa** **02 April 2015**

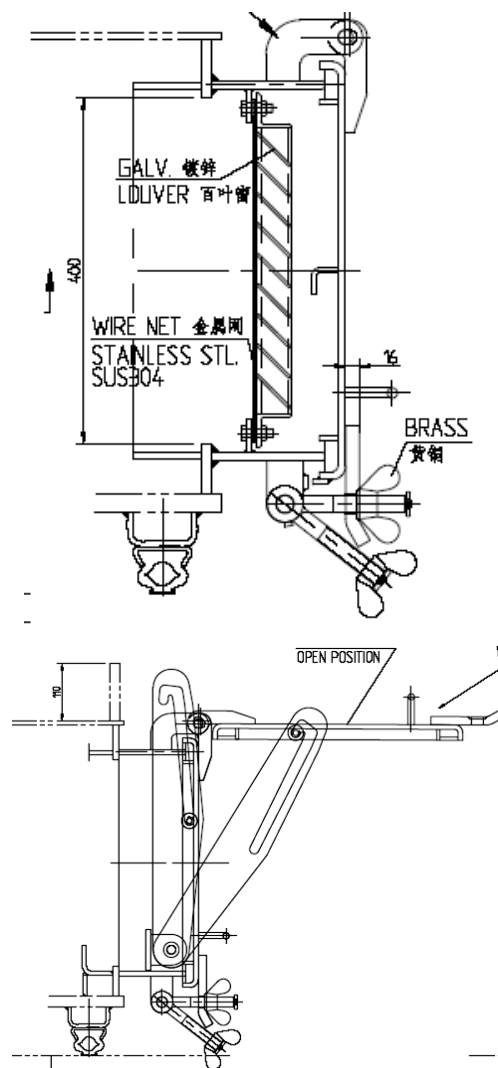
Figures 2a and 2b: Cargo hold's ventilation louvers

The cargo hold's ventilation louvers consisted of an opening measuring 600 mm by 400 mm, serving all the cargo holds. The maximum height of the ventilation louvers is 2500 mm from the main deck. The opening was protected by means of a stainless steel wire net fitted behind galvanised louvers. A ventilation louver board was also fitted which would open upwards up to a maximum angle of 90° (Figures 2a and 2b).

The closing of the cargo hold's ventilation louvers necessitated that the ventilator's board is pushed upwards, while the support bracket holding the board is pushed inwards to free the board. In order to open / close the cargo hold's ventilation louver board in a

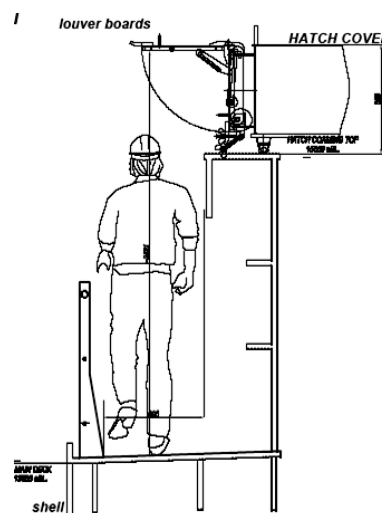
Figure 3: Access from the main deck

safe manner, the crew members had to reach it from the main deck, using a portable ladder (Figure 3).

During an on board meeting held on 05 April 2015, the operation of the cargo hold's ventilation louver board was discussed. Crew members were reminded that the cargo holds' ventilation louver boards have to be opened / closed from the main deck with the safe use of a ladder. It was also reiterated that the operation of the cargo holds' ventilation louver boards from above (*i.e.* by standing on top of the cargo hatch covers) was strictly prohibited.

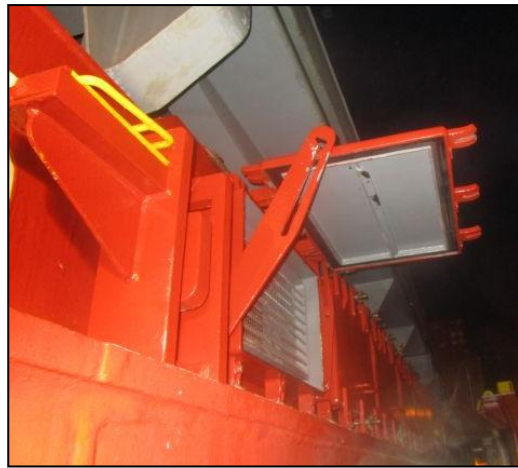
Figure 4: One of the hatch cover ventilation louver board

The cargo operation was uneventful and just after 0200, the duty AB informed the second mate that the cargo discharge operation in bay 18 had been completed. At about 0230, on 02 April, the second mate proceeded on the hatch cover in way of bay 18 on starboard side. The officer wanted to close the cargo hold's ventilation louver boards (Figure 4) in order to prevent any damage during the cargo operations³.

The closing of the louver from above was a very dangerous operation. As explained elsewhere in this safety investigation report, the closing operation necessitated that the louver board is slightly lifted in order to free the support bracket. Once the support bracket had been freed, the weight of the louver board would have had to be carried by the hinges and the crew member.

This was considered to be a significant weight, taking also into consideration the less than optimal position of the crew member holding to the louver board from above.

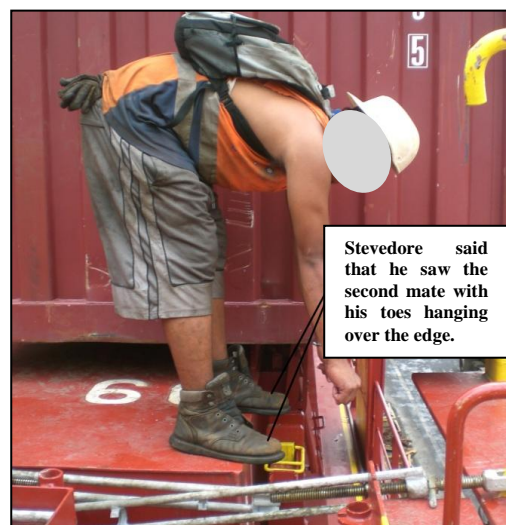
Figure 3: Stevedore simulating the position of the second mate to close the louver boards

The stevedore recalled that he observed the second mate on the cargo hatch cover bending over and pull the louver board up before letting it go to close. The stevedore also observed that the second mate's left leg was on the edge whereas the right leg was over the edge. The stevedore said that the second mate almost fell down and he asked him whether he was fine. The second mate gave him the 'thumbs up' and walked over the second ventilator to close it down.

This time, the stevedore observed that the second mate's both legs were over the edge (Figure 3). The stevedore stated that he was close enough to the second mate to observe that he seemed tired, with his eyes red.

2. The position adopted by the crew member to close the ventilation louver board was not appropriate.
3. The MSIU was unable to exclude fatigue as a contributing factor to the fall of the crew member.

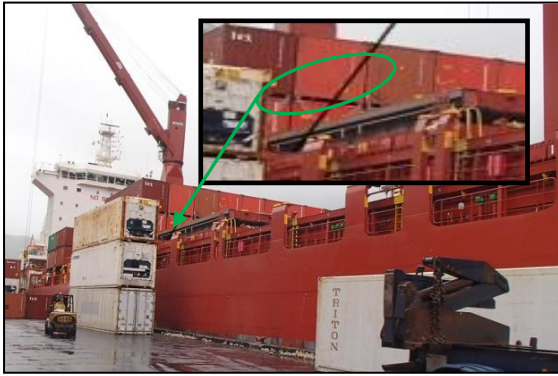
Figure 4: Area in way of bay 18 on starboard side where the accident happened

Suddenly, the second mate flipped over and fell from the top of the hatch cover. The stevedore witnessed the crew member hitting the vessel's side rails with his legs, before eventually falling overboard on the concrete wharf (Figure 4). None of the crew members witnessed the second mate falling. The time was about 0235.

1. The crew member sustained fatal injuries after falling from the cargo hatch cover to the quay on the vessel's starboard side while attempting to close a cargo hold's ventilation louver board.

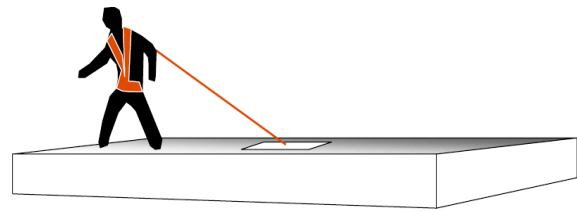
Figure 5: Fall restraint system with anchor point

Considering that the crew member opted to climb on top of the hatch cover to close the ventilation louver board, then the use of a means of fall restraint system would have been necessary (Figure 5). This did not transpire to have been the case.

The intended actions necessitated the crew member to approach the edge of the hatch cover. The personal fall restraint system would have allowed the crew member to approach the edge of the hatch cover but would not have allowed him to go beyond the edge in the event of a slip or fall.

4. The crew member was not wearing a fall restraint system.
5. This initiative taken by the crew member to close the cargo hold's ventilation louver board, allowed for a one-person error situation to develop.

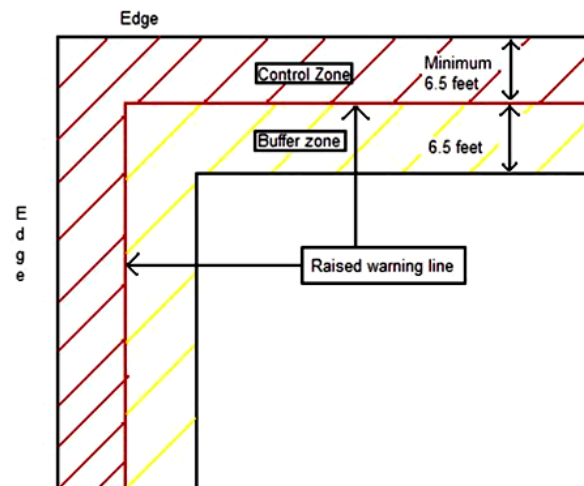
Figure 6: Typical 'control' and 'buffer' zones

Even if the fall restraint system, in the absence of a physical barrier system would have not been practical, symbolic barrier systems were not present on the hatch cover. For instance, 'control' and 'buffer' zones may be considered to serve as a means of preventing crew members from approaching the edge⁷ (Figure 6).

It has to be mentioned, however, that symbolic barrier systems, being the weakest of all barrier systems, would not have physically stopped any crew member from approaching the edge; yet, they would have certainly enhanced his awareness.

8. Symbolic barrier systems were not present on the cargo hatch cover.

- High caution areas have been marked, as symbolic barrier systems, at the edges of the hatch covers of the entire container fleet, eliminating the risk for the personnel to fall overboard;
- The deck and operation manual for container vessels has been amended with particular reference to the control of hatch covers access. It is now being required that access is only granted following specific instructions and with adequate supervision during cargo operations.
