Acindar, Argentina: Strong river currents in Parana River

August 2018

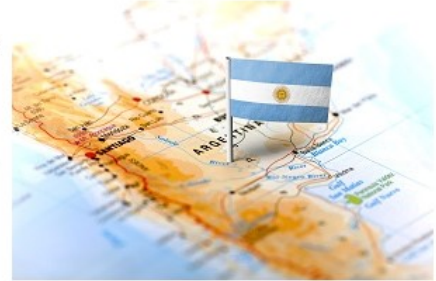
Information from investigations into these claims show they share the same root cause: attempting to berth fully loaded Panamax bulk carriers without tug assistance in an area where the river currents may be relatively strong and also unpredictable. The berth is located just downstream of a port bend in the river and the outer starboard bank, i.e., close to the terminal is where the maximum current flow can be expected:

A local port agent (<http://www.antareshipping.com/northern-pampa-ports/villa-constitucion/puerto-acevedo-acindar-mineral-wharf/>) reports that tug use at the terminal is not compulsory and therefore experience suggests that the natural inclination of vessel Masters, being mindful of managing voyage costs, will be to not engage them. While this desire is understandable the Club recommends that vessel Masters, in consultation with pilots, should carefully consider the undoubted benefits and assurance that tugs can provide against the relatively modest additional costs of using them.
