# SAFETY CAMPAIGN

2018

## FOREWORD

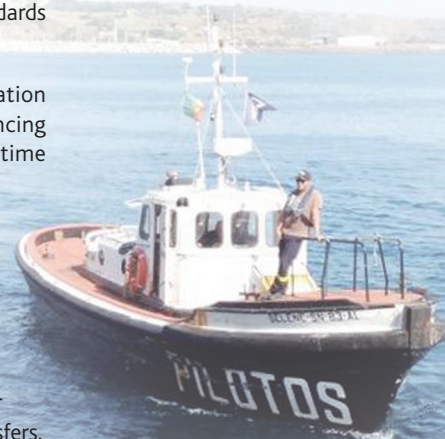
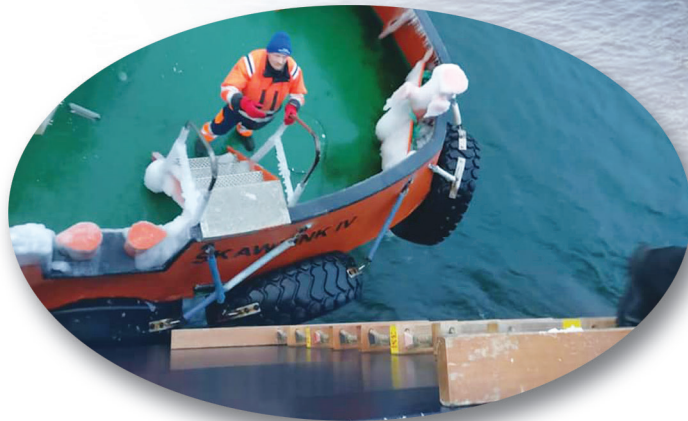
*Right and below:* Compounding the danger to Pilots of non-SOLAS compliant Boarding Arrangements, is the efforts of some Administrations to force Pilots to use Elderly or Unsuitable vessels (like Tugs) to executive transfers. These two examples are both from Europe.
