MARINE ACCIDENT
INVESTIGATION BRANCH

SAFETY DIGEST

**Lessons from Marine
Accident Reports
2/2015**

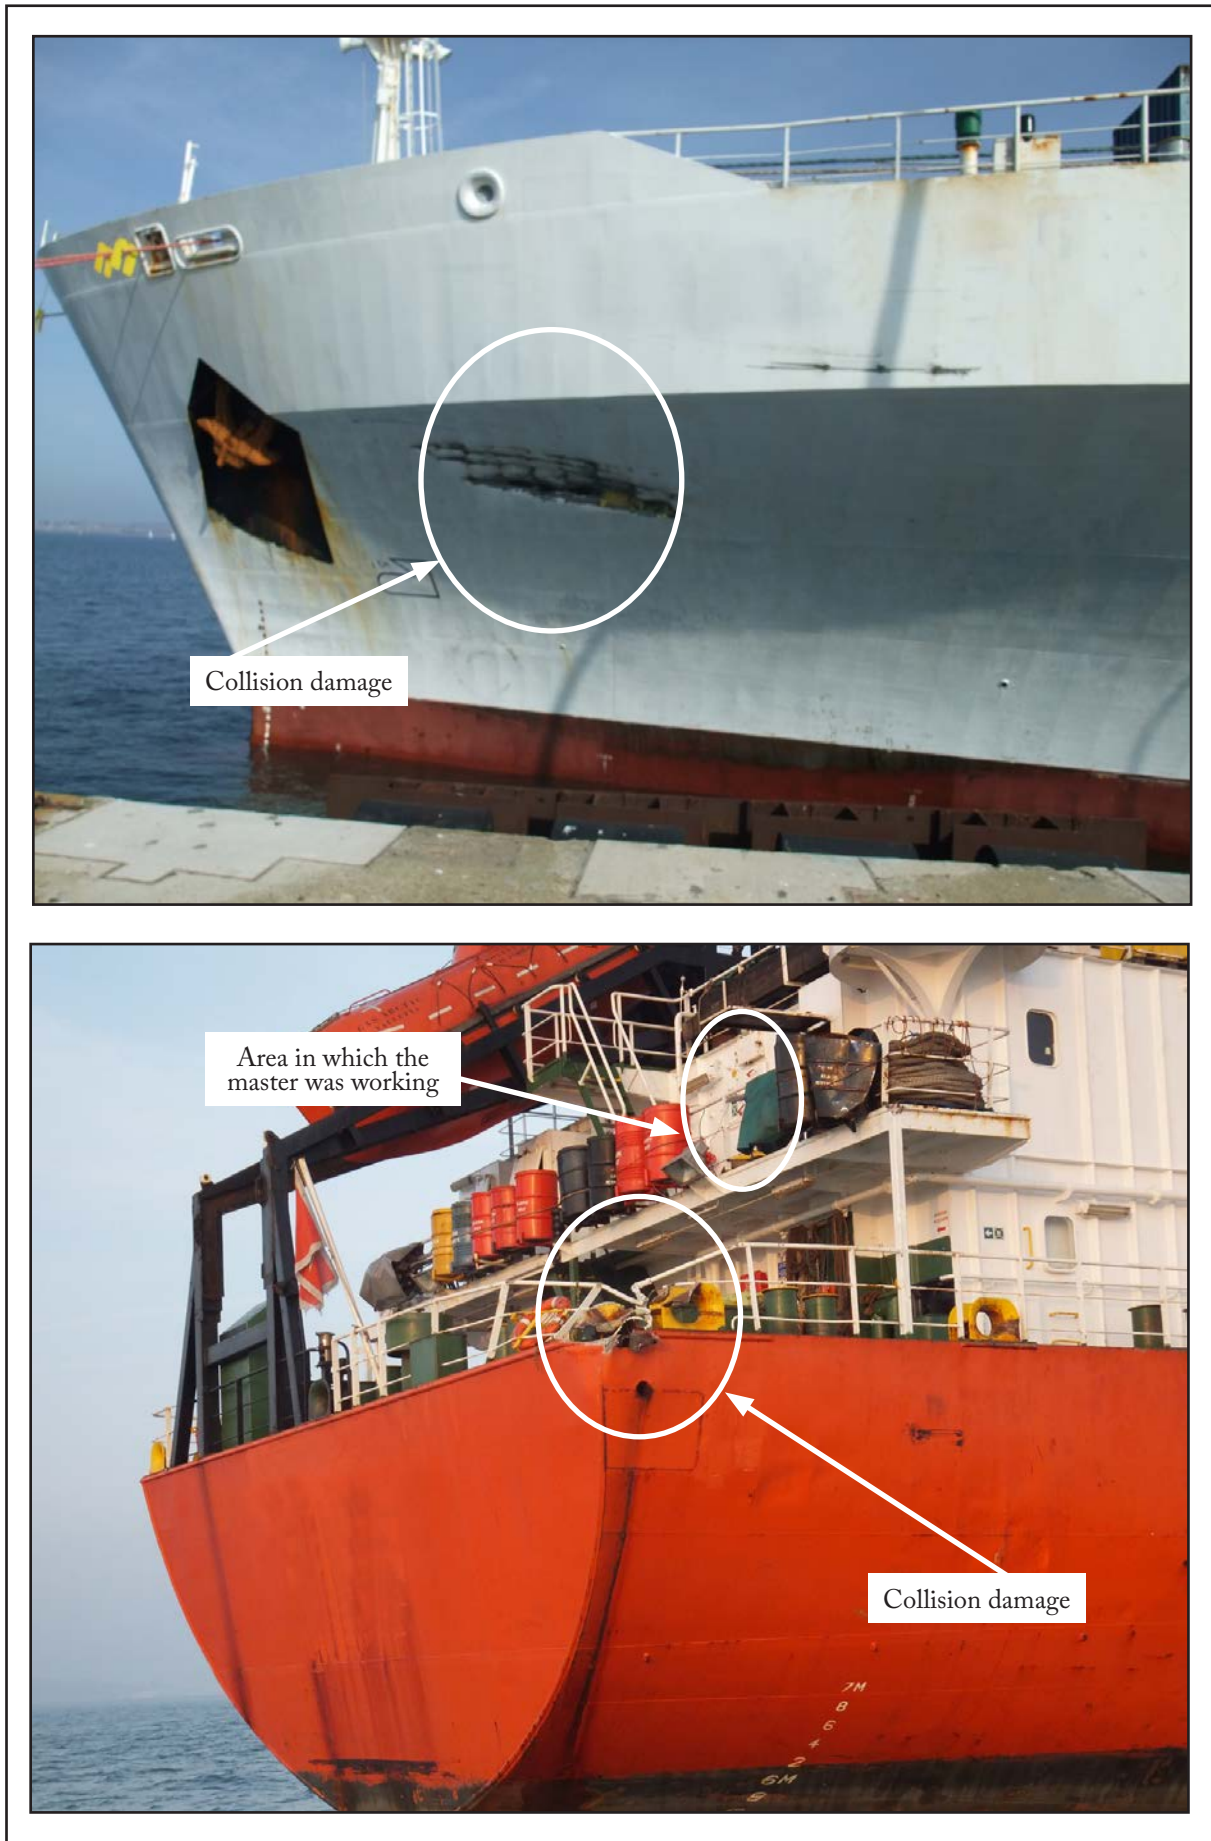
The general cargo vessel's port bow collided with the LPG tanker's port quarter and the hulls of both vessels were breached above their respective waterlines. Both vessels were directed by the coastal state to a nearby port of refuge for inspection and repairs.

Figure 1: Damage to both vessels

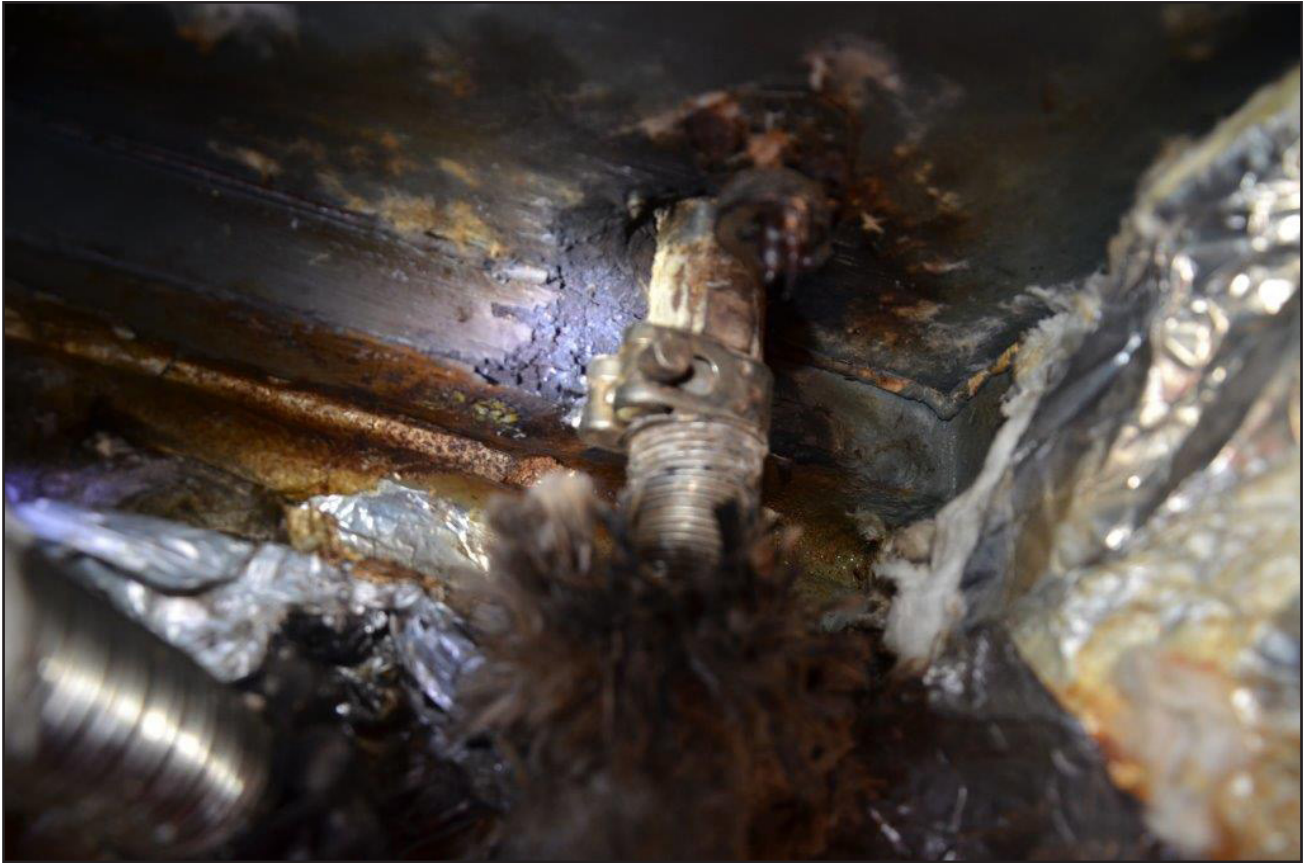
- A section of the air heater exhaust pipe passed through the plywood deck; this section was not insulated.
- There was little or no clearance between the bare exhaust pipe and the plywood; this led to charring of the under-deck area (Figure 2).
- Cans of diesel, cotton rags, paper and other flammable material were stored in the same compartment as the heater.
- The heater compartment was not fitted with fire detection or fire suppressant systems.

Figure 2: Uninsulated exhaust pipe causing the wooden deck to char

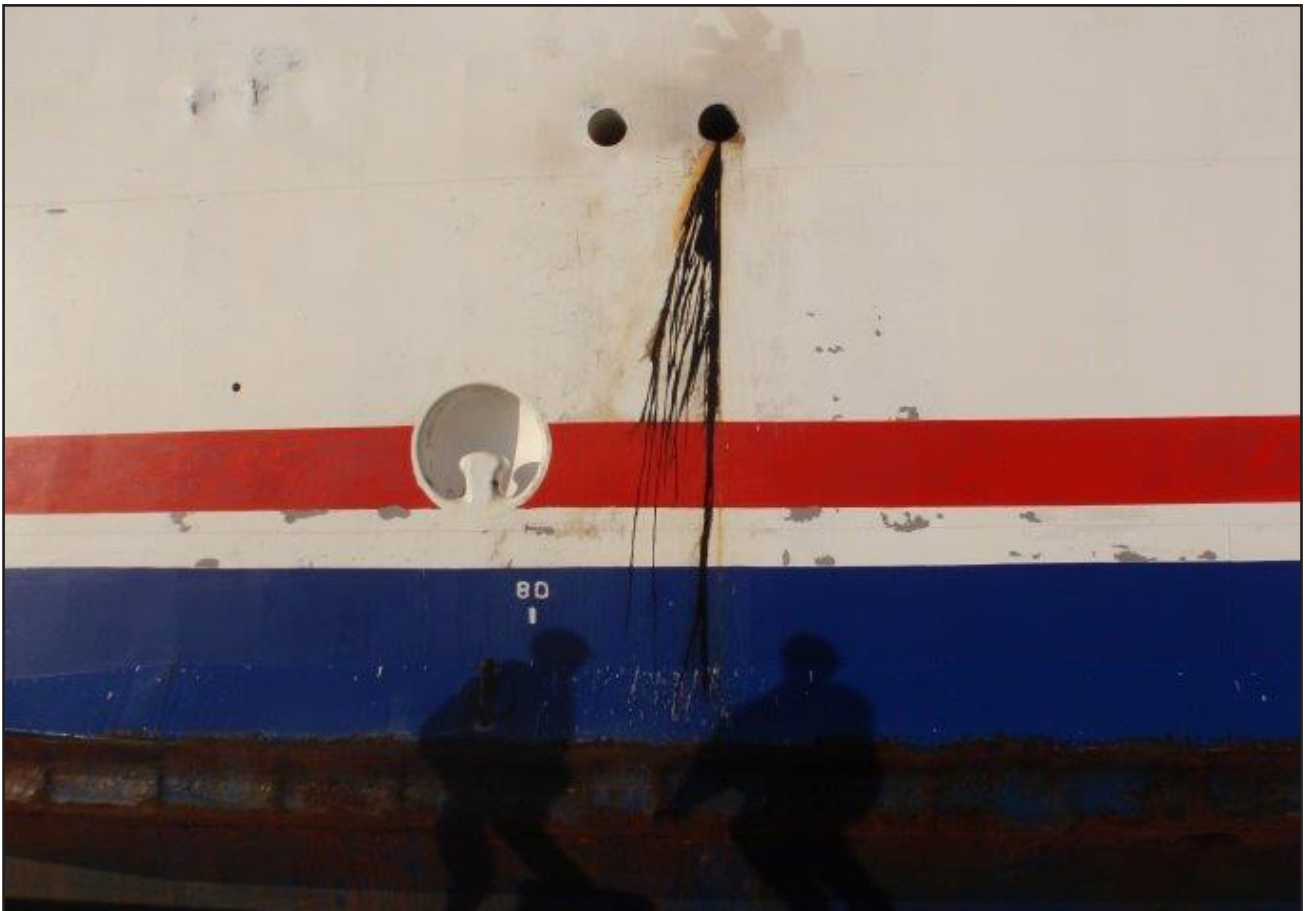
tank as intended. This caused 600 litres of oily water already in the tank to discharge overboard through the tank's air vent (Figure 3).

Figure 3: Oily water discharge on ship's side

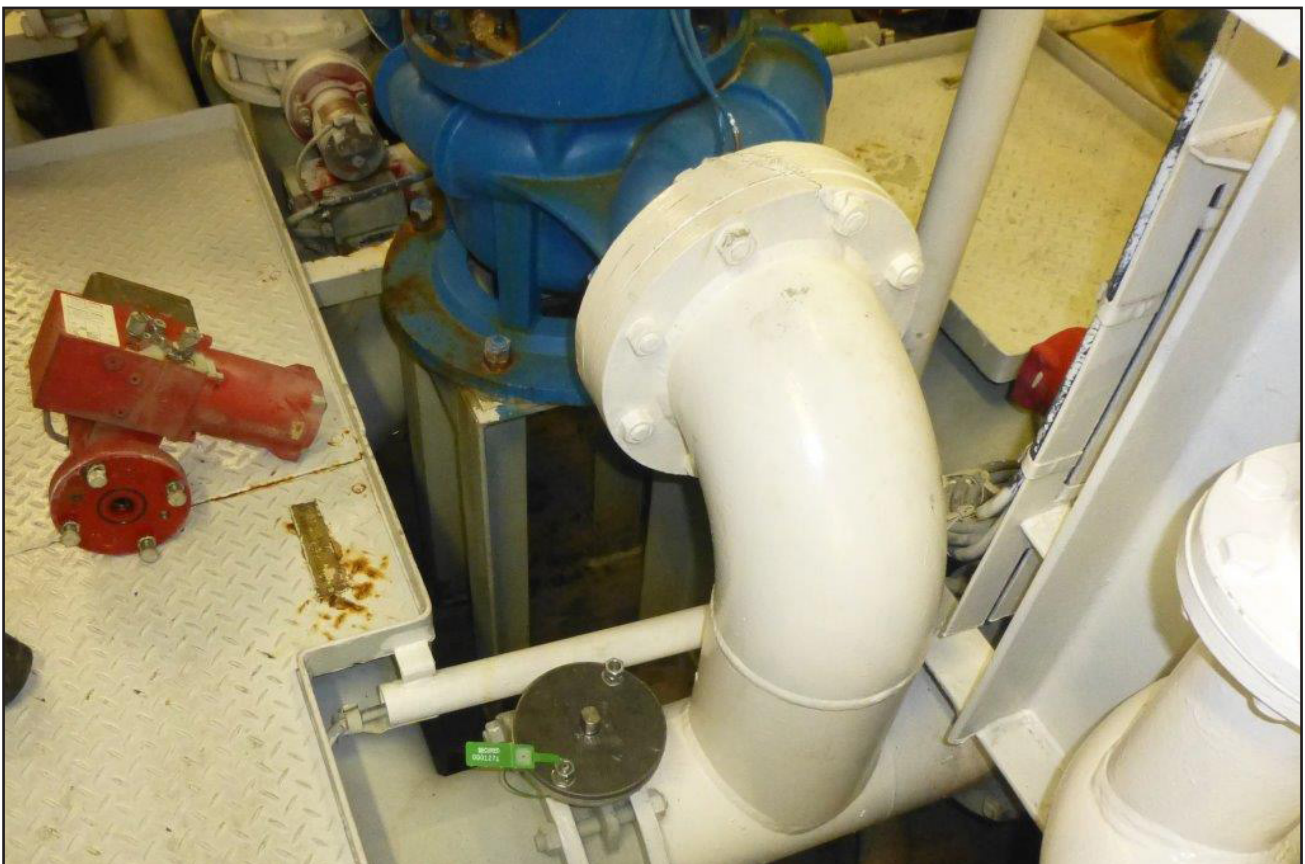
Figure 4: Modified cross-over valve - actuator removed, locking device fitted

3. Where key ship systems can be cross-connected, a padlock or equivalent is a simple measure that goes a long way in preventing inadvertent operation and unintended consequences (Figure 4).

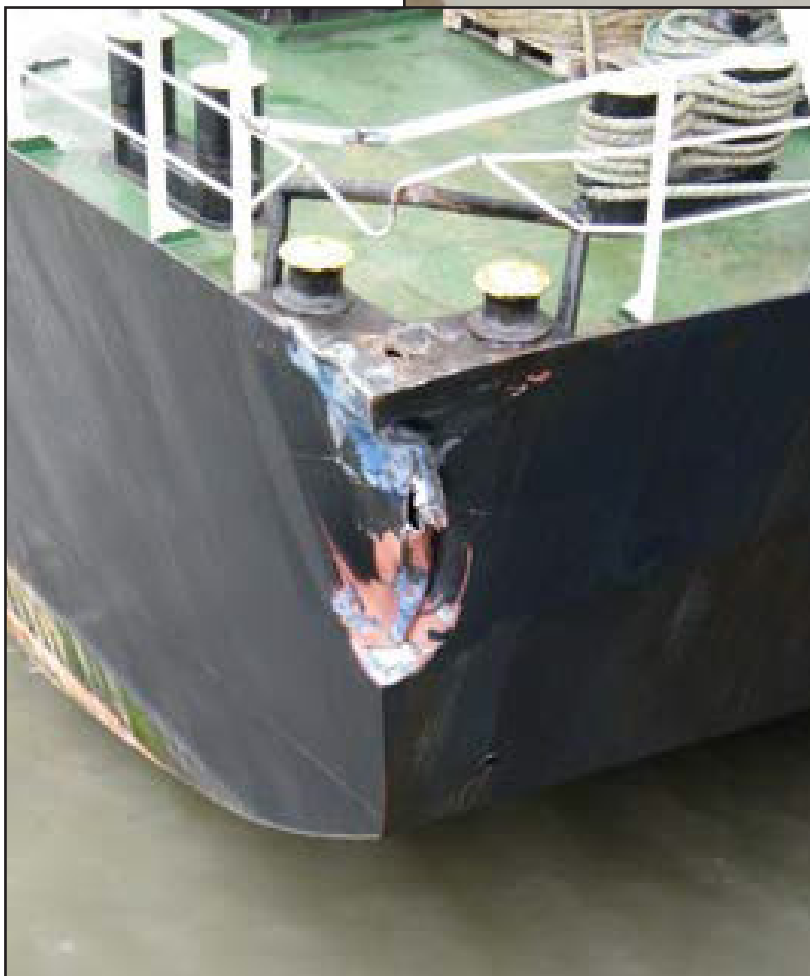
The damage (Figure 3) to the shell plating on both vessels was significant and resulted in the two vessels being out of service for several days for repairs to be undertaken. Fortunately there was no injury to personnel or any pollution as a result of the collision.

Figure 3: Damage to shell plating

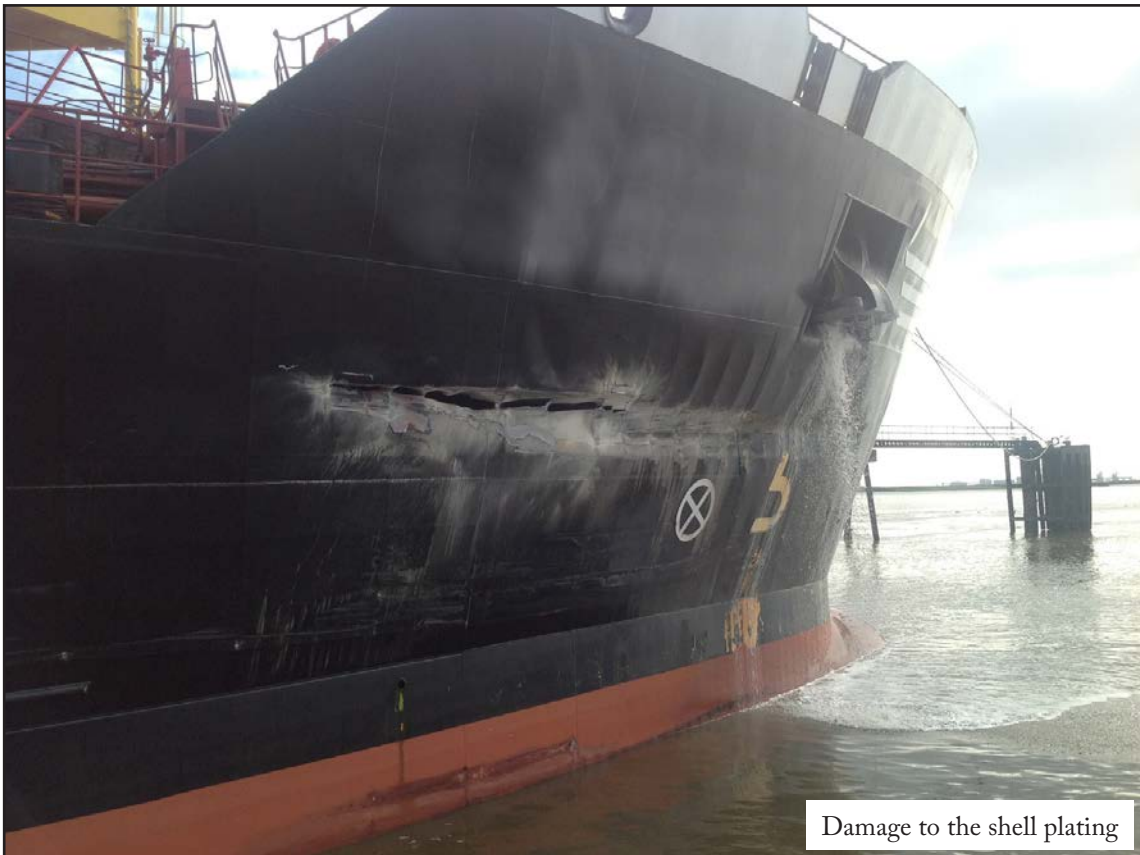
Damage to the shell plating

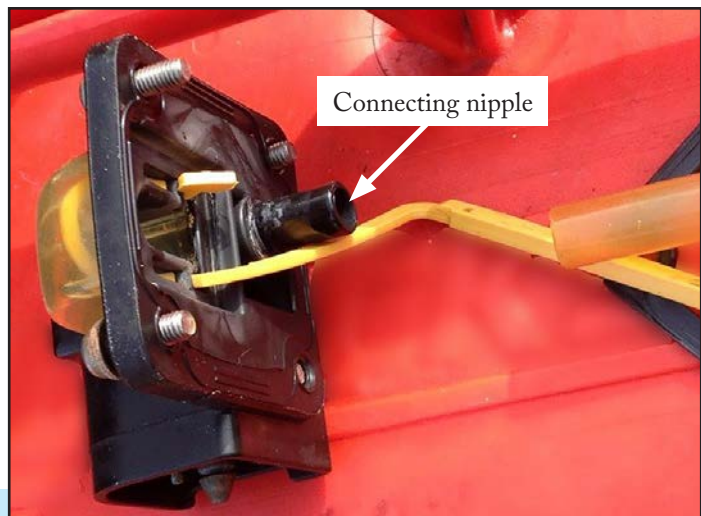
Information from the engine and fuel tank supplier indicated that an annual inspection of the fuel tanks should form part of the boat's maintenance schedule. The pick-up tubes were secured to the tank top assembly by use of an adhesive. The vessel had a diverse operating schedule and, over a period of time, had purchased petrol from a number of different countries. There was a risk that fuel with a high ethanol content could cause the adhesive to deteriorate.

Fuel tank pick-up tube assembly

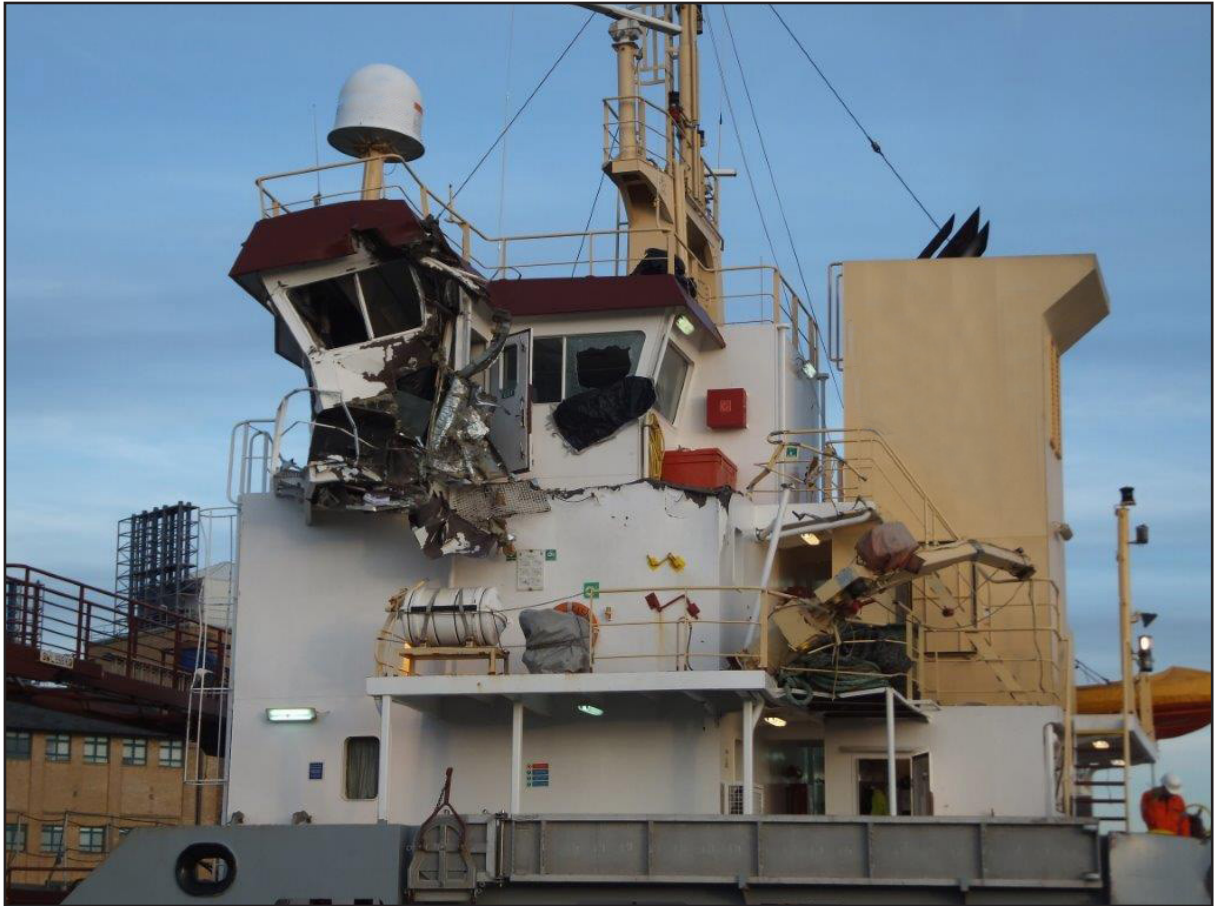
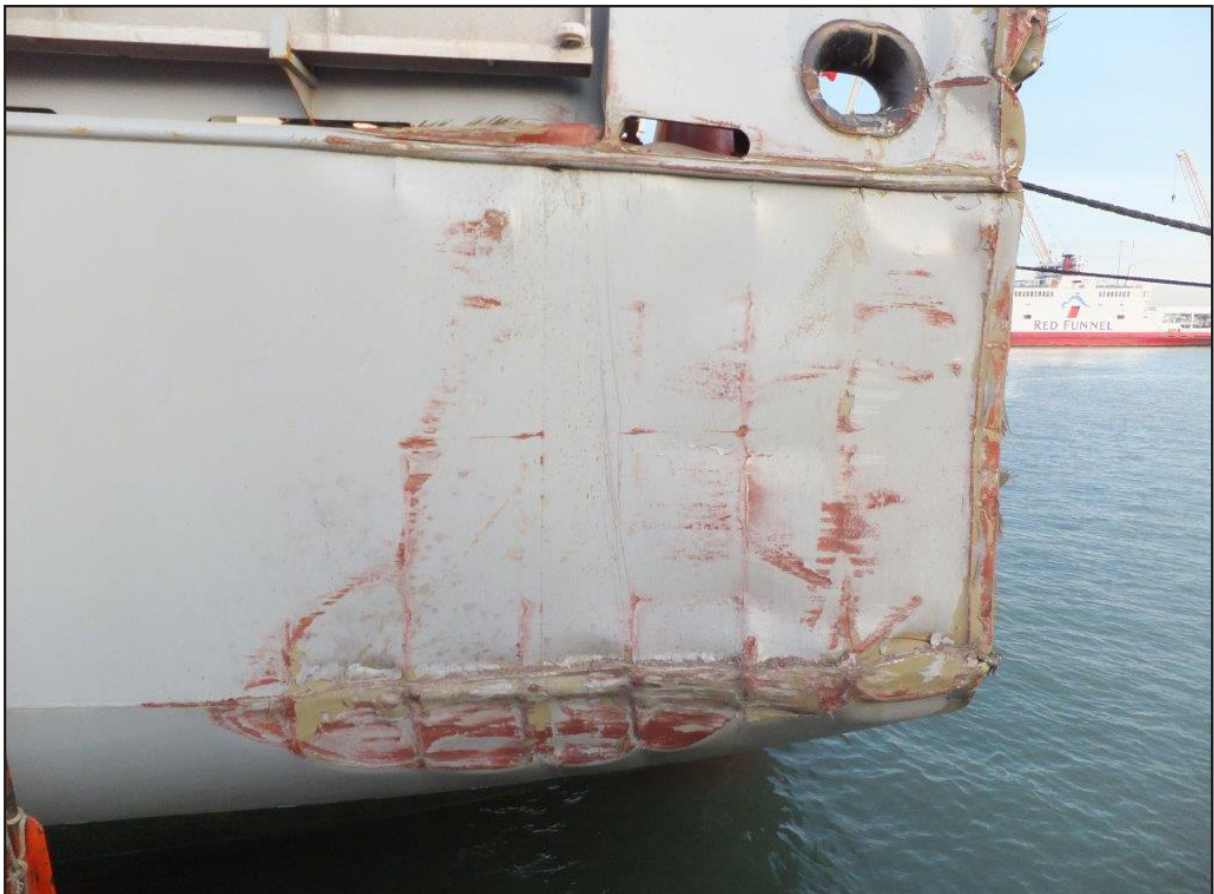
Damage sustained to the general cargo vessel

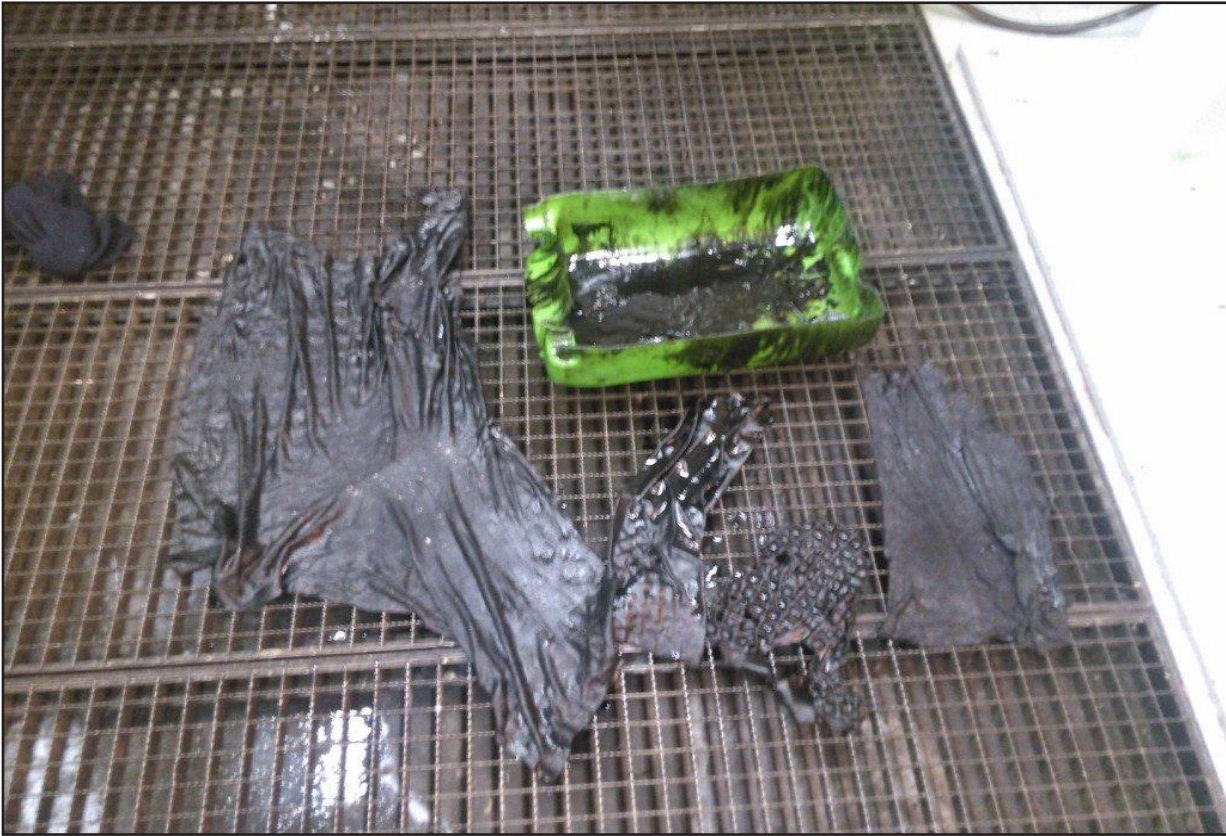
Figure 1: Rags found in the drain tank

1. Tanks and engine crankcases should not be left open after work has finished. Before being closed, they should also be thoroughly inspected to ensure that no detritus or tools are left behind. Ideally this should be done by someone not involved with the work being carried out.
2. Prompt and appropriate responses to machinery alarms are necessary if damage to equipment is to be prevented. This requires the on-watch engineers and the bridge team to have a good understanding
- of the propulsion system and to be well drilled in the event of an alarm or breakdown.
3. Anchoring and returning alongside following mechanical problems inevitably causes delays. However, it is better to be late than to not reach the intended destination through 'pressing on' until a problem is sorted. Tug assistance and engineering expertise are easier and less expensive to access in port than they are elsewhere.

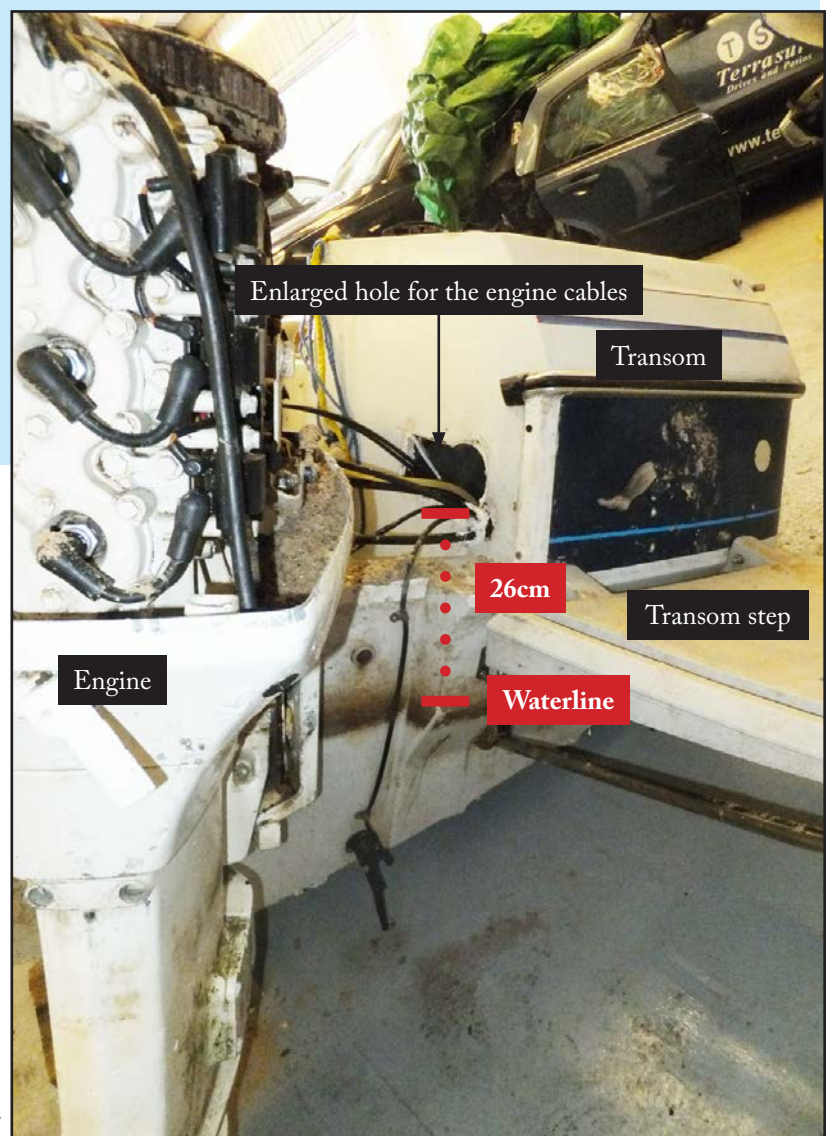
Figure 2: Stern view showing enlarged hole cut in transom for engine cables

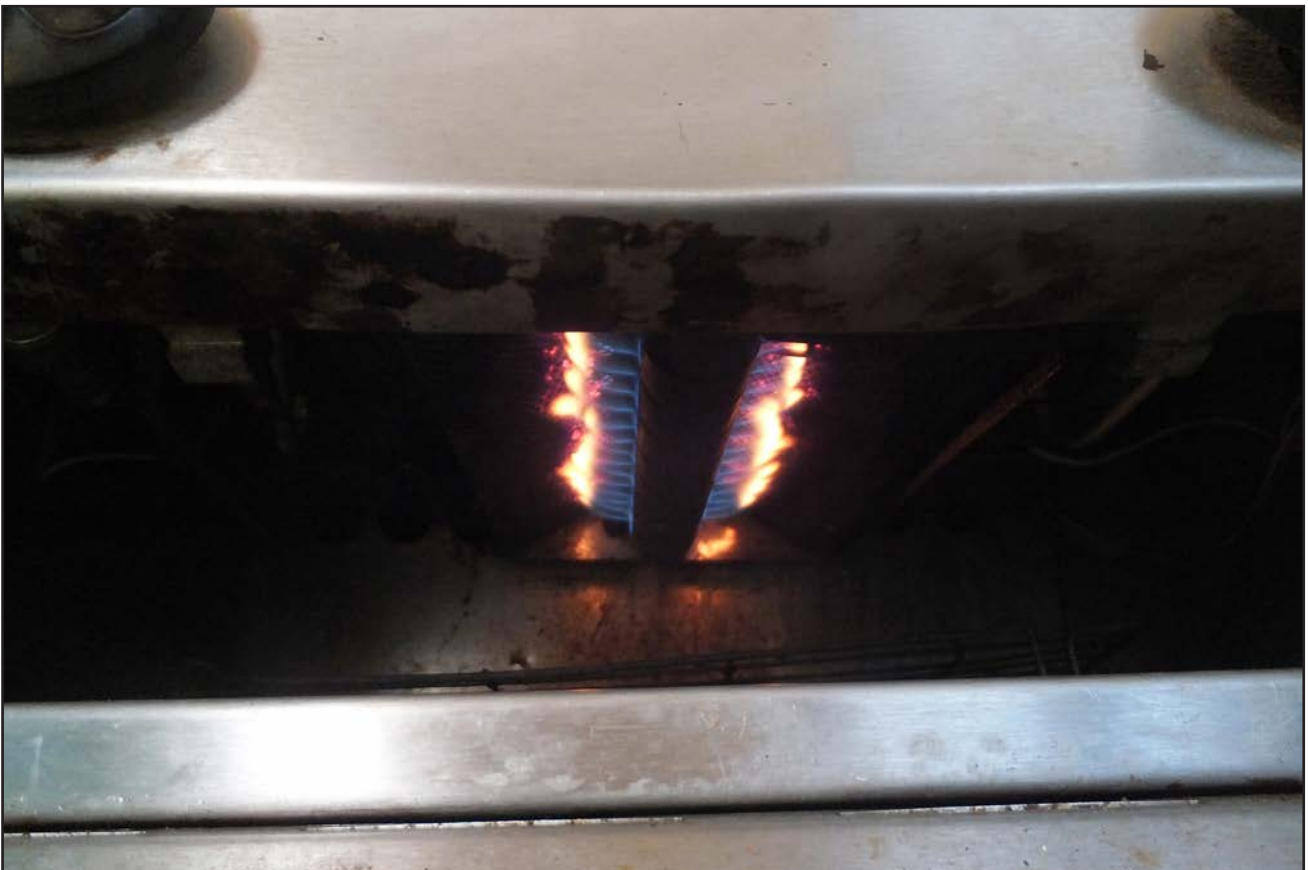
The deceased had left the grill lit overnight to heat the wheelhouse and the accommodation. The grill was corroded (see figure) and emitted high levels of CO. Another crewman, who had recently left the dredger, had shown the symptoms of CO poisoning a few days earlier. A CO detector was not fitted.

Corroded grill

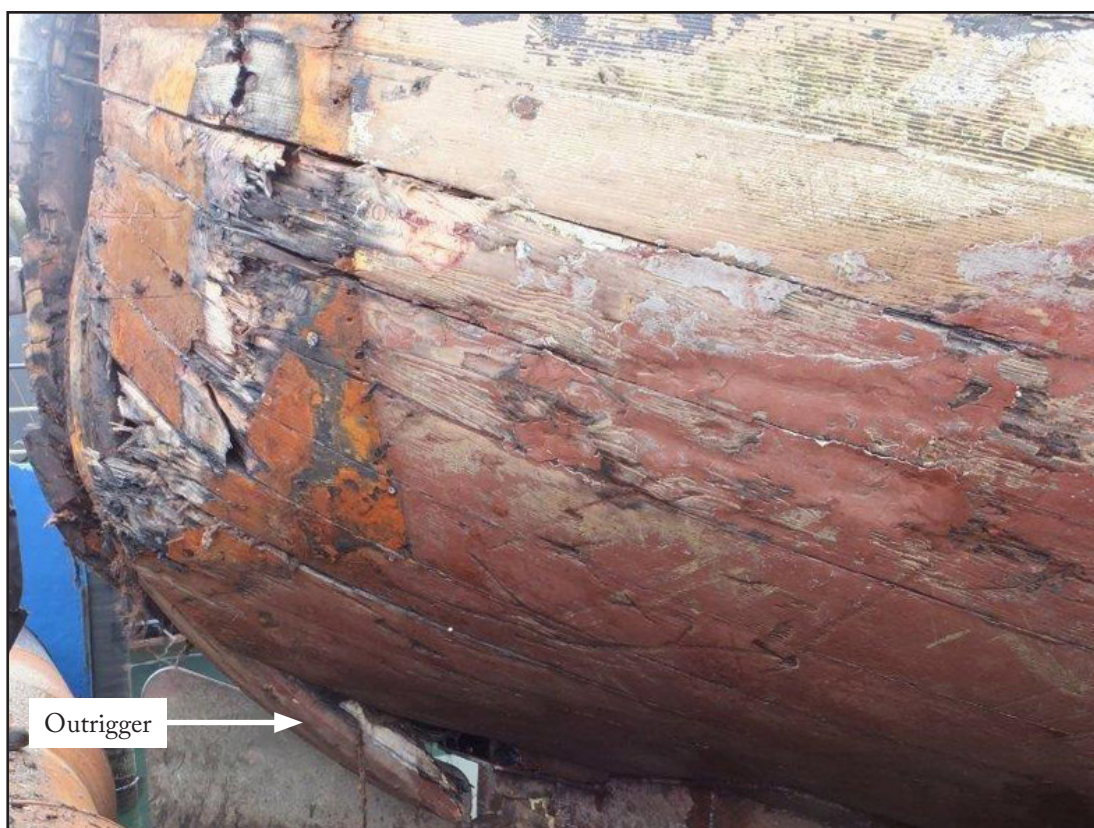
Figure 1:
Stern damage

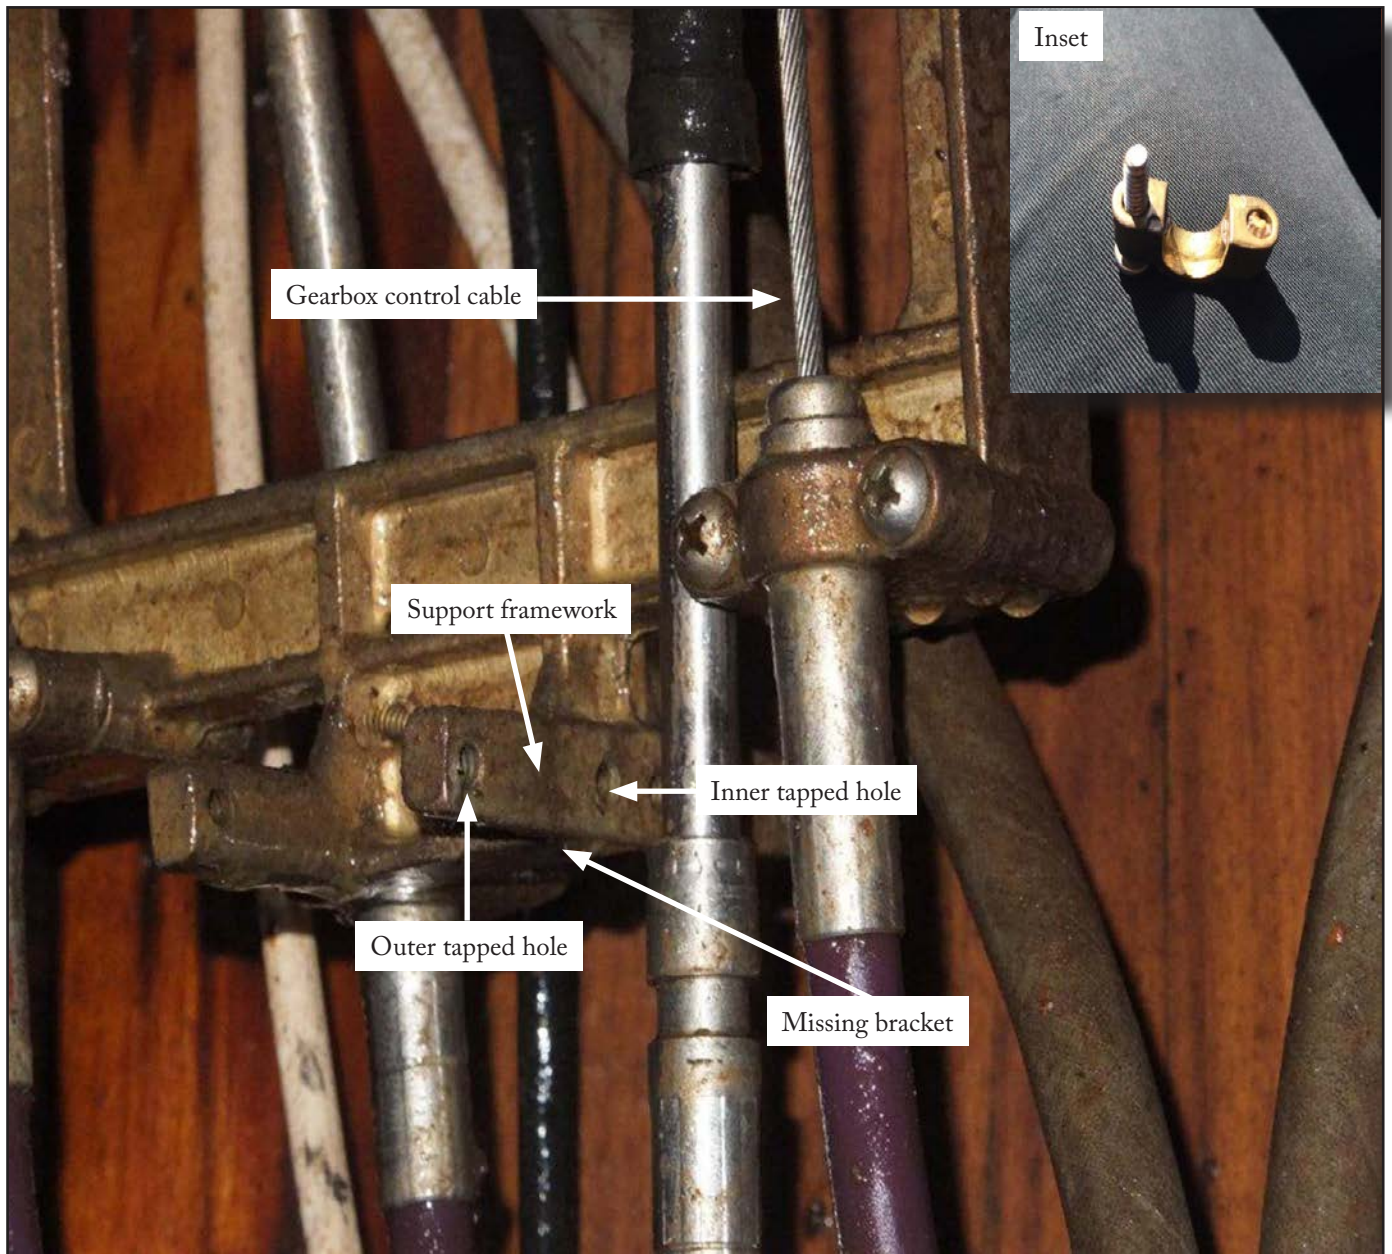
The trawler was eventually re-floated (Figure 2) and an investigation discovered that the loss of control was due to a clamp, used to secure the Morse cable between the control lever in the wheelhouse and the engine and gearbox, detaching from supporting framework (Figure 3). The clamp had been secured with one rather than two screws as intended (Figure 3 inset) and the lone screw had worked loose and had fallen out.

Figure 3: Support framework and detached securing bracket (inset shows clamp secured with one screw)

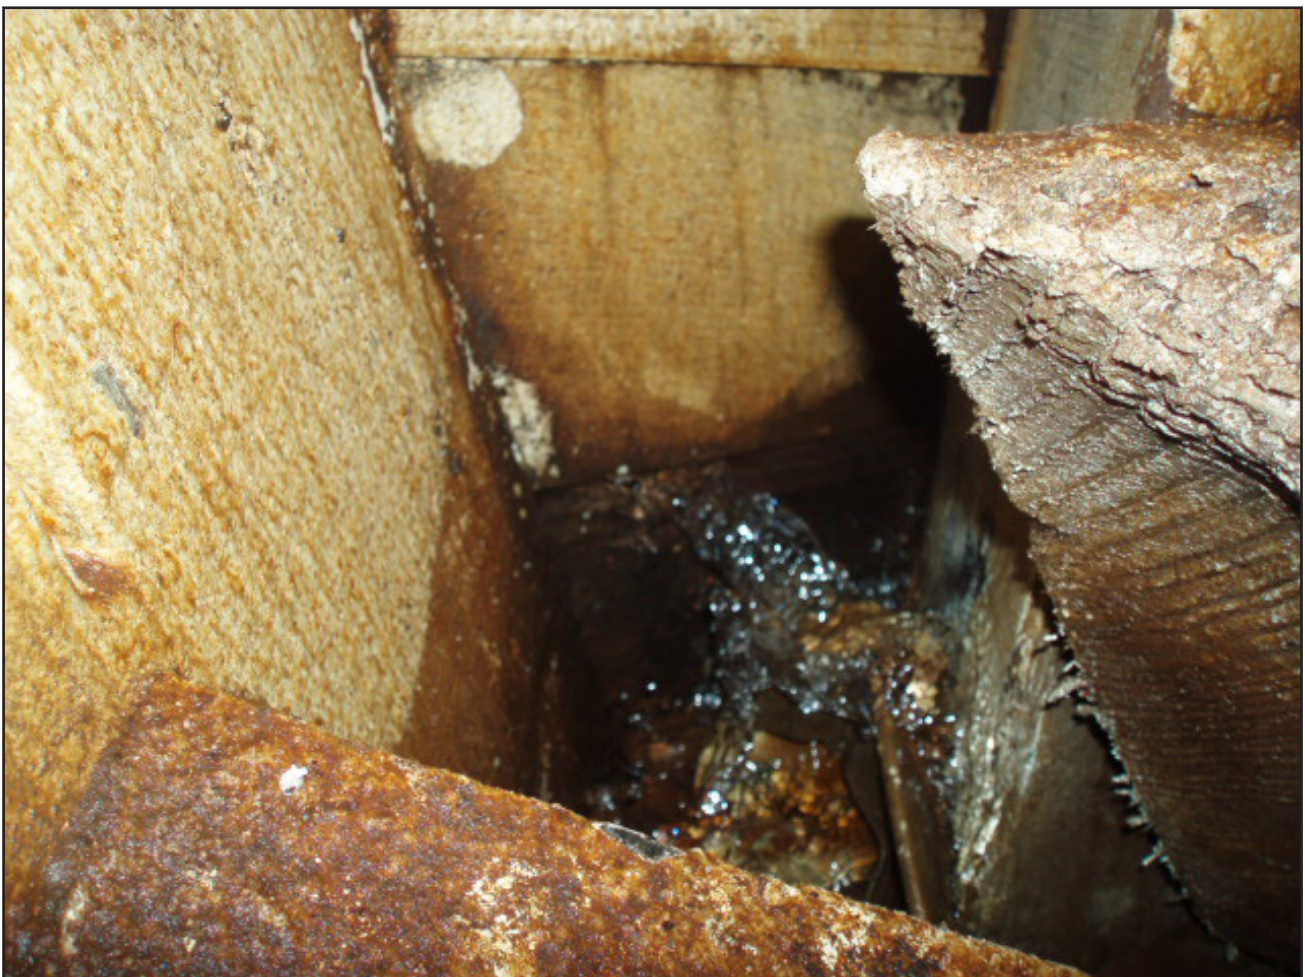
When the trawler had been on the slipway, the sun had dried out the caulking around its stem. The caulking eventually fell out, leaving gaps of approximately 6mm between the planking, which allowed seawater to penetrate into the forepeak and beyond (see figure).

Water ingress between the planks
