Seaways

The International Journal of The Nautical Institute

Mariners' Alerting and Reporting Scheme

MARS Report No. 288 October 2016

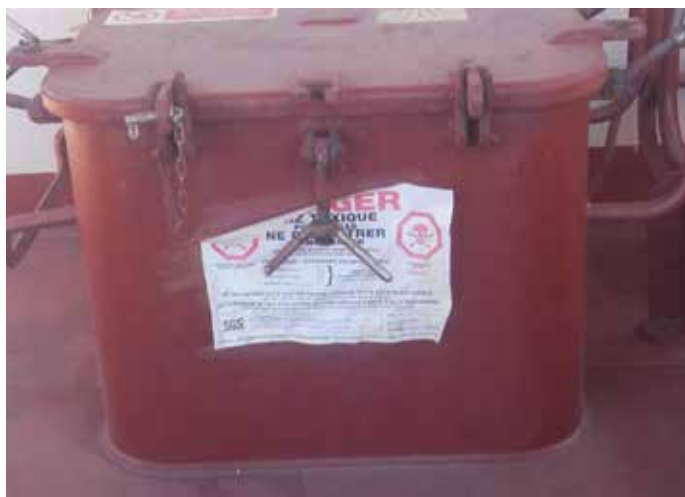
MARS 201651

Fumigation fracas

➔ A cargo of maize was loaded and fumigation initiated at the loading port. The fumigation was to continue in transit and warning signage was posted on the hold access hatches. The vessel then departed on a trans-oceanic voyage. Once at the arrival port the warning signs had become substantially detached from the coamings. According to the port reception officials, fumigation signage is often totally lacking.

Port reception officials at this port also informed MARS that although the Master should inform the Harbour Master or port safety authority in advance when they are carrying cargo with in-transit fumigation, this is unfortunately not always the case.

- Always ensure arrival port officials know in advance about in-transit fumigation.
- For the safety of crew, stevedores and port officials always ensure access to fumigated holds is restricted and fumigation signage is well displayed.

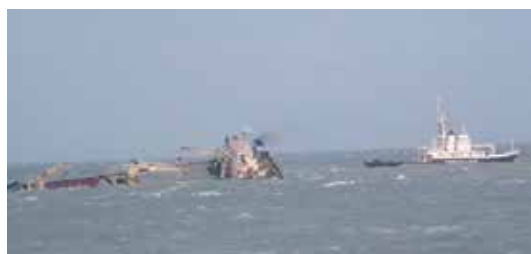
reason. The Master did not follow this instruction. About 25 minutes later the vessel hit an underwater object on her port bow. It was later determined that they had hit a known wreck, a vessel that had sunk two months earlier.

The emergency alarm was sounded and the Master ordered to abandon ship about five minutes later as the vessel began listing to port. Although all crew were eventually rescued by nearby SAR resources, things did not go smoothly during the abandon ship:

- The starboard-side lifeboat was launched and automatically released from the falls before crew could board. The boat drifted away crew-less. Nine of the crew then switched to the port-side lifeboat, successfully launching and boarding the craft.
- The two inflatable liferafts were also launched, but the nine remaining crew members could not embark due to failure of the embarkation ladder. They were later rescued by a ship in the vicinity.

A salvage operation started the next day, but the vessel capsized and sank four days later.

Vessel listing during salvage attempt

- The Master of the vessel did not ensure that all the latest navigational information and warnings had been considered in the voyage planning before sailing;
- The exchange of maritime safety information by means of VHF between ship and shore was not effectively carried out; the navigation officers of the vessel did not endeavour to clarify and heed the warning messages from shore;
- The bridge team members failed to communicate the navigation warnings and instructions received from shore to fellow members; and
- The navigation officers of the vessel did not maintain a proper look-out as they did not spot the wreck – which was marked by a red light and had a ship mast protruding 7m above the sea surface.

- Before leaving port ensure your charts are up to date for the required voyage.
- When passing the con to a relieving officer, even to the Master, inform them of all important issues concerning the navigation of the vessel.
- When undertaking your monthly abandon ship drills take them seriously, as one day you may need those same skills to save your life.

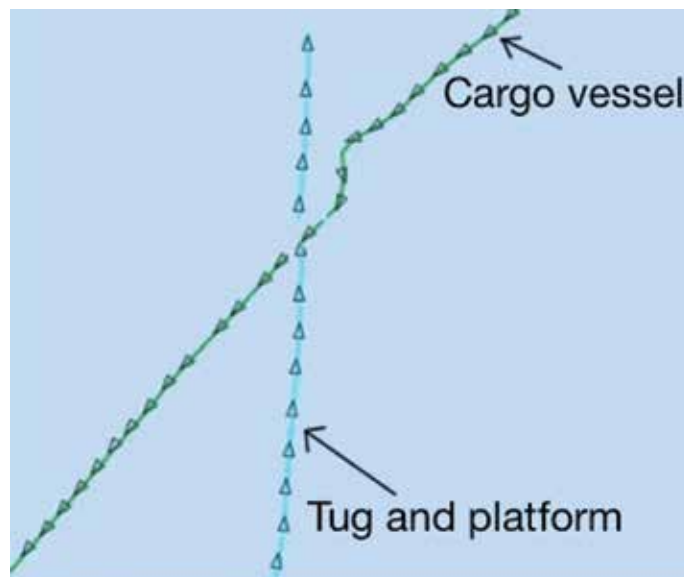
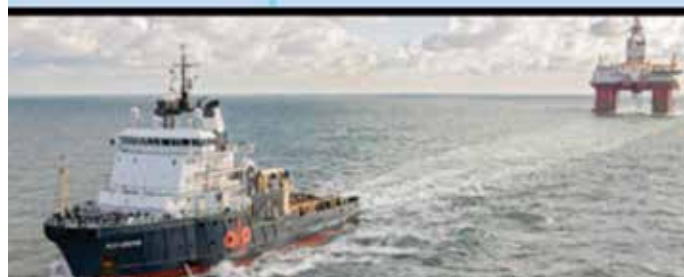
MARS 201654

➔ A tug was towing an oil production platform on a line about 1,000m long in good visibility and sea conditions. A close quarters situation was developing with a cargo vessel to starboard. Given the tow, the tug was unable to manoeuvre. The OOW of the tug contacted the cargo vessel and requested the cargo vessel alter course to port to go around the stern of the rig. The OOW of the cargo vessel, who was the Master, signalled his agreement and began altering course to port, but very slowly.

A few minutes later, the tug OOW again contacted the Master of the cargo vessel and insisted they alter to port more quickly as the CPA between the rig and the cargo vessel was zero. After further communication the Master of the cargo vessel then realised he was about to pass between the tug and the towed platform, so he made a hard alteration to port and passed the platform's stern by about 260 metres.

An investigation by the cargo vessel's company was initiated because the tug company contacted the cargo vessel company about the close call. From the data on the voyage data recorder (VDR), it was found that the Master of the cargo vessel was navigating visually and had no indication of CPA whatsoever, as both radars were set on standby during the near miss situation. According to the VDR recording, the Master initially steered the cargo vessel towards the stern of the tug, probably unaware of the fact that a tow line lay between the tug and the oil platform.

It was later discovered that the vessel's three senior officers, Master, chief mate and chief engineer, had serious alcohol consumption problems. Junior crew were aware of these facts but they were afraid to report the senior officers to the company management. Given the sequence of events it is highly likely that the Master, acting as OOW, was under the influence of alcohol at the time.

- Irrespective of your rank, always take measures to inform management of alcohol abuse on your vessel – your life may depend on it.
- The company's safety management system should allow for a procedure to report any deficiency to company management, including drug and alcohol abuse by the crew and Master.

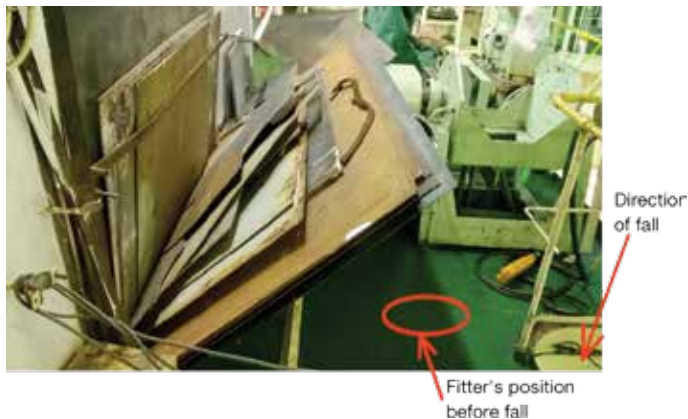
MARS 201655

The fitter began the job by unscrewing the securing bolts of the angle bar at one end of the plates, then moved to the other end. The moment he removed the last screw of the securing angle bar, the steel plates shifted towards him. The fitter jumped back in a reflex reaction and hit the lower railing bar behind him. His impact on the railing caused it to bend and fail. As a consequence, the fitter fell to the engine room lower platform about 10m below. Although the victim was quickly transported to a local hospital he nonetheless succumbed to his injuries and was pronounced dead.

The railing that failed was the removable type which, when removed, allowed movement of larger parts lifted by the ER crane.

The company investigation found that although a toolbox meeting was supposedly held before the job being performed, the risk of shifting steel plates was not specifically mentioned during the meeting.

- Avoid the checkbox mentality when conducting a tool box meeting; simply telling everyone to do the job safely is not enough. These meetings are meant to discuss the inherent risks involved for the job under review and help crew mitigate those risks.
- Steel plate storage should incorporate protections against having the plates tip over, domino style.

■ **Editor's note:** Another fatality due to shifting steel plates was recorded in MARS 201423 as well as a serious injury in MARS 201211. Steel plates are heavy, cumbersome items and when stored on edge are a potential hazard. These items should be the subject of careful consideration and storage.

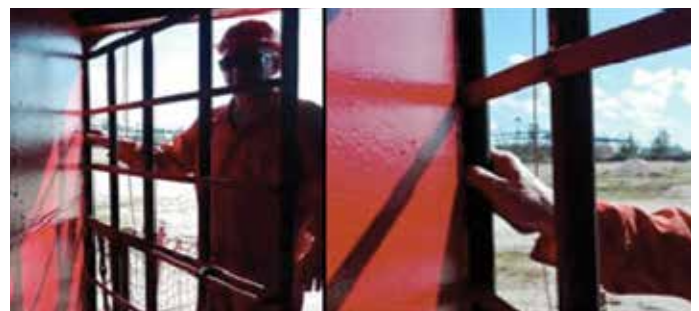
MARS 201657

→ An additional security gate was being installed at the top of the gangway in way of the pilot boarding access. One crew member was holding the gate in position while a second crew member located the securing bolts for the new gate. The second crew member was unable to see the first, as the pilot door in the ship's side was blocking his field of view. To access one of the securing bolts, the second crew member closed the pilot door without warning, trapping the first crew member's finger between the gate and the pilot door.

As a consequence the victim lost the top of his right thumb above the first knuckle line. He was immediately taken to the ship's hospital and the Master informed.

- The work was viewed as an everyday task, with the consequence that the risk assessment was inadequate and vigilance was lowered. **Never assume any job is risk-free.**
- Lack of communication between the two crew involved in the task contributed to the accident. A good practice when working as a team is to verbalise your intentions before acting on them.
