RISK ALERT

NAVIGATION SAFETY-LOOKOUT

Written by
Nahush Paranjpye
Loss Prevention Team

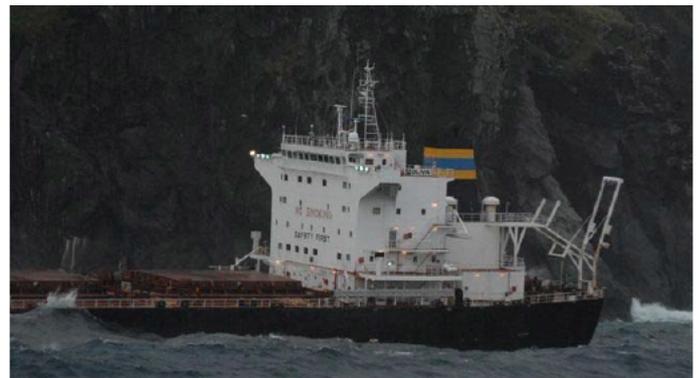
Bulk carrier MV Oliva went aground on Nightingale Island (Tristan da Cunha) on 16 March 2011 while on loaded passage from Santos, Brazil to China.

TM 14/2012 – MV Oliva (aground)

Just after 0400, the 2/O noticed a **large defined echo on the radar screen**, about five nautical miles, passing clear down vessel's port side and **assumed it to be rain clouds or an iceberg**; believing the vessel to be within iceberg limits according to the routing chart he has seen.

2/O hands over to the C/O **advising him the course is set on autopilot and leaving the bridge at about 0425 without telling the C/O of the radar echoes as they had passed clear of the vessel, neither did he tell him that the vessel would be passing close to land during his watch.**

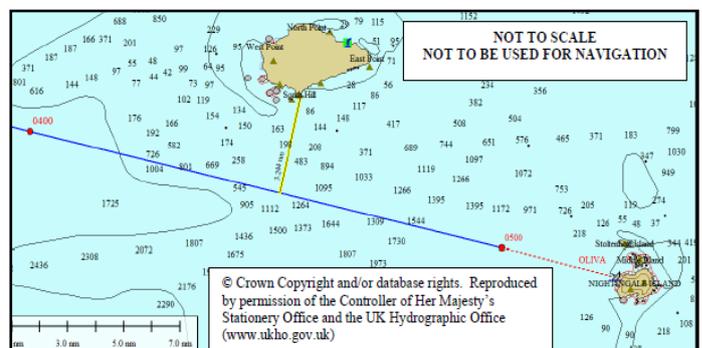
TM 14/2012 – Extract of BA Chart 1769 showing vessel's position

The vessel passed **Inaccessible Island to port within 3.25 nm** at about 0430, at which time Nightingale Island would have been right ahead approx. 9.9 nm. **At about the same time the AB reported a white light forward of the port beam, which he assumed was a fishing vessel. The C/O, now sitting in the pilot chair, responded that he**

could see it but did not get up to investigate.

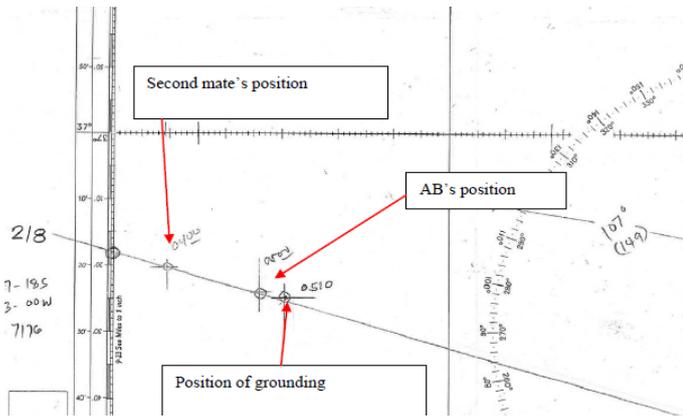
TM 14/2012 – Extract of plotting sheet in use

Just after 0500, the C/O noted that the AB had plotted a position on the chart. Returning to the pilot chair he noticed a large echo on the radar screen, very close ahead, assumed it was a heavy storm cloud and thereafter felt the impact of the vessel running aground.

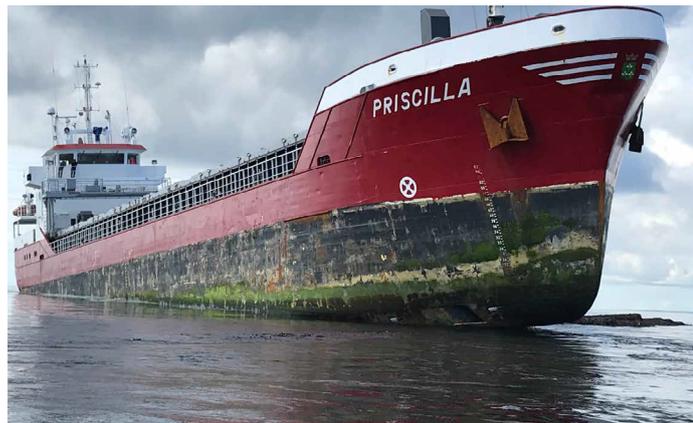
General cargo vessel *Priscilla* ran aground on Pentland Skerries in the eastern entrance of Pentland Firth, Scotland on 18 July 2

MAIB 12/2018 – Priscilla (aground)

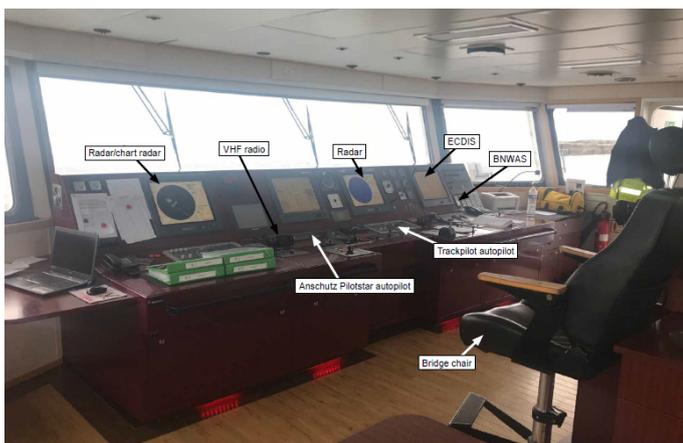
Approaching Pentland Firth, *Priscilla* was set to the south of the planned track, but this was not observed because the OOW failed to monitor the vessel's progress for about 2 hours; instead, he sat in the bridge chair and watched videos

MAIB 12/2018 – Priscilla Bridge

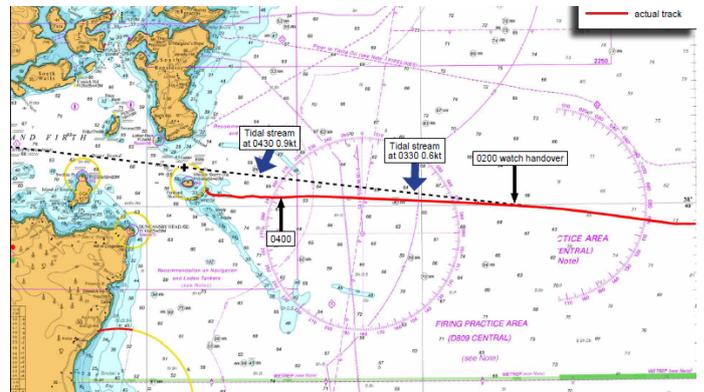
The OOW responded to verbal warnings of the danger ahead from both the Orkney Vessel Traffic Services Officer and the Shetland Coastguard Operations Centre. However, the action taken in response to these warnings was not effective and indicated that he did not have adequate situational awareness to understand the gravity of the vessels position and turn away from danger.

MAIB 12/2018 – Planned and actual track prior to grounding

The vessel was badly damaged and remained aground for several days until the cargo had been removed and sufficient tugs were available to haul it off the rocks.

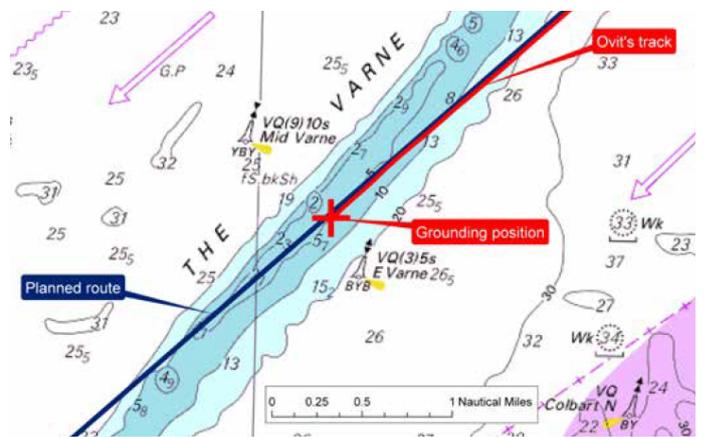
At 0434 hours on 18 September 2013 Maltese flag Chemical Tanker *OVIT* ran aground on the Varne Bank in the Dover Strait while on a loaded passage from Rotterdam, Netherlands, to Brindisi, Italy

MAIB 24/2014 – Ovitt Grounding position – The Varne

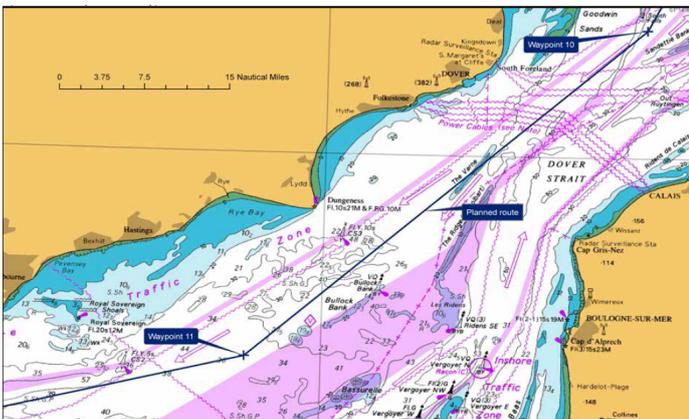
The intended route through the Dover Strait was prepared using the ship's ECDIS by an inexperienced and unsupervised junior officer; the plan was not checked by the master before departure or by the officer of the watch at the start of his watch – route passed directly over the Varne Bank.

MAIB 24/2014 – Detail of Dover Strait passage plan

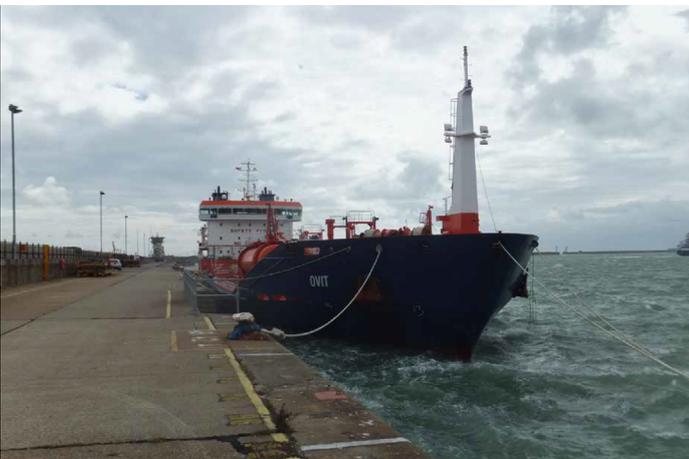
As *OVIT* approached the Varne Bank, the deck cadet, using binoculars, became aware of flashing white lights ahead. He did not identify the lights or report the sighting to the OOW.

MAIB 24/2014 – OOW (moored at berth)

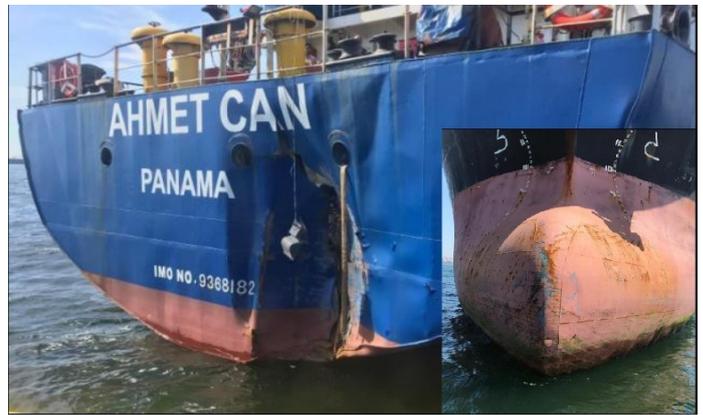
18 May 2019 - Maltese flag 18,873GT bulk carrier *Persenk* on passage from Istanbul to Ashdod, Israel, was involved in a collision with the 1,972GT general cargo vessel *Ahmet Can* in the Sea of Marmara

TM 12/2020 – Damage to Ahmet Can stern & Minor damage to Persenk bow (inset)

The collision occurred in the afternoon and in good visibility. At the time of the collision, both vessels were in sight of one another, making way in the Turkish Straits Traffic Separation Scheme. They were proceeding in the general direction of traffic flow for that traffic lane, albeit on a converging course, and *Persenk* was gradually drawing ahead of *Ahmet Can*. Although the weather was fine and clear it appears that the watchkeepers on *Persenk* and *Ahmet Can* failed to discern the developing close quarters situation until *Ahmet Can* was very close and right ahead.

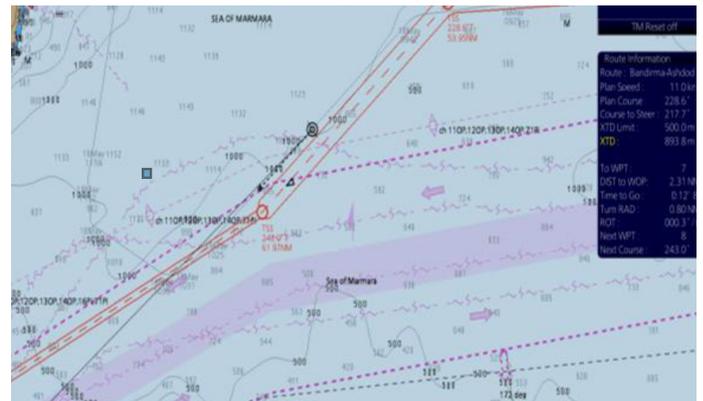
TM 12/2020 – ECDIS playback showing a segment of passage plan in the Sea of Marmara

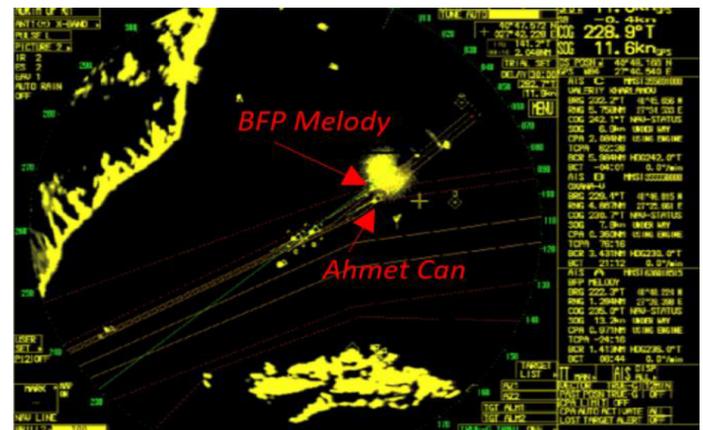
Ahmet Can along with other vessels in the vicinity had **not been acquired** and displayed and no navigational data appeared on *Persenk*’s X-band radar which was set on 12nm range (S-band X-band not being used - kept on stand-by). There was no attempt to scale down the display to a suitable range and the cursor was not moved

TM 12/2020 – Radar image showing traffic situation at 1300

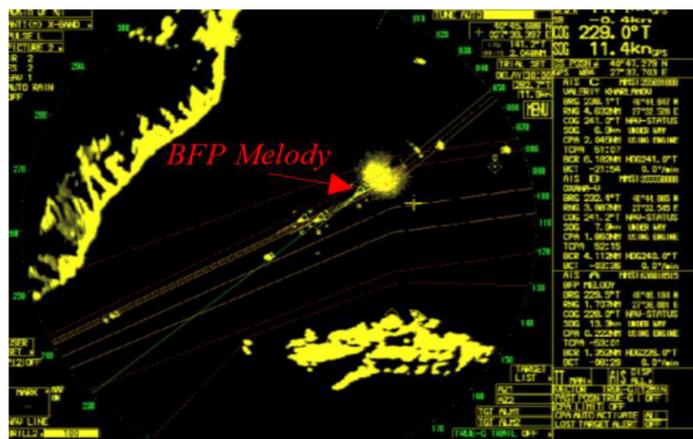
As the vessels drew closer, the radar echo for *Ahmet Can*, became masked by the clutter (anticlutter had not been adjusted).

TM 12/2020 – Radar image showing traffic situation at 1315 – Ahmet Can echo concealed by clutter

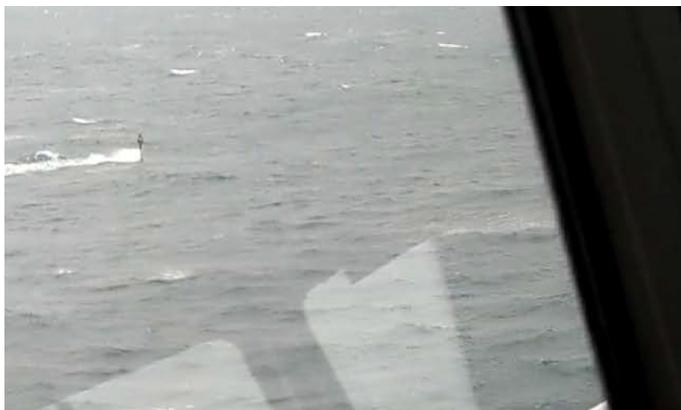
MAIB 13/2020 - Submarines periscope seen from bridge of *Stena Superfast VII*

At 1254 the AB lookout saw and immediately reported to the OOW a submarines periscope, at close range on the port bow crossing from port to starboard. Quickly assessing the situation, and determining that there was imminent risk of collision, the OOW had the AB adopt hand steering and altered course to port.
