RISK ALERT

Scrubber overboard connection-Severe Corrosion

Written by
Vijay Rao
Loss Prevention

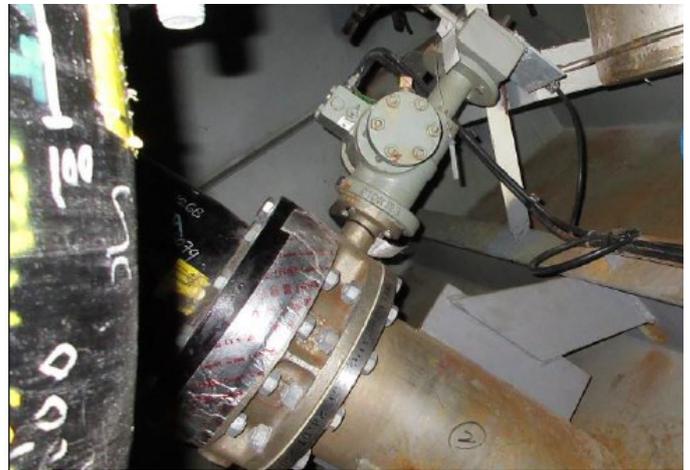
Of particular concern is the case of severe corrosion in the section of the discharge piping outboard of the scrubber overboard valve – the distance piece. Wastage and failure of this piping section could, in worst case scenario, lead to flooding of the engine room.

The vulnerability of seawater piping due to pitting, galvanic reaction and cavitation is well known. Similarly, the corrosion of discharge piping associated with the inert gas systems on tankers is also a known issue. The difference with the exhaust gas scrubber system is that it is a far more corrosive environment with the lower pH values (higher acidity) of discharge washwater, higher temperatures and variation in flow in the drain piping.

The continuous operation of the scrubber system, improper selection of material and poor workmanship are also identified as likely causes for

early failure of the piping.

Scrubber overboard discharge connection

It has now been suggested that the thickness gauging of the connection should be carried out annually, to ascertain the rate of any diminution in the piping thickness. Diminution could suggest damage to the applied corrosion protection where such is provided.

It is, however, recommended, that where possible, the thickness measurement is undertaken at 6 monthly intervals and that a diver inspection of the overboard discharge connection is undertaken to ascertain the condition of the diffuser, attachment and any protective coating that might have been applied.

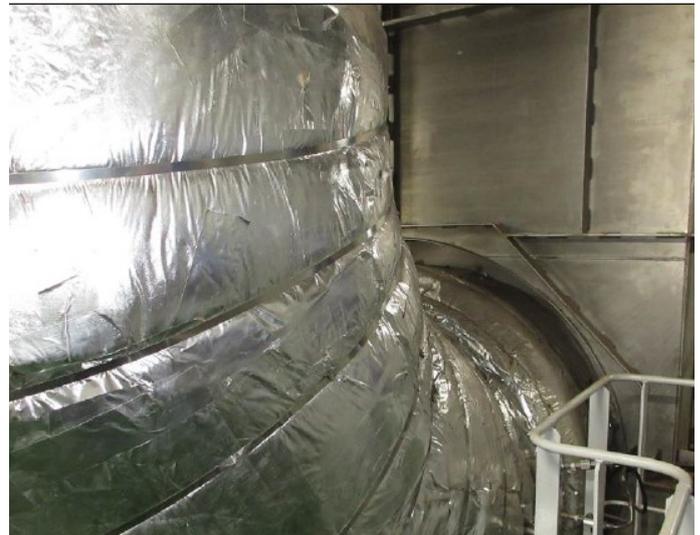
Scrubber installation-exhaust connection
