SAFETY INVESTIGATION REPORT

REPORT NO.: 09/2023

MV KIRAN ANATOLIA **Fatal burn injuries to a crew member** **during maintenance work on deck,** **while drifting in position** **31° 32.7' N 029° 52.1' E** **05 June 2022**

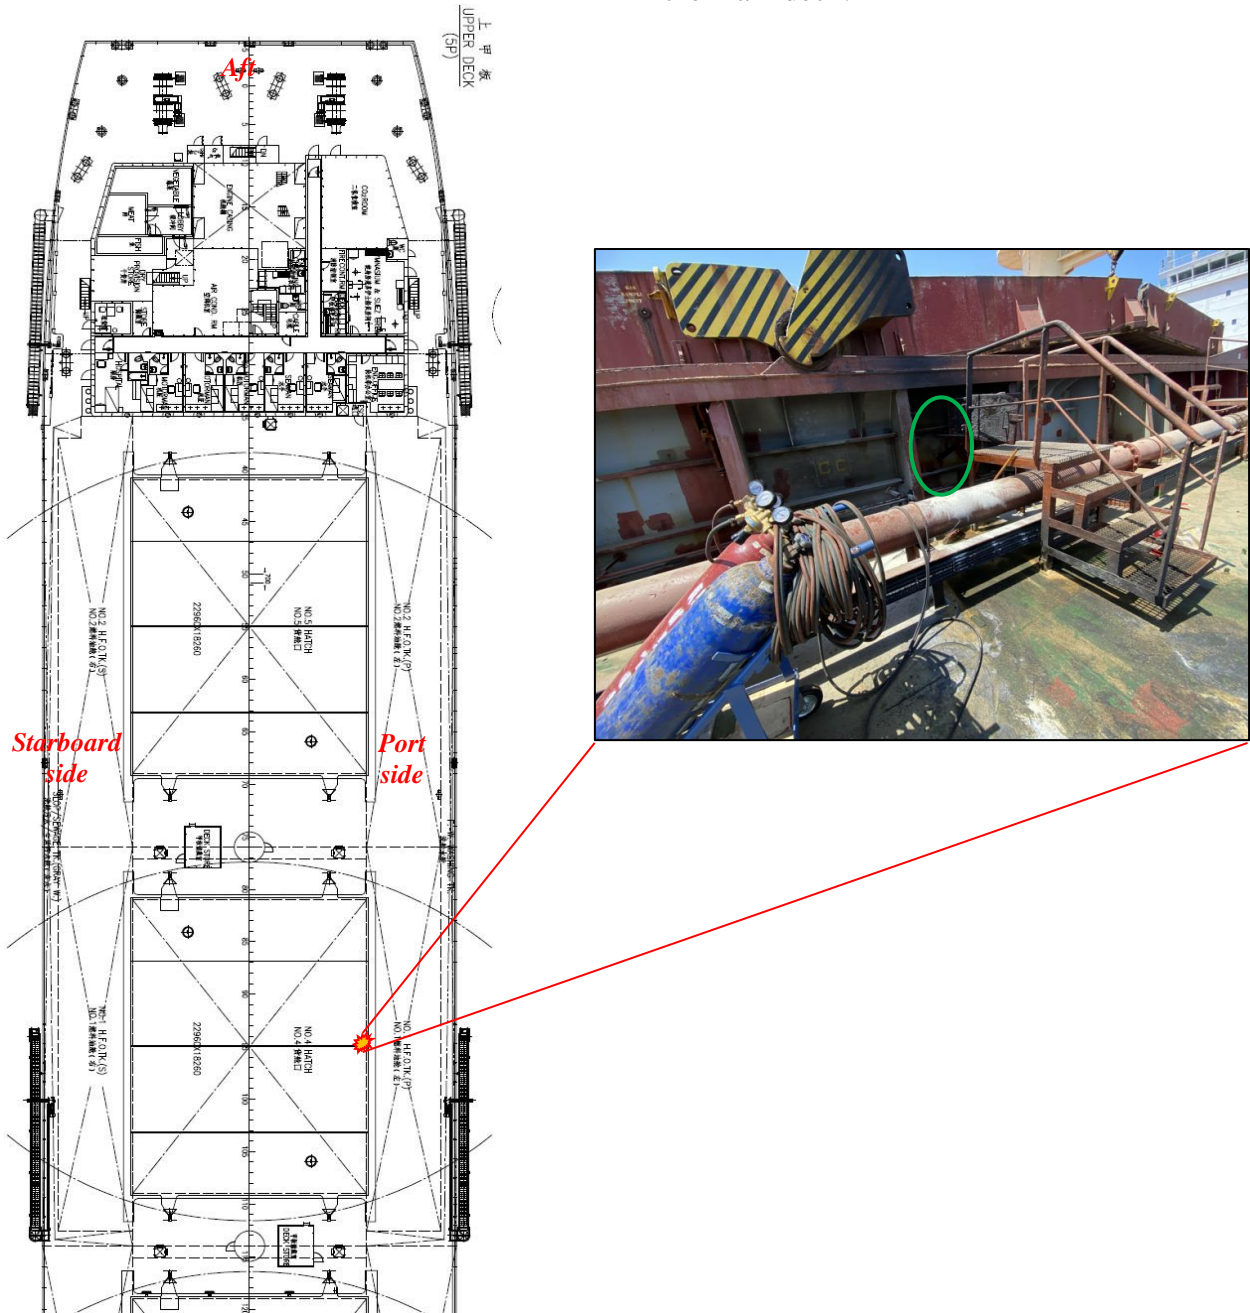
At around 0940 (about 10 minutes after the C/O started pumping the bilges), the OOW noticed thick black smoke on the main deck, followed by rising and quickly receding flames, from the port side hatch coaming of cargo hold no. 4 (**Figure 2**).

Figure 2: Location of the occurrence; the green circle (inset) shows the location where the deck fitter would have been positioned to carry out the task

Furthermore, the deck fitter was working in a confined location and would have to be crouching down to access the leaking section of the hydraulic pipe (**Figures 2 and 5**). It is likely that hydraulic oil would have permeated parts of his overalls while he was working in that position, and a spray of hydraulic oil would have contaminated the overalls further. Consequently, the overalls would have caught fire and the fire would have spread rapidly across his body, after the flashback / ignition of the hydraulic oil spray.

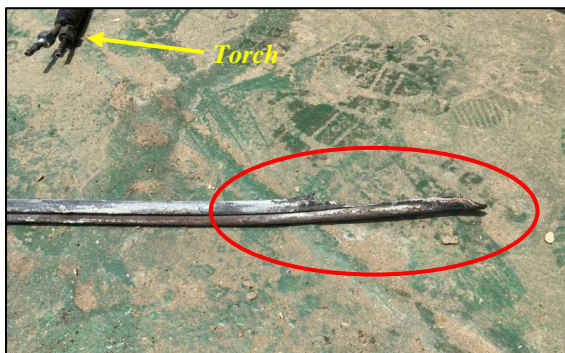
The crew members found that the hoses of the oxy-acetylene set were damaged around the region at which they were connected to the torch (Figure 3). The torch was also damaged and had parted from the oxygen and acetylene hoses (Figure 4).

Figure 3: The damaged oxygen and acetylene hoses (circled in red)

torch; the damages observed on the torch and the hoses (**Figures 3 and 4**) suggested that a flashback may have occurred.

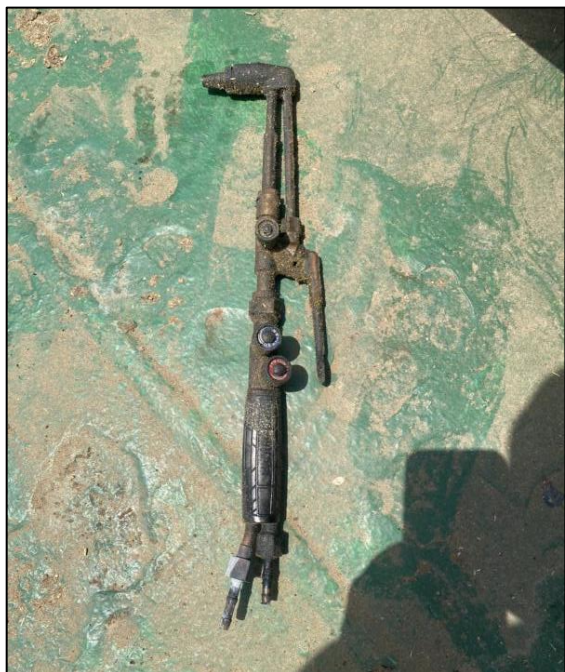
Figure 4: The damaged torch

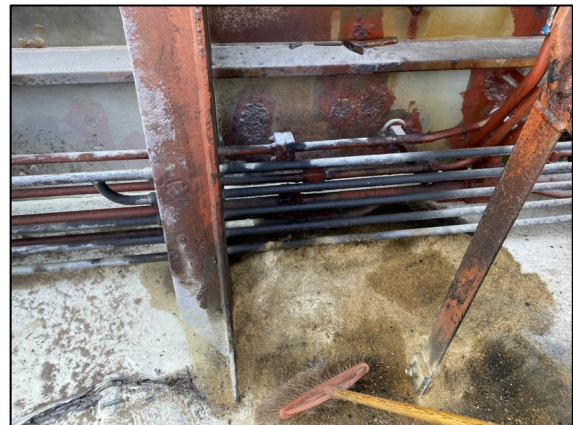
While no other damages were observed by the crew members, they noticed that four bolts' heads on one flange of the leaking section of the hydraulic oil pipe had been cut and hydraulic oil was dripping slowly from the flange. They also noticed that hydraulic oil had accumulated below the pipes and they had to spread sawdust around the area to absorb and contain the oil (Figure 5).

Figure 5: Sawdust soaked with the hydraulic oil that leaked out

Furthermore, the safety investigation had also observed that along with signs of sprayed hydraulic oil on the hatch coaming, the paint on the hydraulic oil pipes in that area appeared charred (**Figure 5**). This suggested that a spray of hydraulic oil from the leaking section of the pipe may have ignited when it came into contact with the flame of the torch. As the crew members found four bolt heads of one other flange cut, with hydraulic oil dripping slowly from the flange, after the occurrence, it is possible that hydraulic oil may have sprayed out from this flange.

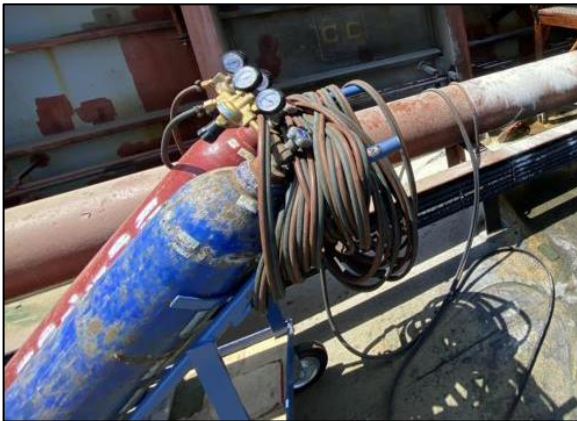
The oxy-acetylene set used by the deck fitter was a portable one *i.e.*, the cylinders, hoses and torch were secured on a trolley (Figure 6). This portable system was neither fitted with flashback arrestors, nor with non-return valves.

Figure 6: The oxy-acetylene set used for the task

The safety investigation noticed (and the company confirmed) that flashback arrestors and non-return valves were not fitted on the oxy-acetylene set used by the deck fitter. However, the safety investigation was provided with data that indicated that all the other oxy-acetylene sets were fitted with flashback arrestors at the cylinder pressure regulators, one of the portable sets was fitted with non-return valves at the torch (**Figure 8**), one spare torch was fitted with non-return valves, and another spare torch was fitted with non-return valves with flashback arrestors (**Figure 9**).

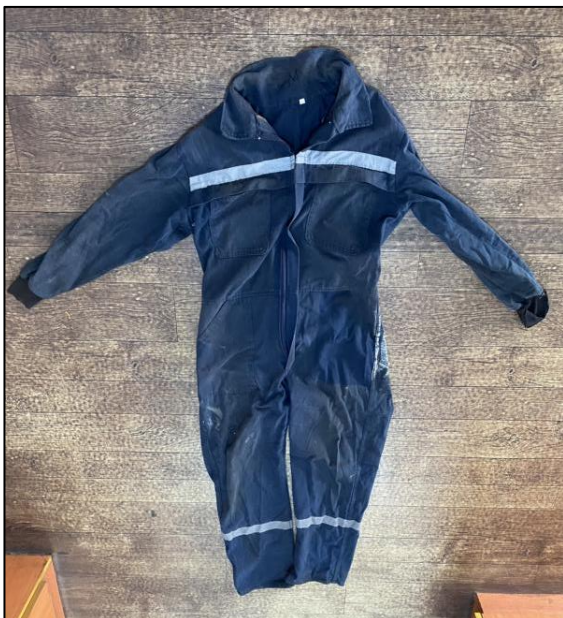
Both the master and the company confirmed that the overalls worn by the deck fitter were similar to the ones used by other crew members on board *Kiran Anatolia* (Figure 7). There were no labels on it to indicate whether it had any degree of fire resistance.

Figure 7: Overalls similar to the one worn by the fitter around the time of the occurrence

The safety investigation noted that the overalls did not bear any labels indicating whether they offered some degree of fire protection or not. However, considering that the deck fitter was witnessed to have been covered in flames, before he jumped overboard, it is highly likely that the overalls he was wearing did not offer fire protection.

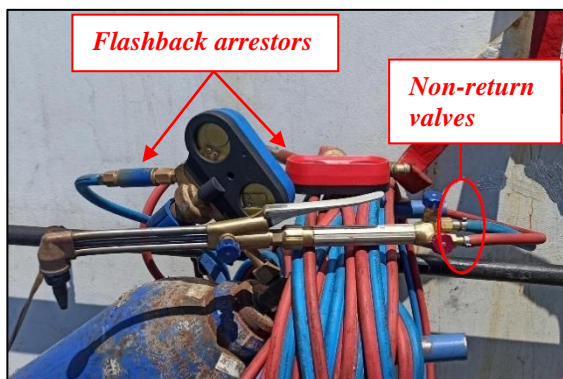
Figure 8: One of *Kiran Anatolia*'s portable oxy-acetylene sets, fitted with flashback arrestors at the pressure regulators and non-return valves at the torch

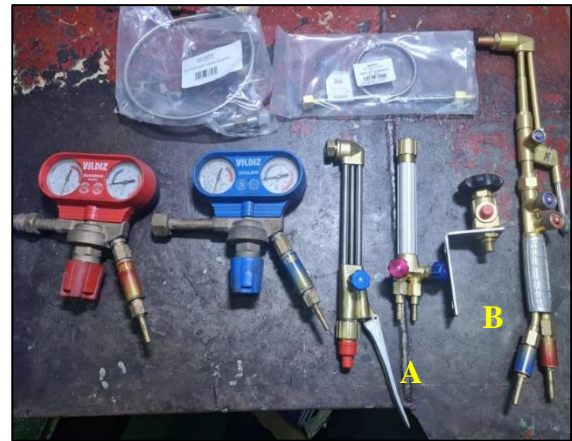
Figure 9: Spare pressure regulators fitted with flashback arrestors, a torch fitted with non-return valves (A) and a torch fitted with non-return valves with flashback arrestors (B)
