Report on the investigation
of the fatal crush accident
on the general cargo vessel

Karina C

at Seville, Spain

on 24 May 2019

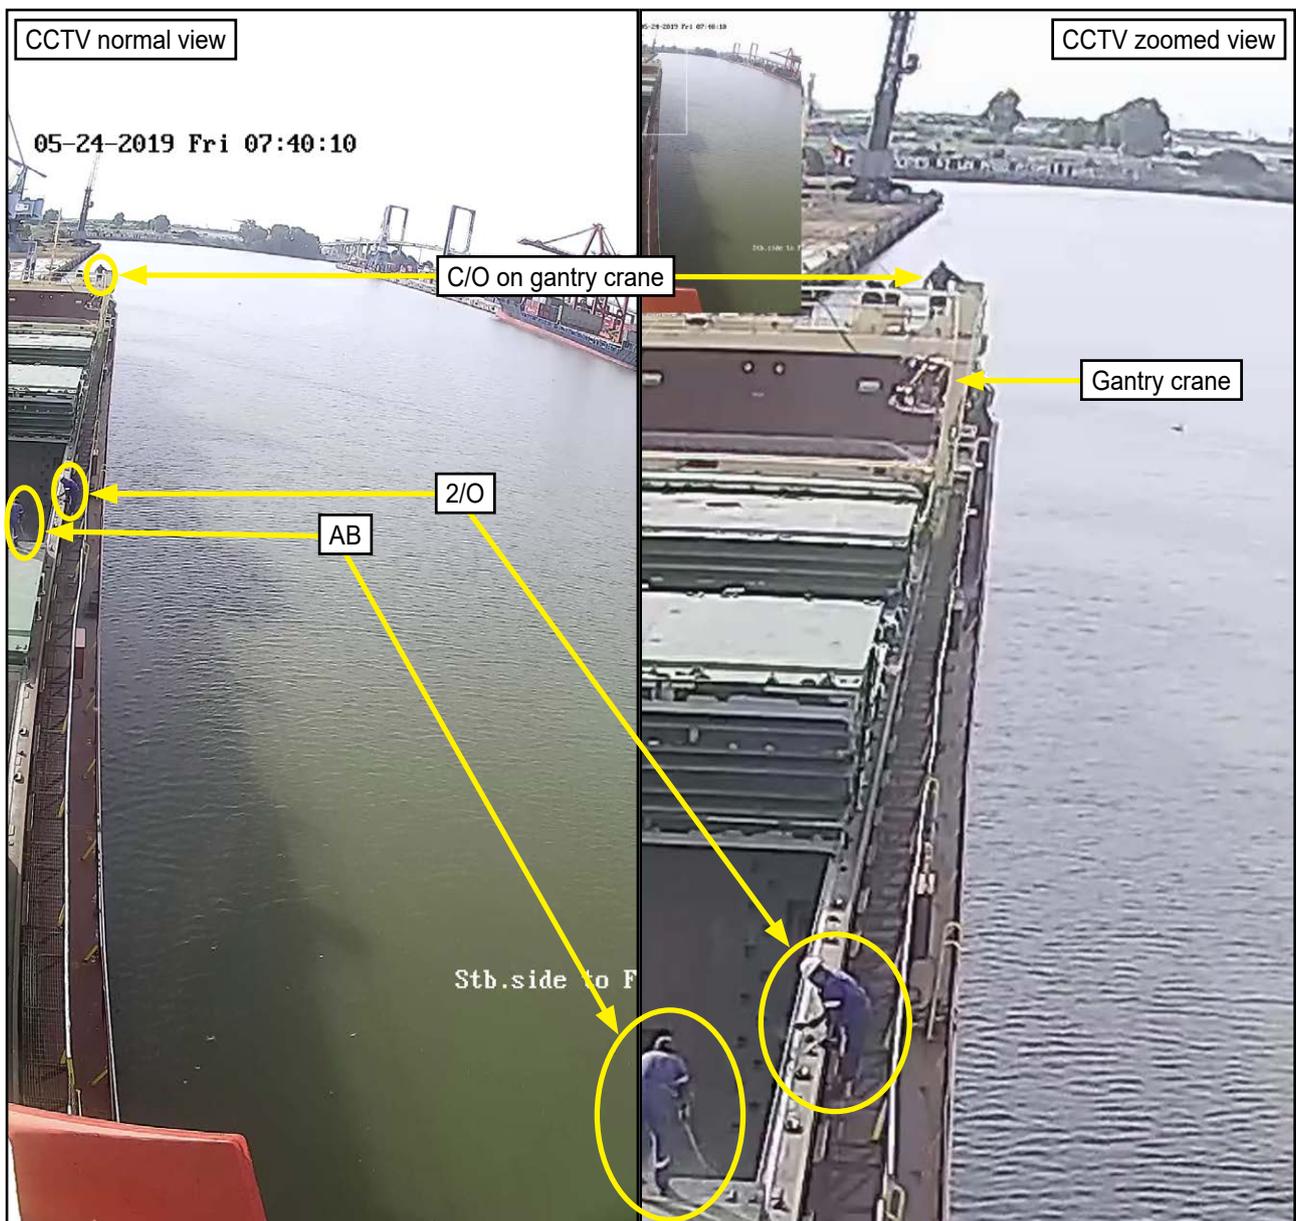
Figure 1: Crew working on deck

During the task of clearing the cement residue from the hatch covers and coamings, one AB was observed walking along and leaning over the unprotected edge of a hatch cover (**Figure 1**). Working close to unprotected open hatch covers is a well-recognised hazard and the consequence of a simple slip or trip, or even a medical event, can often have fatal consequences. The UK Working at Height Regulations require personnel working in such areas to be protected, either by the rigging of temporary guardrails, or by the wearing of a safety harness and the rigging of a fall prevention system (**Figure 18**). This requirement was repeated in Carisbrooke's SMS manual, but on the day of the accident, portable guardrails were not rigged and safety harnesses and fall prevention lanyards were not used.

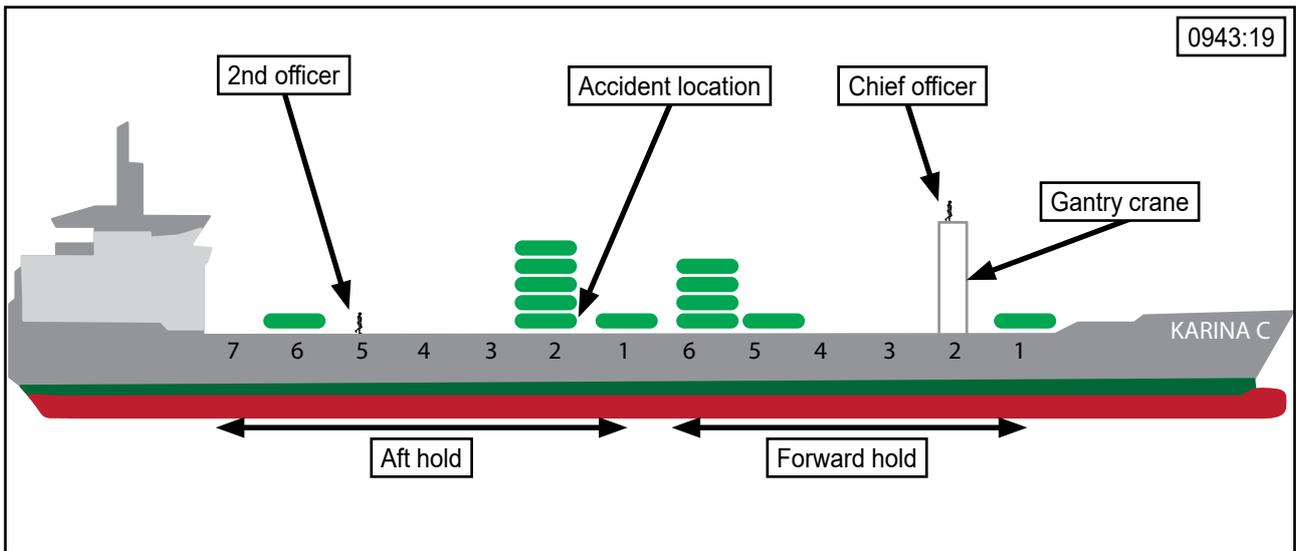
Figure 2: *Karina C*'s cargo hold hatch cover locations immediately before the accident

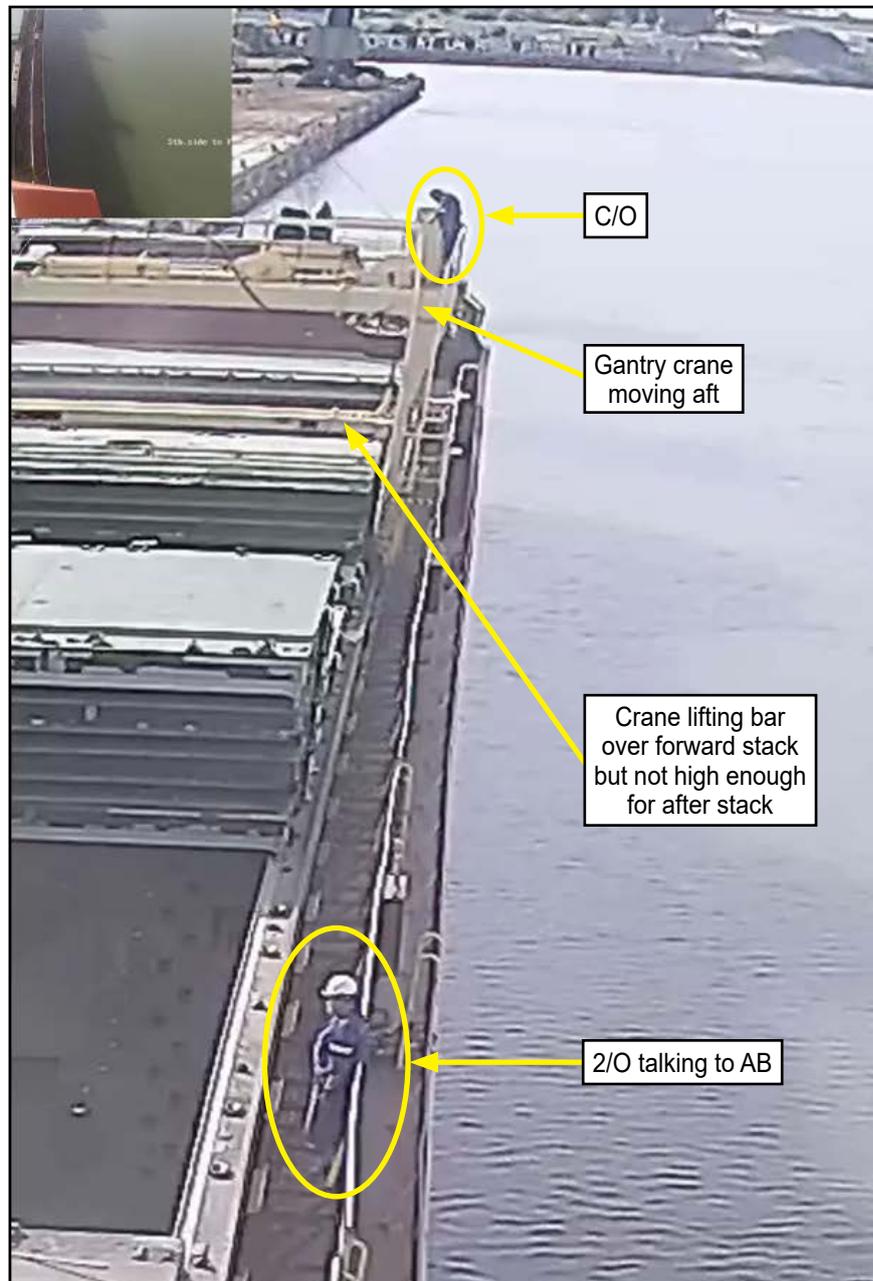
Figure 3: Second officer leaning on the starboard walkway guardrails while the gantry crane was being driven aft

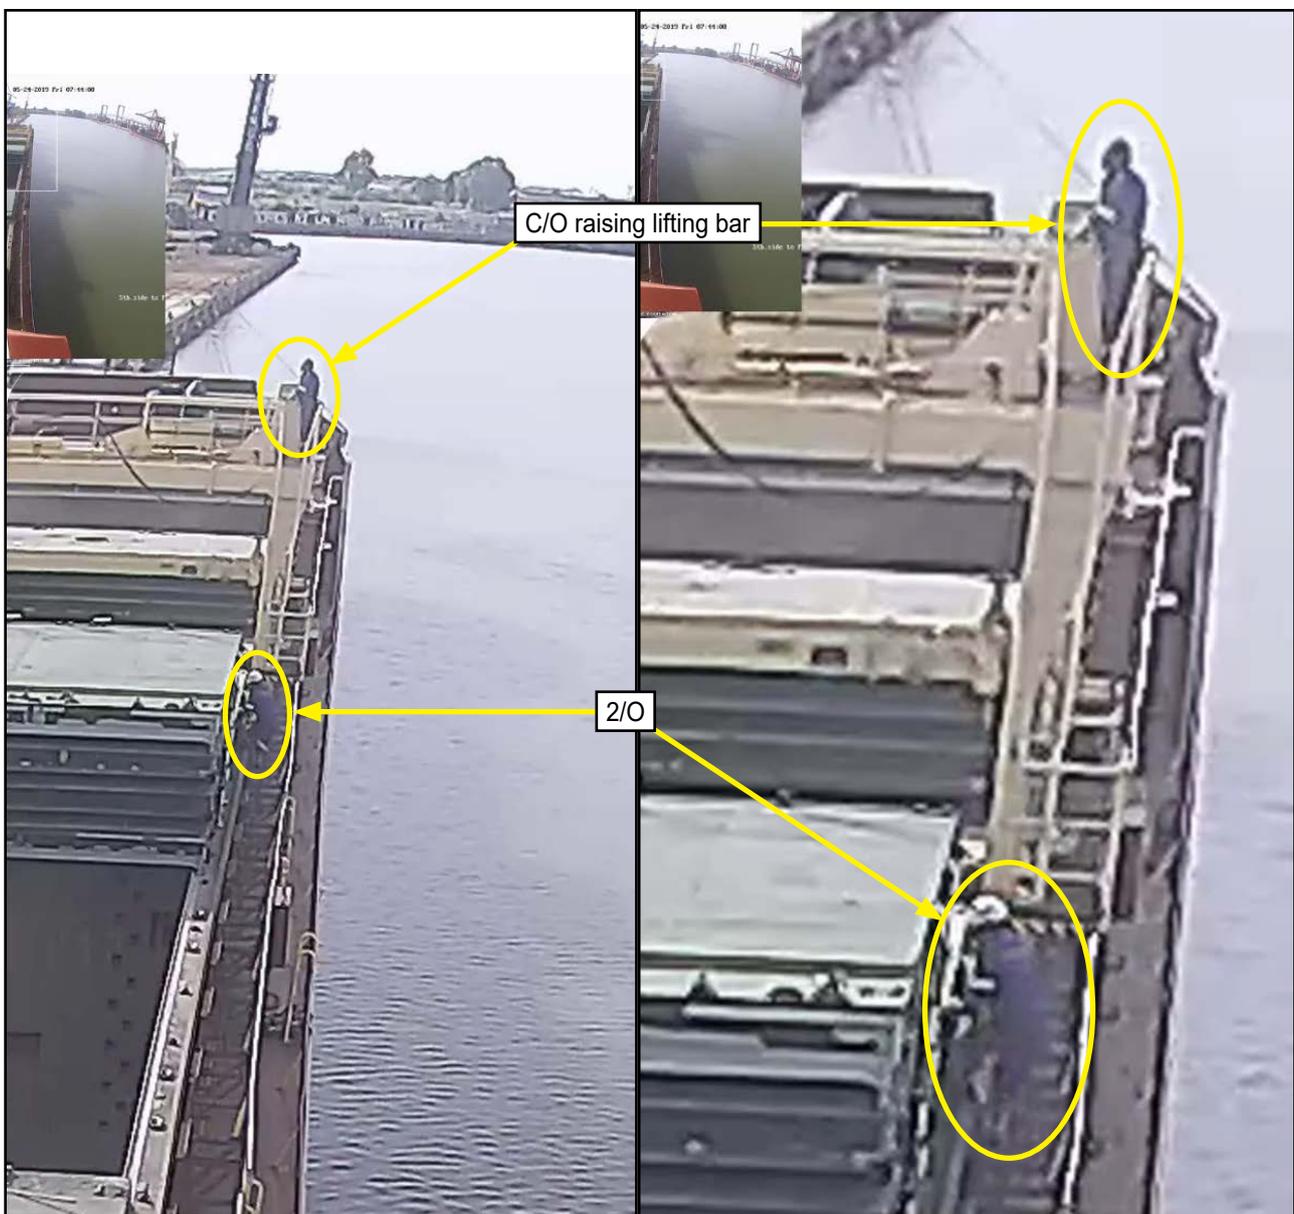
Figure 4: Zoomed CCTV screenshot showing the second officer climbing onto cargo hold hatch coaming at 0944:10

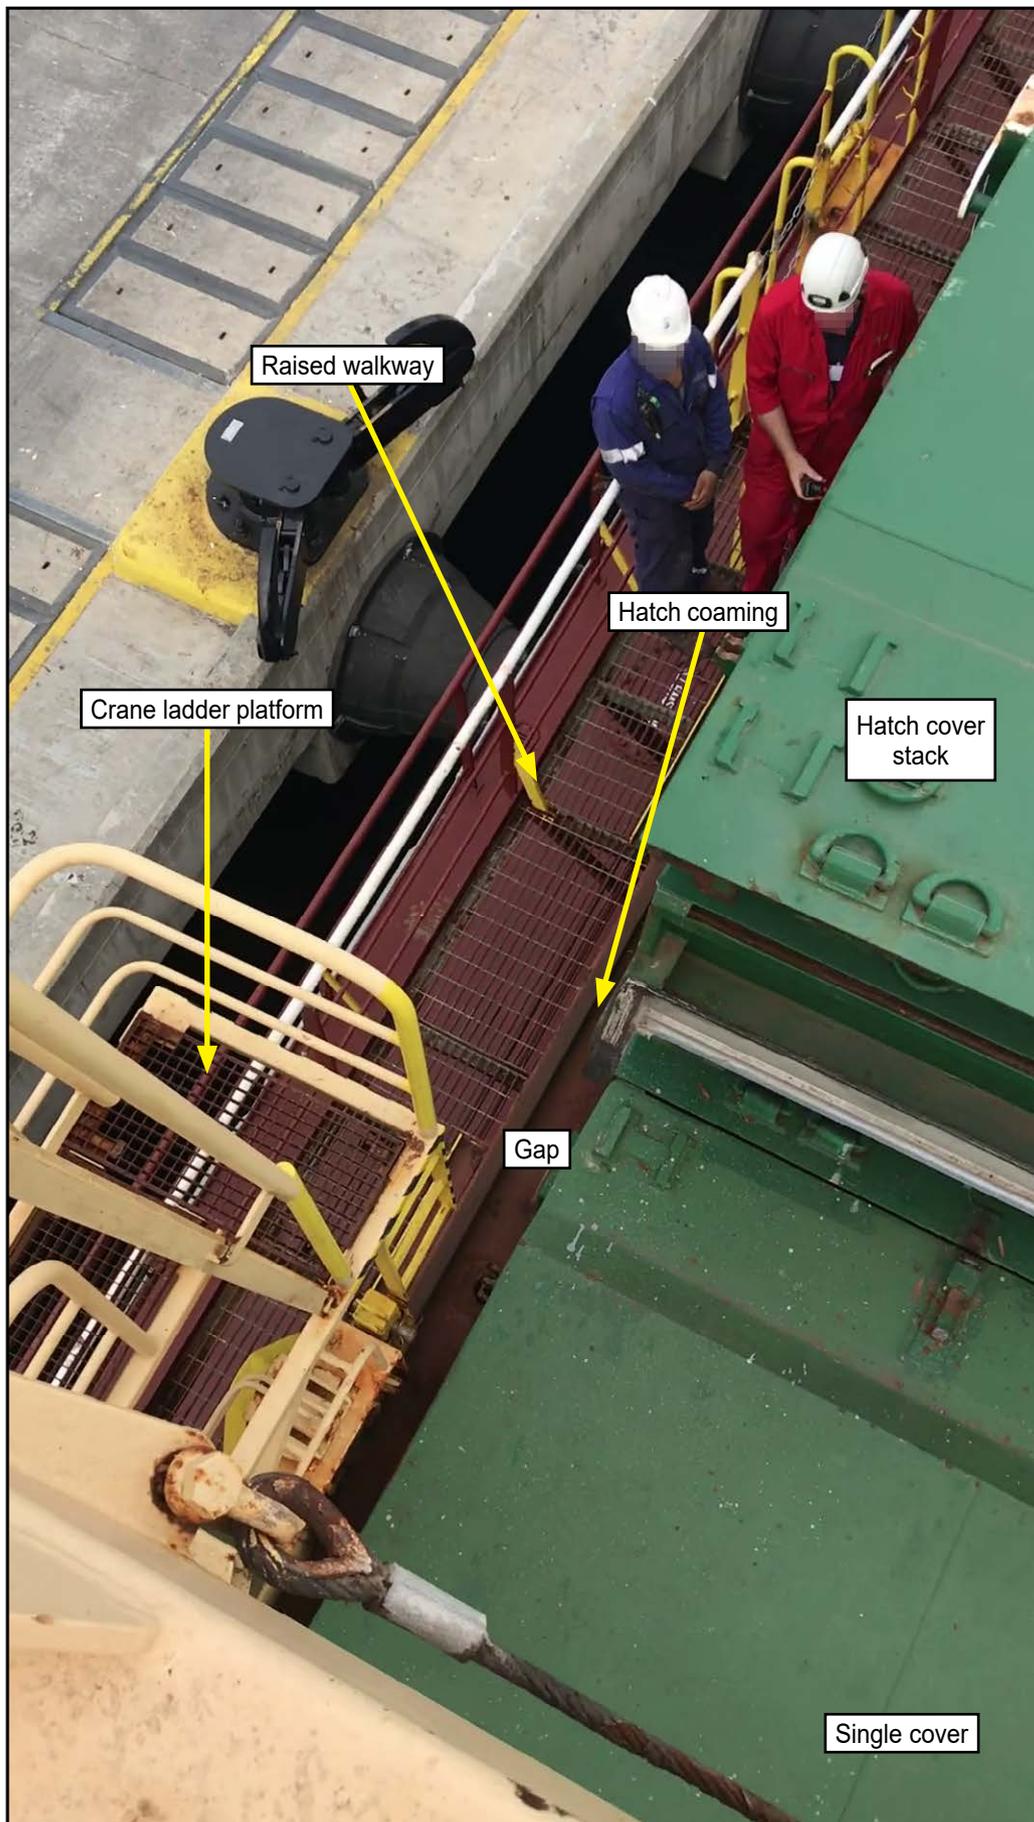
Figure 5: Reconstruction showing the distance between the crane ladder platform and the stack of hatch covers when the second officer climbed onto the coaming

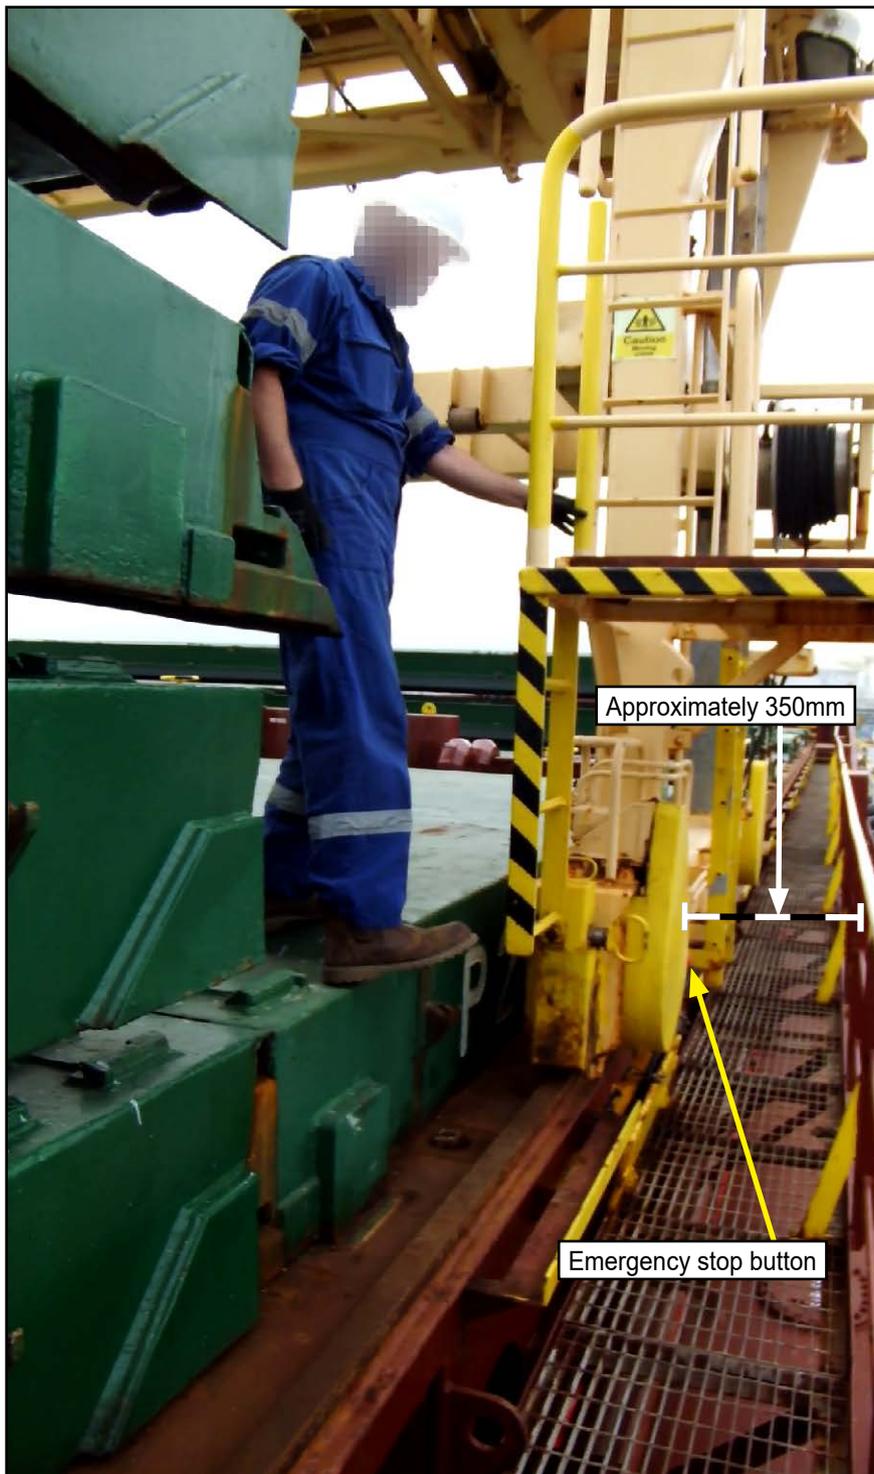
Figure 12: Access to starboard emergency stop

- It was impossible for the 2/O to reach the gantry crane emergency stop button (**Figure 12**) from the position in which he became trapped.
- The gantry crane's audible warning bell could be clearly heard at walkway level.

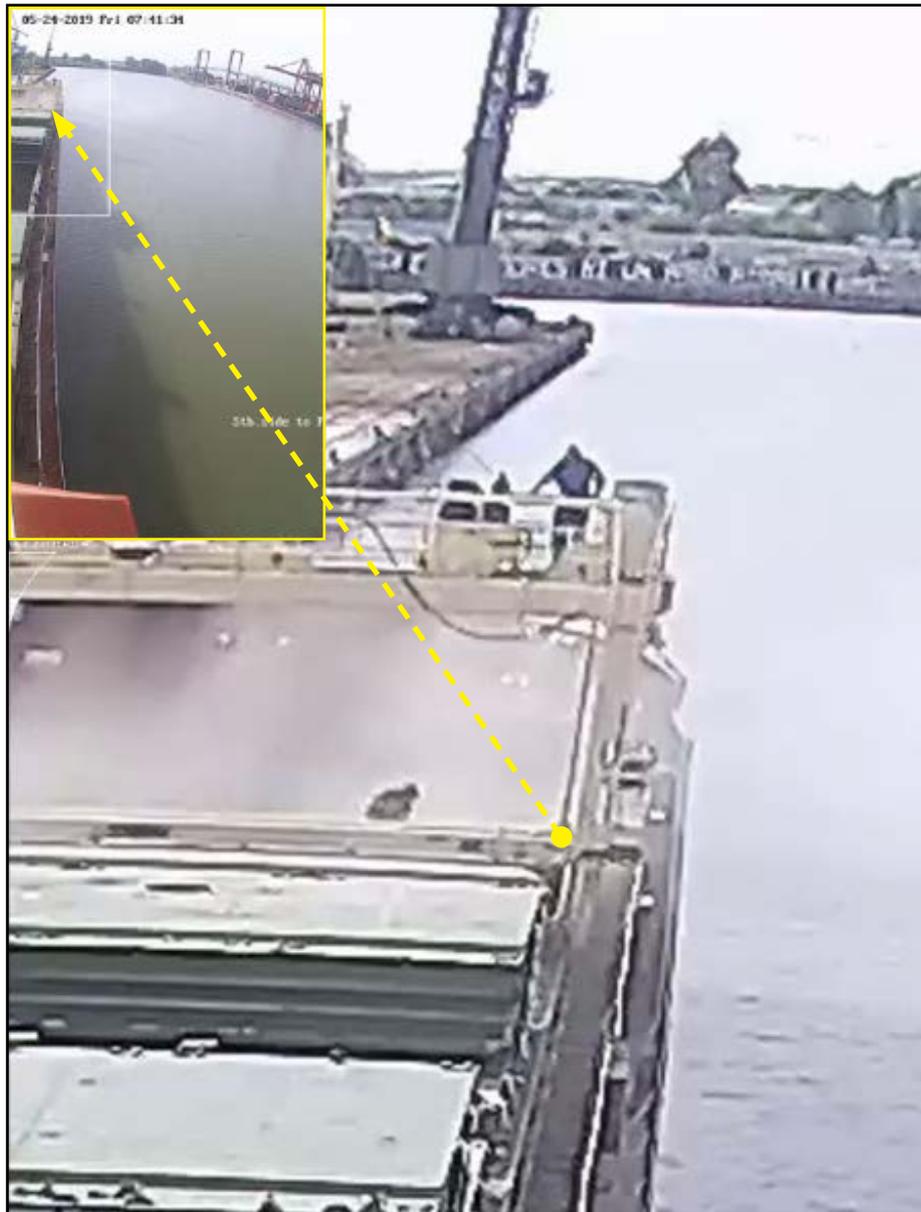
The company's *RA D15 – Loading and Discharging Dusty Cargo (Annex C)* required the use of suitable personal protective equipment (PPE), which included face masks and goggles. During the pre-departure cleaning operation occasional clouds of cement dust were created (**Figure 13**). The deck cadet and two ABs were wearing face masks and eye protection; the 2/O and C/O were not.

Figure 13: CCTV screenshot showing cement dust cloud

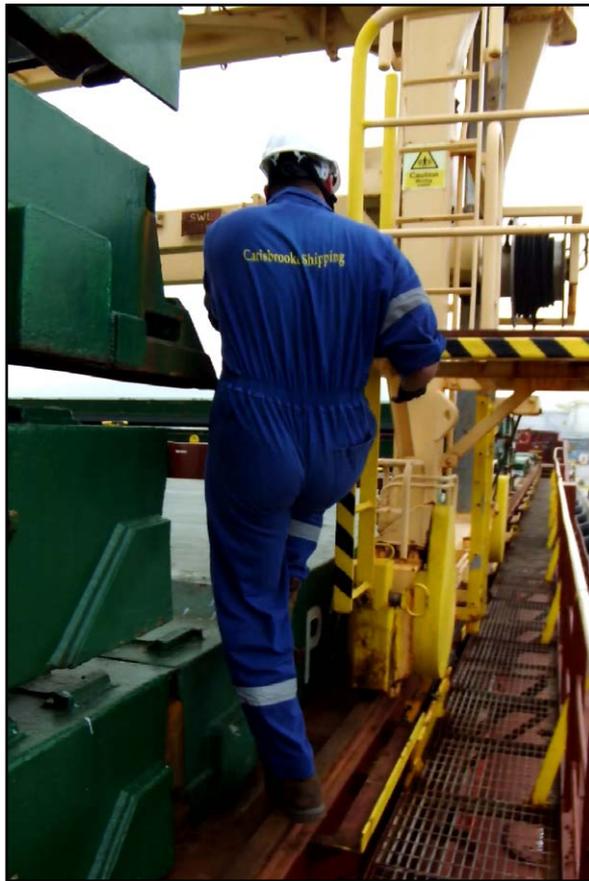
Figure 14: Climbing through the gap between the hatch covers and gantry crane (reconstruction)

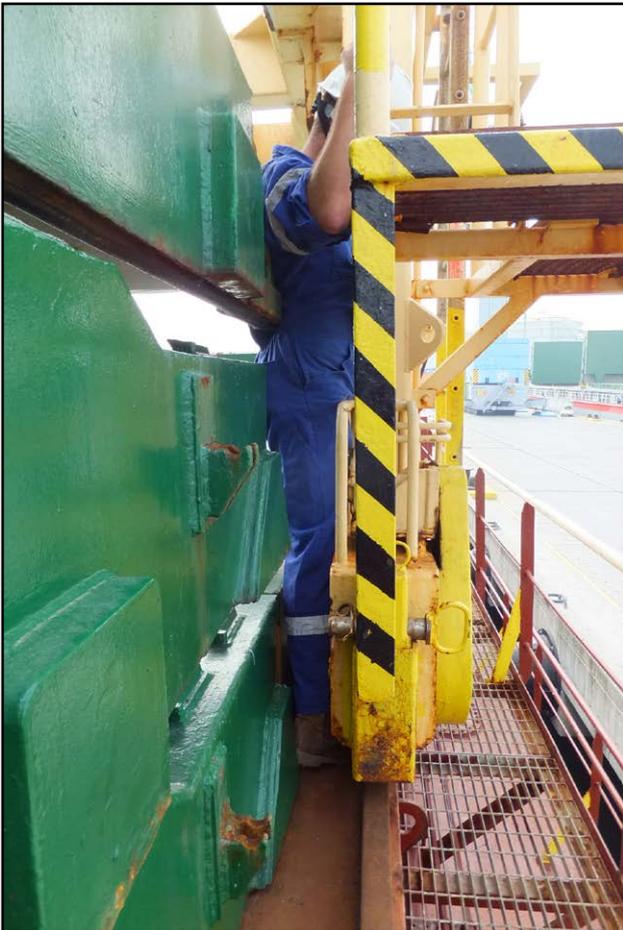
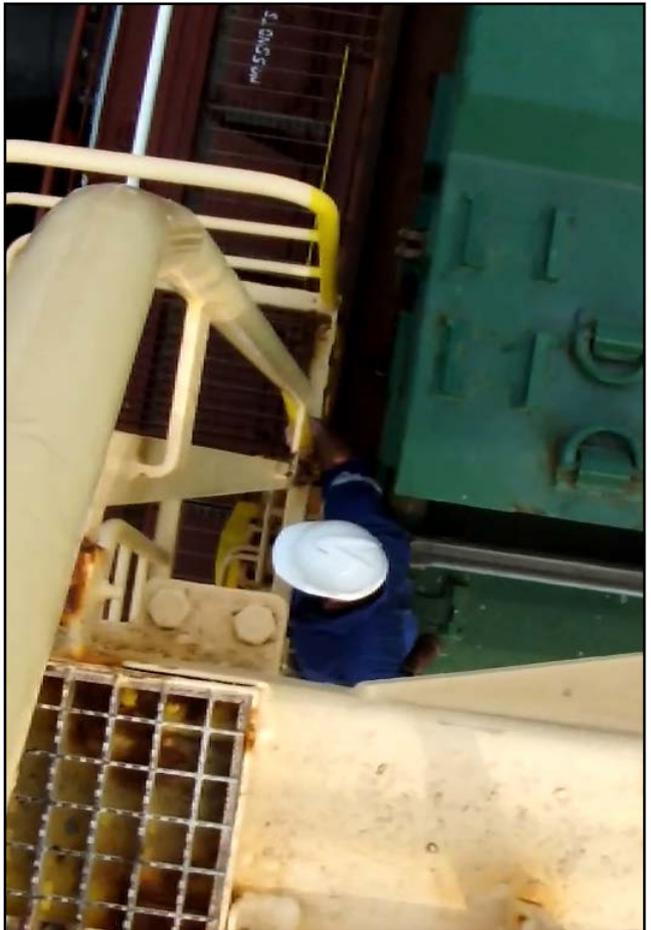
Figure 15: Reconstruction showing size of the gap between the ladder platform and the stacked hatch covers

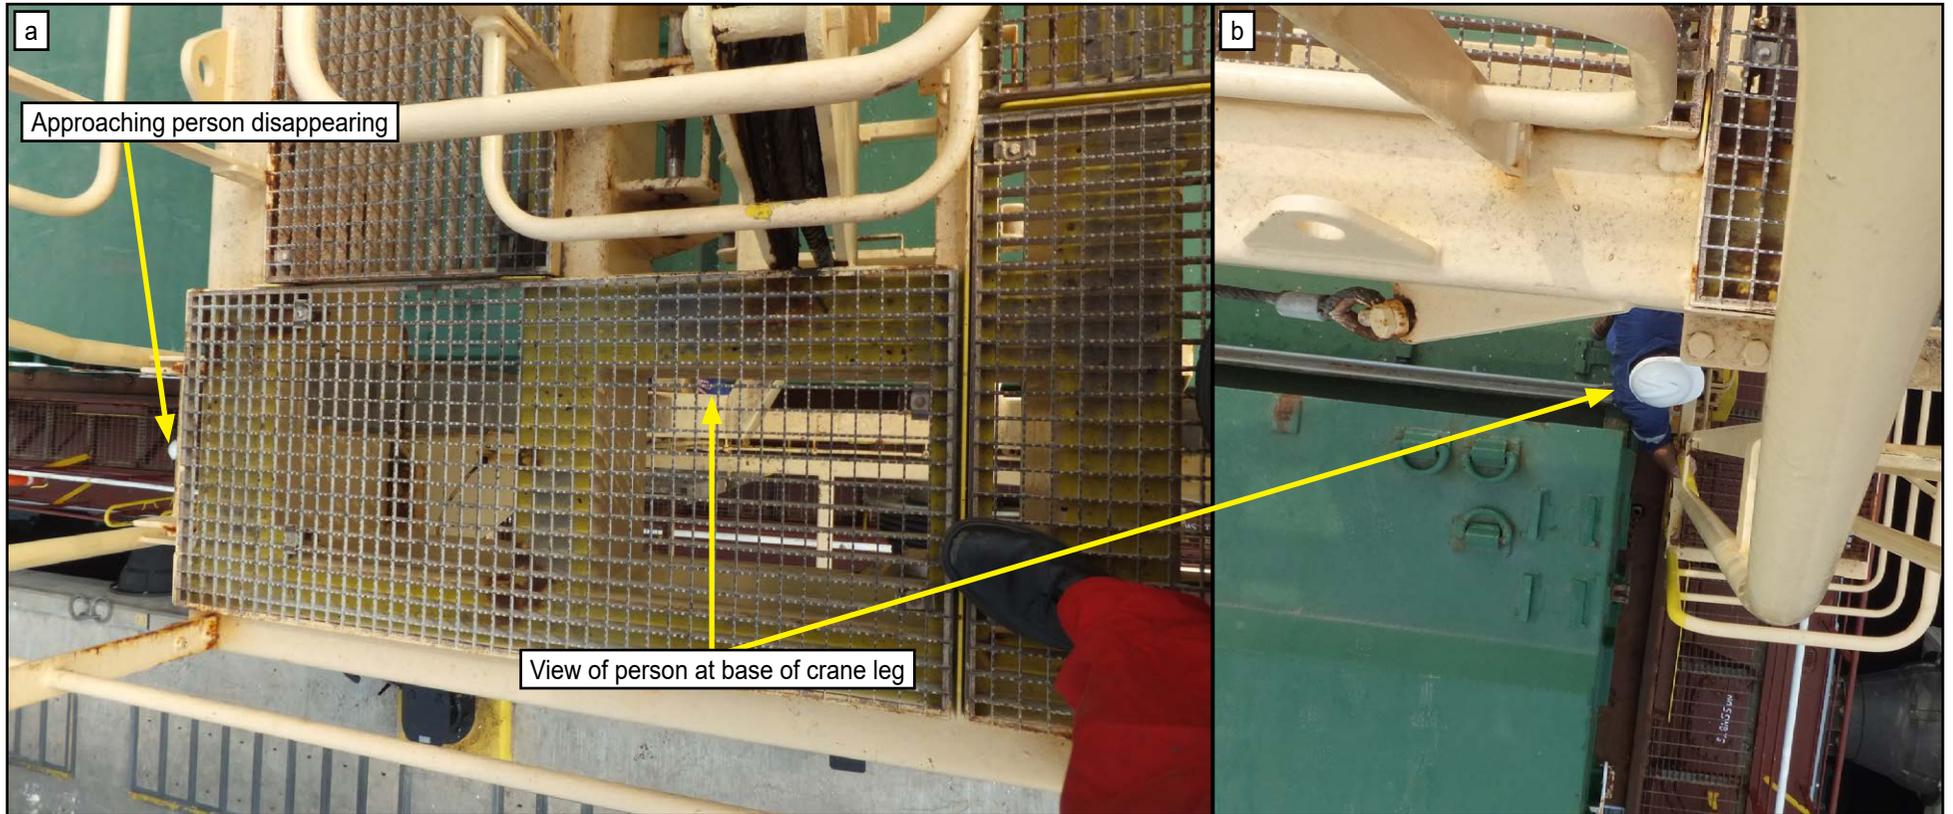
Figure 16: View directly below from the gantry crane operator's position (a) and above ladder (b)

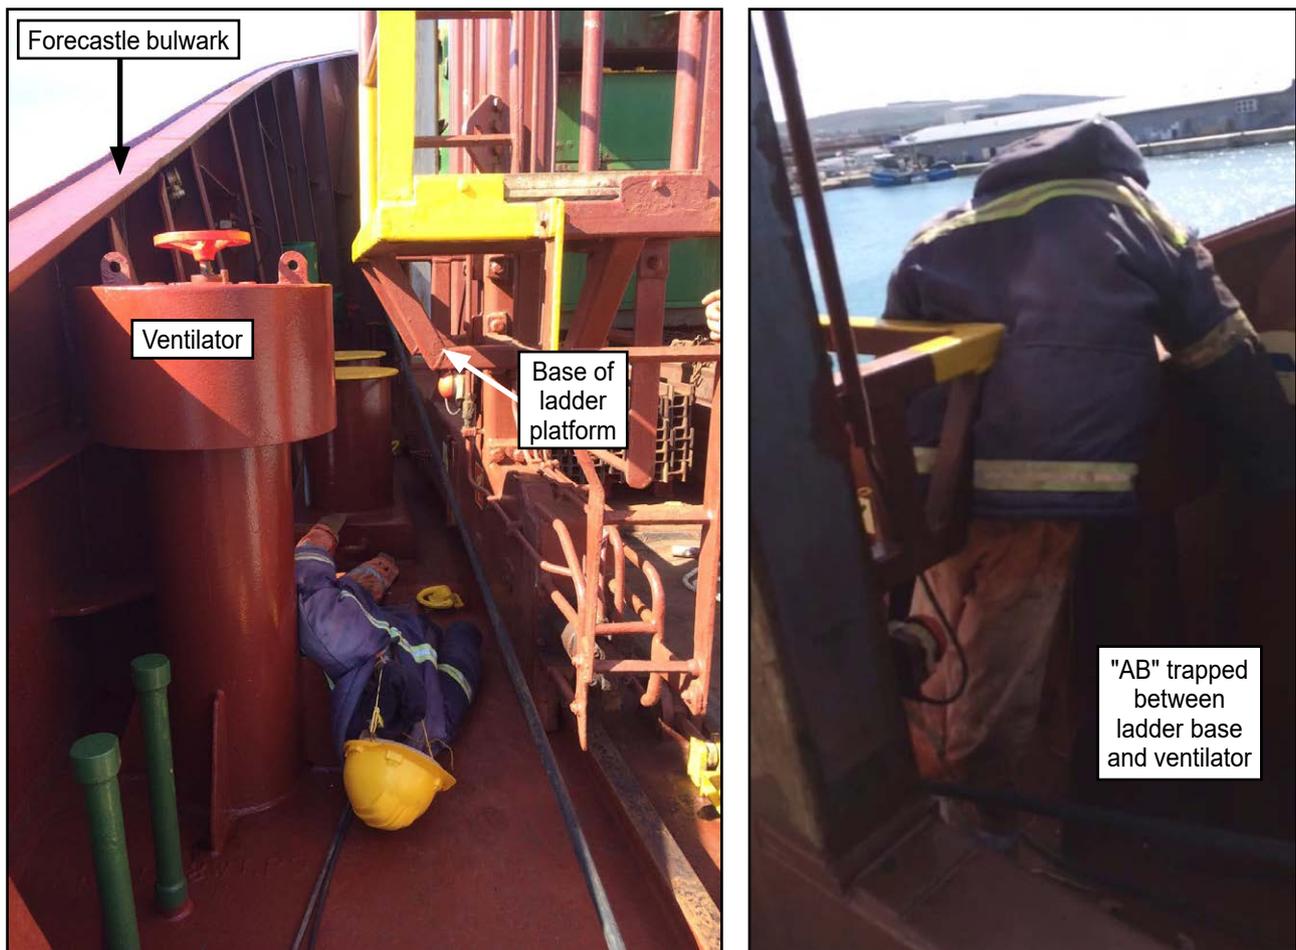
For the majority of the crane's path, the outboard space was unobstructed, allowing safe access past the crane. However, the forecastle area narrowed and the walkway was obstructed by the vent and other deck fittings. The AB, who had not had his minimum hours of rest in the last 24 hours, was not concentrating and misjudged the available space.

Figure 17: Reconstruction of gantry crane accident on board *Vectis Progress*

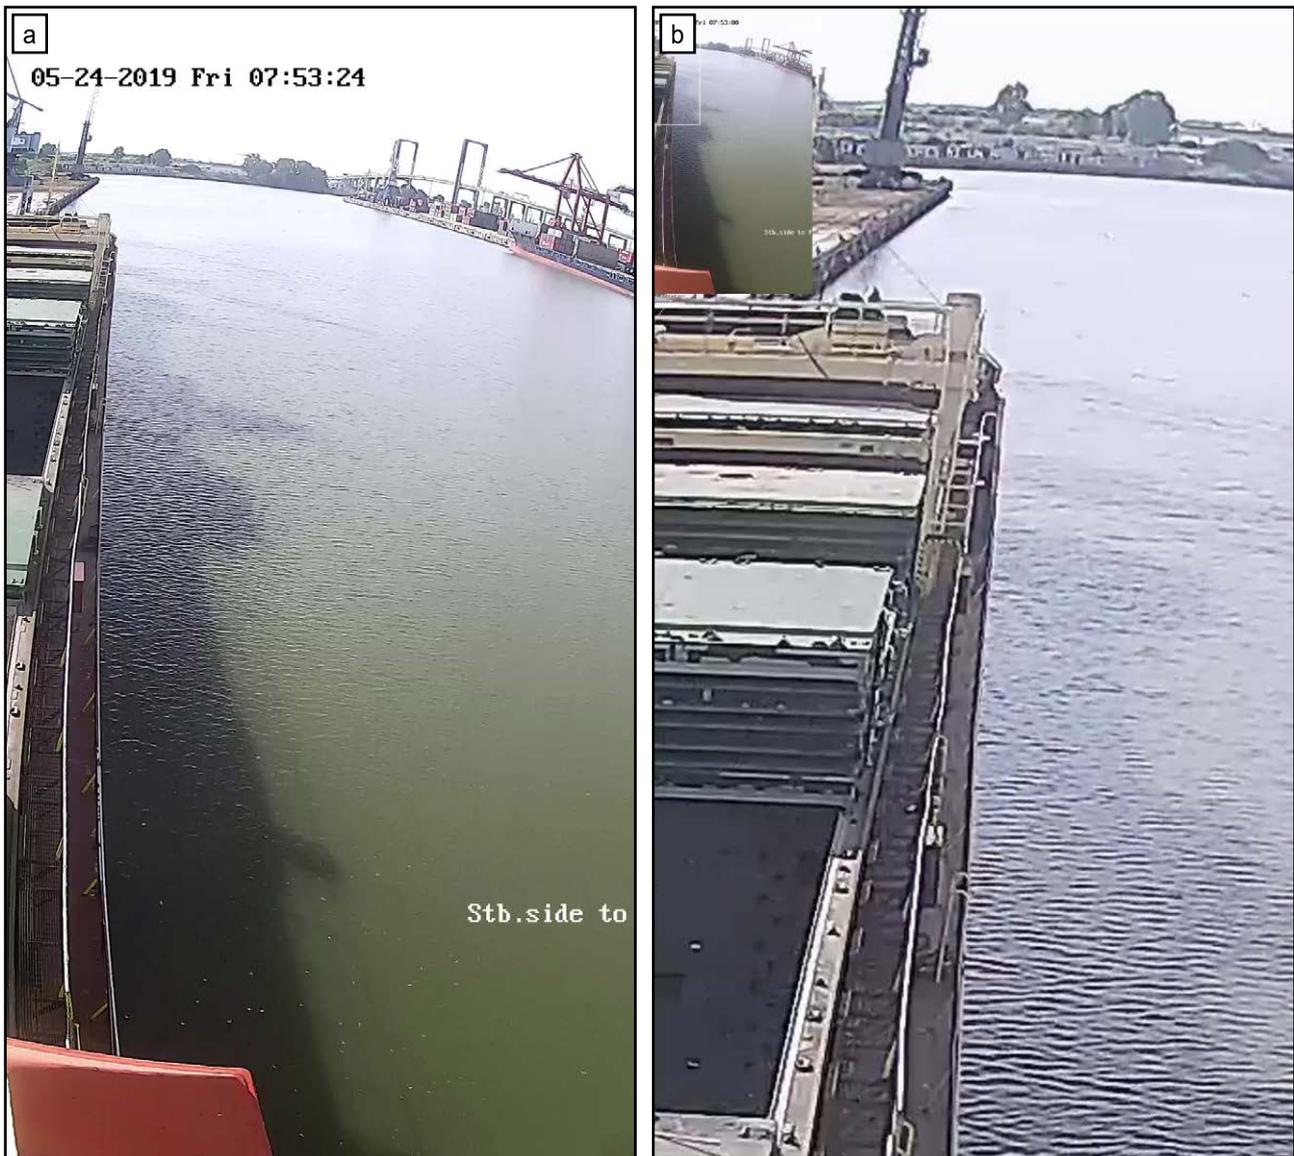
The CCTV recording was obtained by the MAIB in October 2019. From close examination of the recording it was apparent that the crane was involved with the accident. Using commercially available software, the footage was enlarged (**Figure 20**) to make the sequence of events significantly clearer. From the zoomed images it was evident that the 2/O had been trapped by the crane and crushed between the moving crane's ladder platform and the stack of hatch covers.

Figure 20: CCTV snapshot of the starboard side of cargo deck (unenhanced (a) and enhanced (b), showing significantly more detail)
