SAFETY INVESTIGATION REPORT

REPORT NO.: 12/2022

June 2022

MV *Ketter* **Serious injury of a crew member during cargo hatch cover operations in the port of Antwerp, Belgium** **28 June 2021**

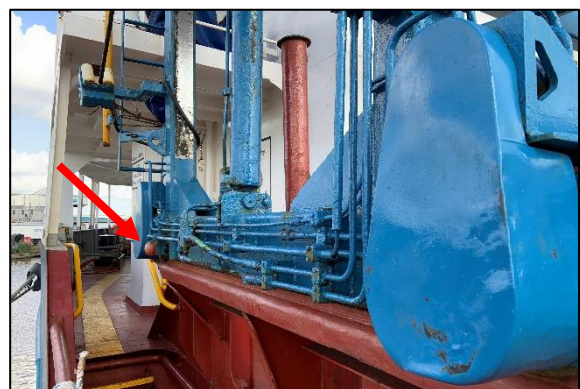
Figure 1: Location emergency stop

The gantry crane was fitted with audio and visual alarms and were automatically operated when the gantry was in motion. It also had three emergency stop buttons, one located at the main control panel, and one on either side of the crane, just forward of the aft wheel (Figure 1).

12/2022_R1 analyse the implementation of effective means to prevent crew members from coming in proximity of the moving gantry crane and whether this could be achieved in conjunction with the relocation / installation of additional emergency stops.

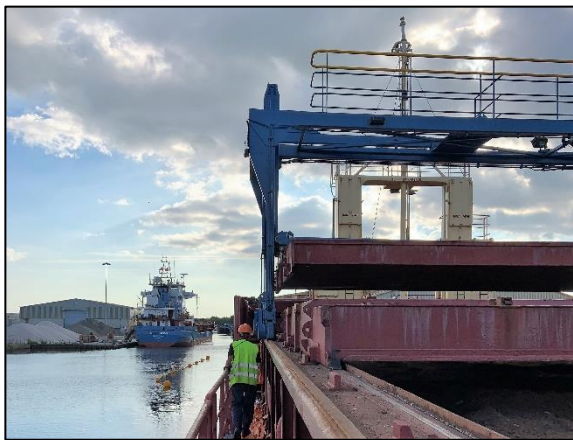
Figure 2: View from port side

The gantry crane operator would stand on the upper horizontal beam of the gantry crane. From the control station, he had an overview of the hatch covers and the walkways on deck. However, he did not have a full view of the track and hatch covers below him when a cover was lifted by the gantry crane (Figures 2 and 3). For this reason, a crew member had to be posted on either side of the gantry to monitor and report to the controller the hoisting and moving of the hatch cover, while remaining in communication over a VHF radio.

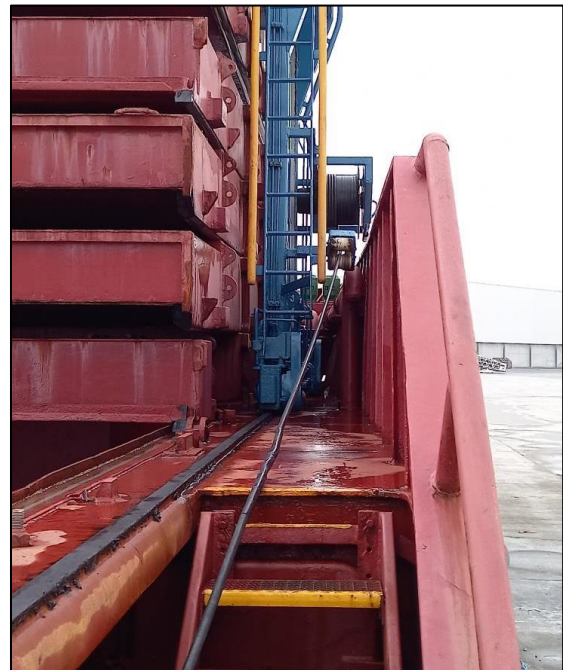
Figure 4: View facing forward

At the forward location of hatch cover stack, the deck walkway turned into a staircase that led to the forward deck, at the same time becoming narrower (Figure 4).

gantry and main deck walkway railings for a person to pass the gantry, although this was not advisable; towards the forward end, there was no space for someone to pass between gantry and the bulwark (Figure 4).

‘Safety constraints’ appeared to apply to this accident. A safety barrier crossing due to a safety constraint, happens when equipment in operation (moving gantry crane), poses a threat to persons when they interact with it. This issue became more critical as the gantry crane moved towards the forward end and where there was absolutely no space for a person to pass safely between the gantry and the bulwark.

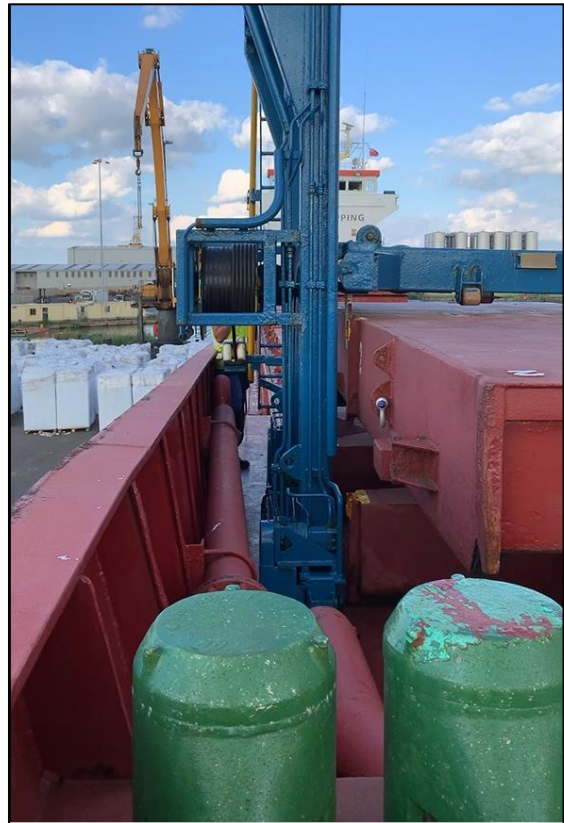
Figure 5: View facing aft

As seen in Figure 5, with the gantry coming towards him, to be in a safe location, because of the obstructions, the AB had to either go forward of the breakwater (from where this photo was taken) or go aft of the gantry before it reached him. In any case, he had to take up a position aft of the gantry as it was the place where he could direct the chief

The safety investigation did not exclude the possibility that when the AB noticed the gantry approaching him in the narrower part of the forward structure, either some element of his clothing snagged, or he lost his footing because of the obstructions, which delayed him in clearing the gantry before it became unsafe to pass, and thus sustained the injury.

The safety investigation also identified an inherent accessible constraint. Forward of the gantry crane, and with the latter positioned towards the forward end of the vessel, access to the emergency stop button (located on the gantry’s sides), was not possible. Without visual contact and no communication on the VHF, the only way to stop the moving gantry crane in an emergency, was by pressing the emergency stop button. This was only possible, subject that there was enough space between the gantry crane and the bulwark and / or the person was positioned aft of the crane.
