MARINE SAFETY INVESTIGATION REPORT

Safety investigation into a fatality and serious injuries on board the
Maltese-registered passenger/ro-ro vessel

Euroferry Malta

MARINE SAFETY INVESTIGATION REPORT NO. 17/2020

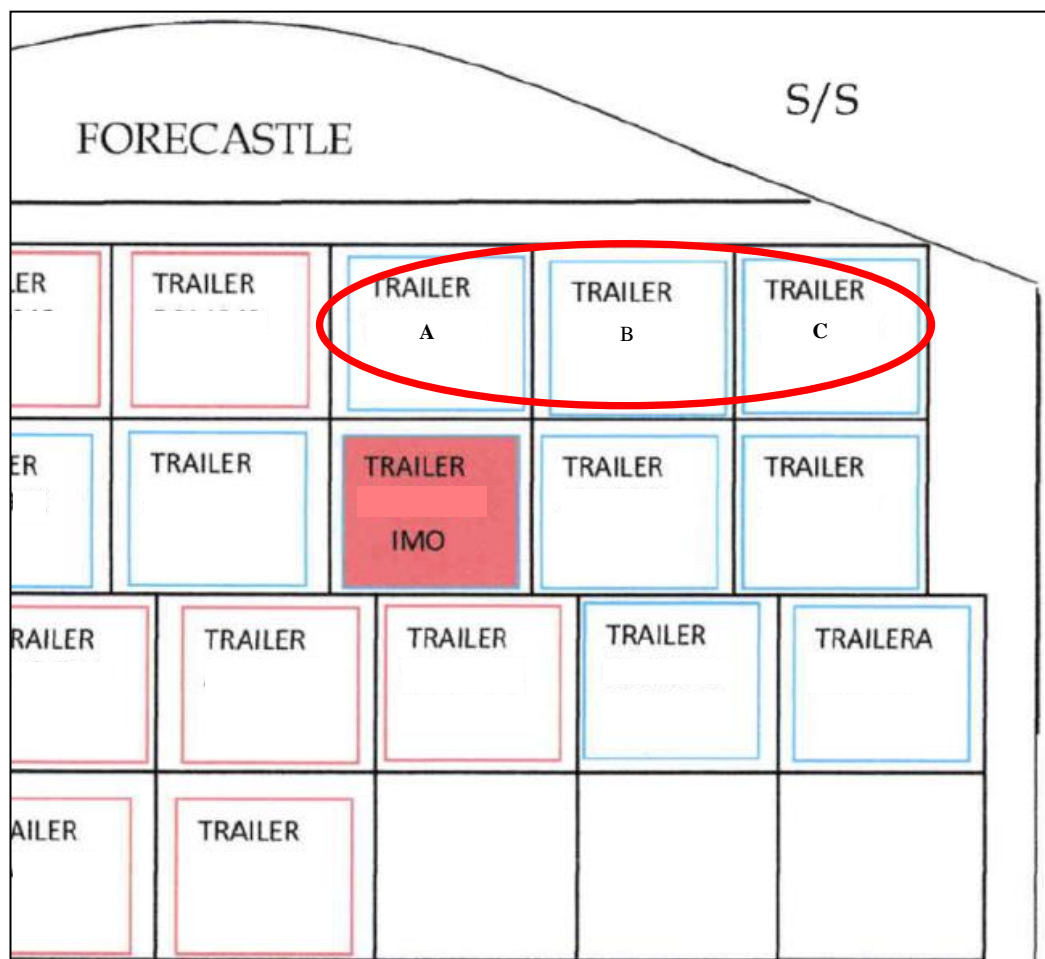
Figure 13: Location of damaged trailers (A, B and C)

Three trailers (Figures 13 to 15), located on the starboard side, just aft of the deckhouse, were found to have sustained substantial damages.

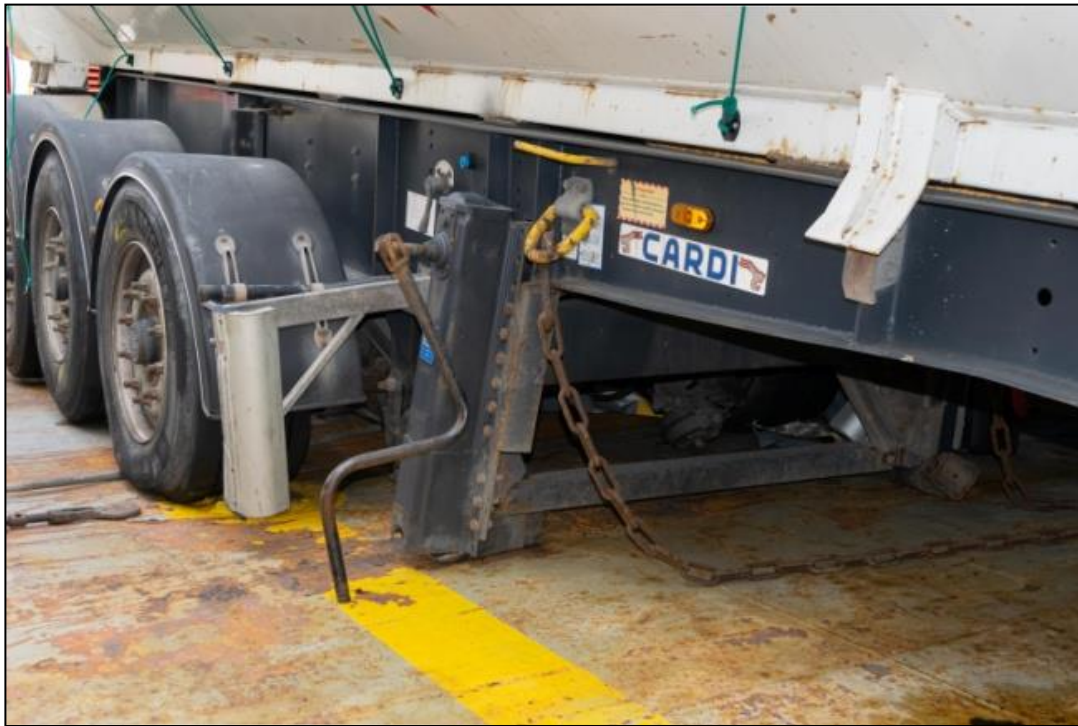
The trestles and landing gear of trailers A and B had failed, resulting in damages to the two trailers. The damages to trailer B were more pronounced (Figures 16 to 18).

Figure 16: Damaged landing gear of trailer A

Taking into account that only four of the cargo securing devices (chains and shackles) were noted to have been damaged and that the damaged trailers had not experienced any longitudinal shift, the safety investigation is of the view that while most of the cargo securing devices could withstand the loads exerted onto them, the trestles and landing gear could not.

The motions of the vessel, shifting of the cargo within the trailers, strain on the cargo securing devices (due to these factors as well as due to some possibly overweight trailers), may have led to the failure of the trestles and landing gear. In turn, this may have led to further cargo shifting and subsequent damages to the trailers, particularly trailers A, B and C.

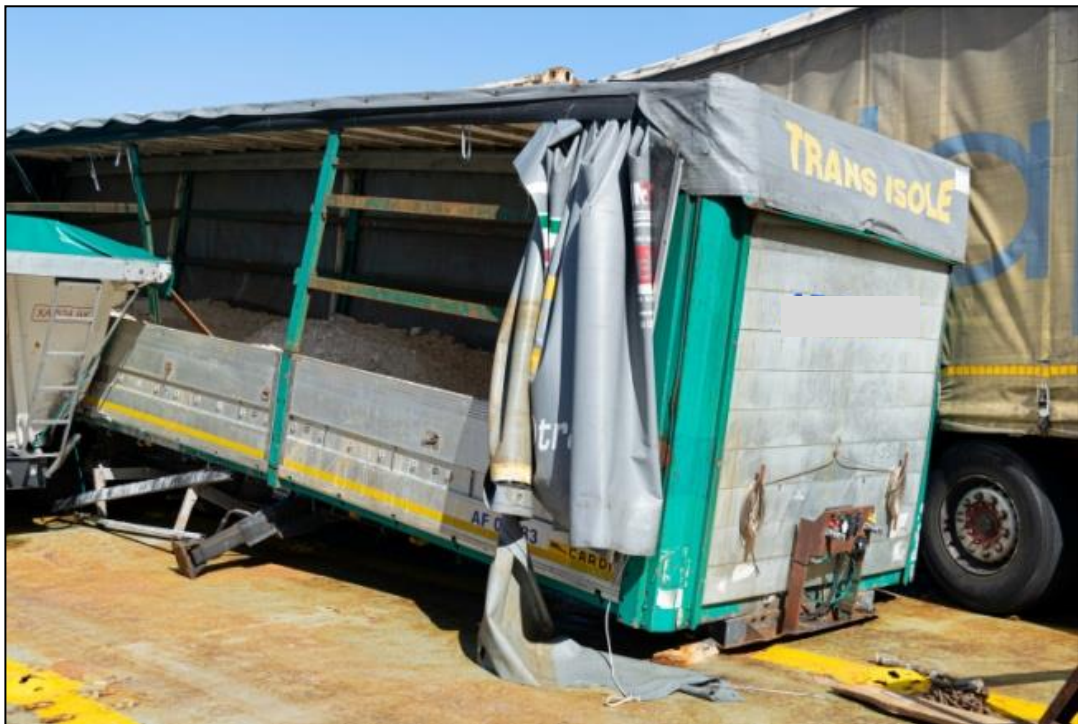
Figure 17: Damaged landing gear of trailer B

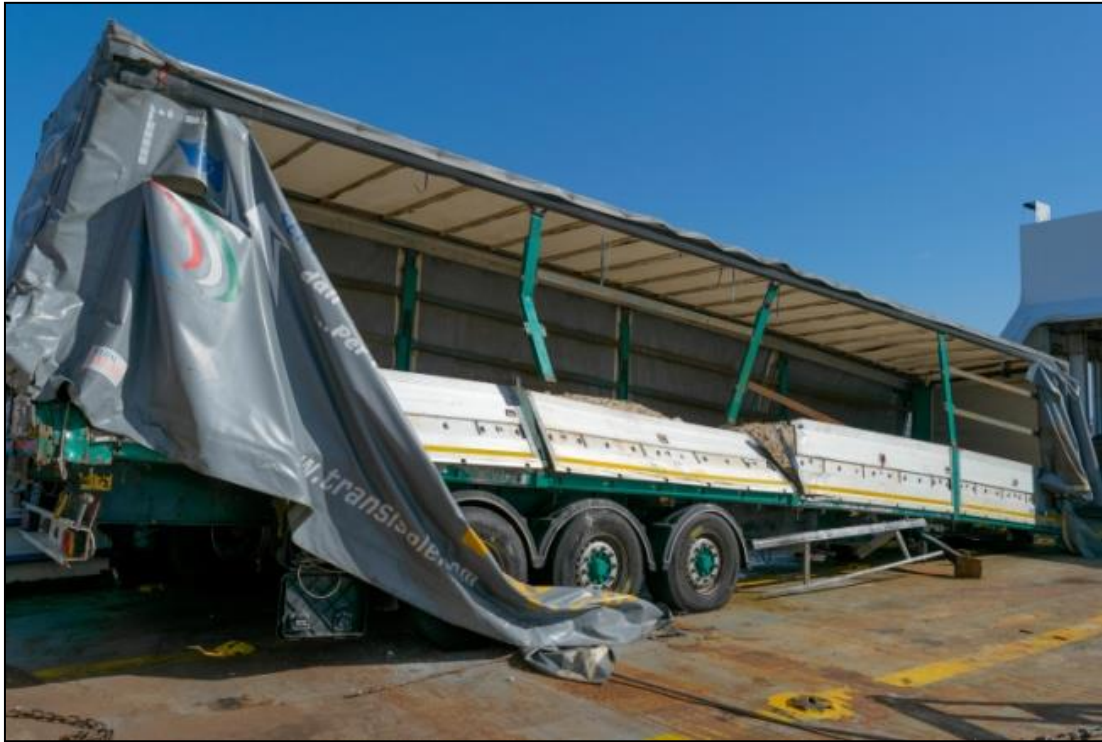
Figure 18: Damaged trailer B

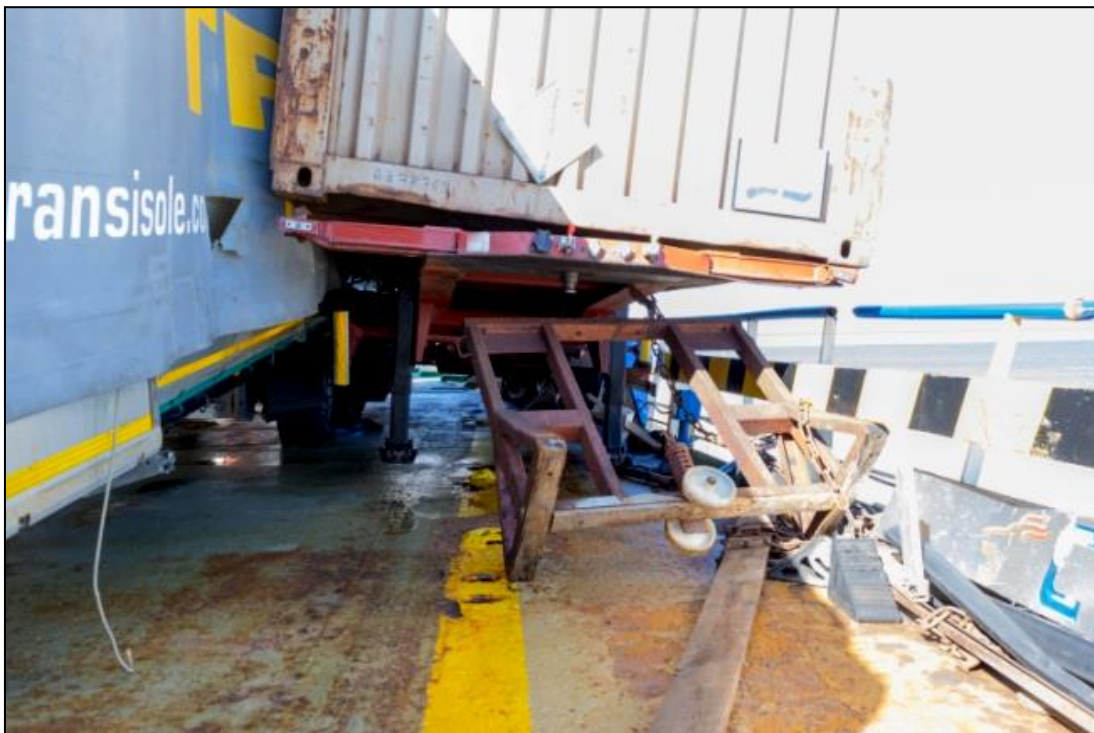
Trailer C was pushed towards the vessel's bulwark and guard rails, causing the container on it to incline over the vessel's side (Figure 19).

Figure 19: Damaged trailer C

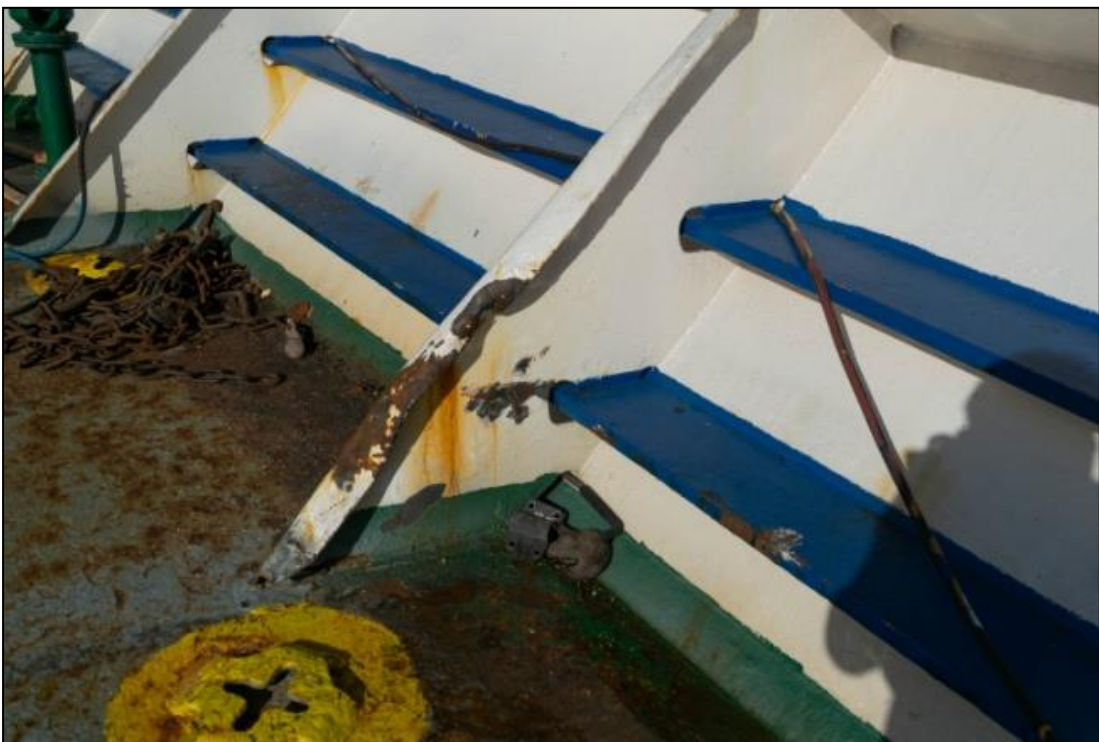
The vessel sustained minor structural damages to her gunwale, bulwark stiffeners, guard rails and an air vent in the vicinity of trailer C (Figures 21 to 24).

Figure 22: Damaged bulwark stiffener

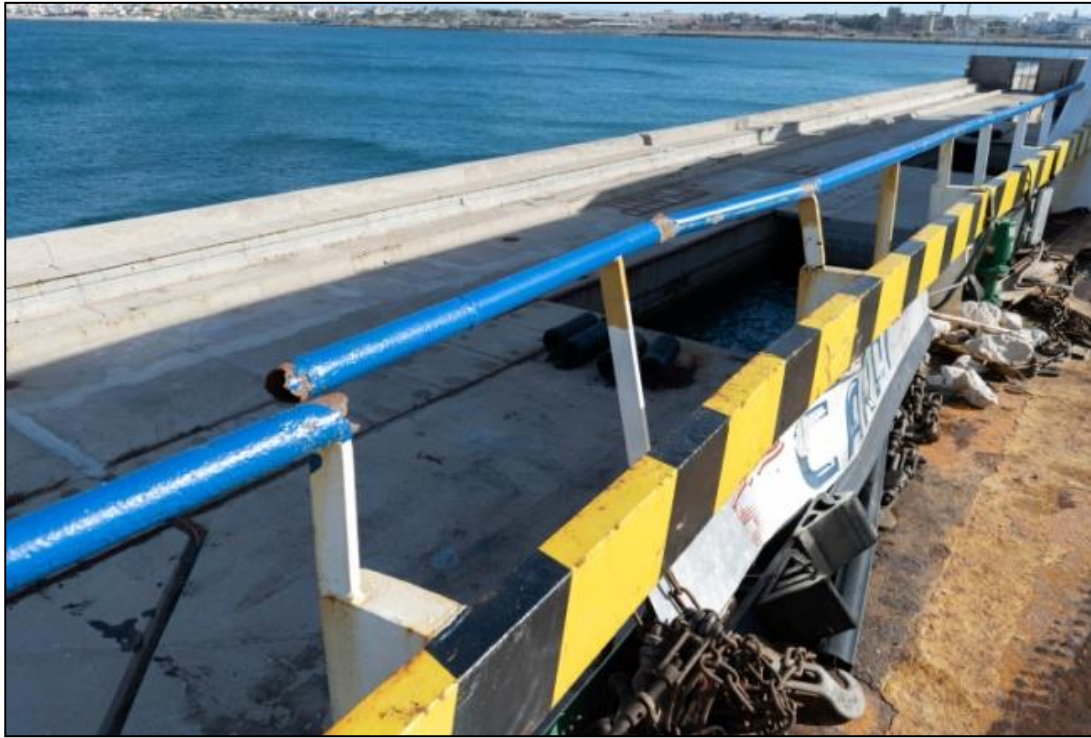
Figure 23: Damaged guard rails

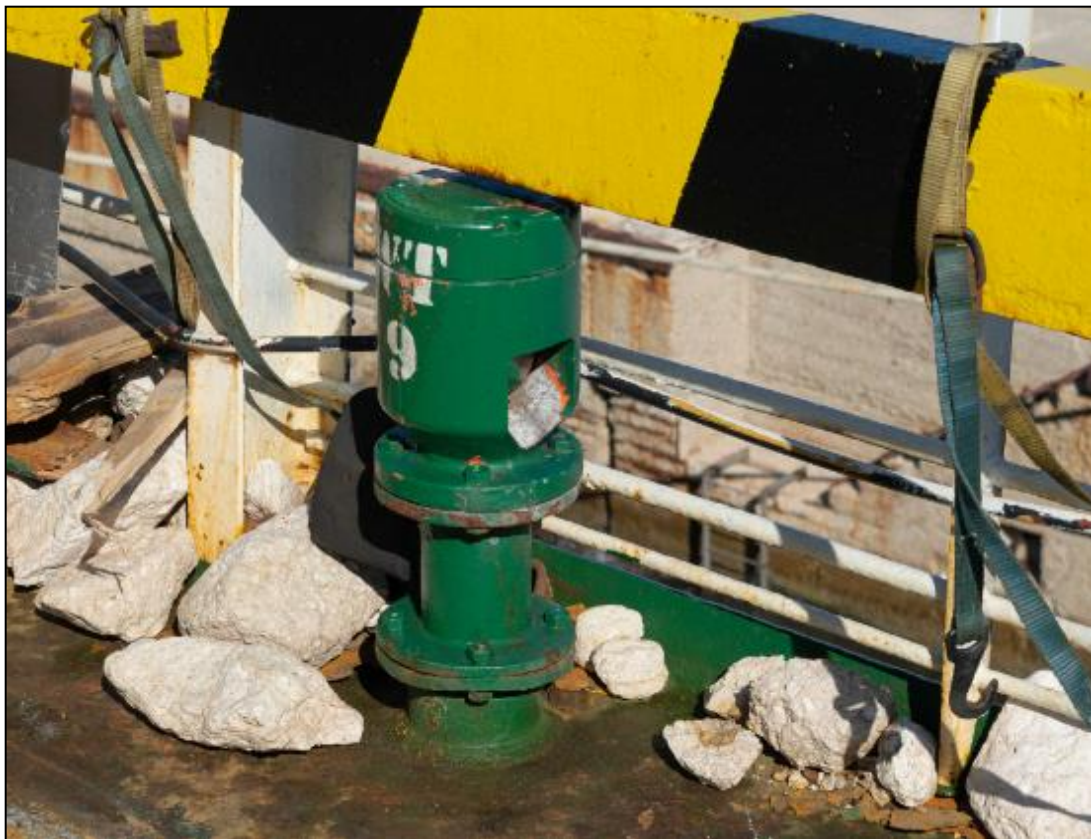
Figure 24: Damaged water ballast tank air vent, and cargo which escaped from trailer B

The damages to the water ballast tank air vent (Figure 24) most likely seemed to be the result of cargo falling out from trailer B and striking this air vent.

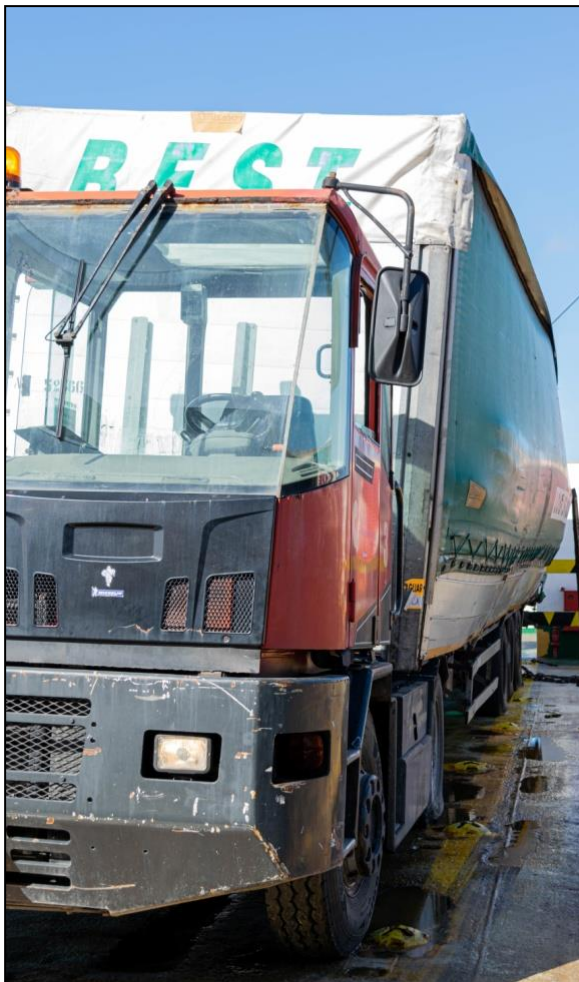
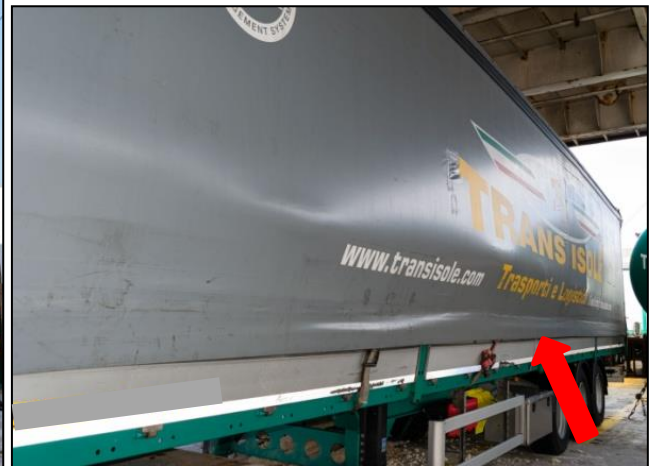
The rolling and the pitching motions of the vessel under the heavy weather conditions caused the cargo within the trailers, especially those loaded on Deck 4, to shift. This resulted in bulging of the sides of some of the trailers (Figures 26a and 26b).

Figures 26a and 26b: Bulging of the sides due to internal cargo shift

Cargo shifts in curtain-sided semi-trailers would lead to a centre of gravity shift towards the bulging side and upward to the side curtain top rail. The MSIU is aware that it is not unusual for vessels to experience problems with curtain-sided units, such as the one in Figures 26a and 26b. Although it is recommended that vehicles with high centres of gravity are stowed in positions of minimal roll, it is not always possible to accommodate this arrangement.
