## SAFETY INVESTIGATION REPORT

REPORT NO.: 18/2019

**MV MAERSK JAIPUR**  
**Fatal accident in the Engine-room**  
**in position 54° 18.9' N 164° 26.9' W**  
**08 October 2018**

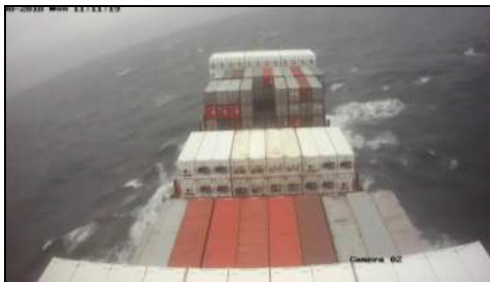
Visibility was moderate to poor and the sky was overcast. The swell was reported to have been coming from a Southeasterly direction, with a height of about 5.0 m, which caused the ship to roll more often and reach angles of 30° to 35° (Figure 1).

**Figure 1: Vessel's rolling heavily to starboard – photo taken from the bridge's dome camera**

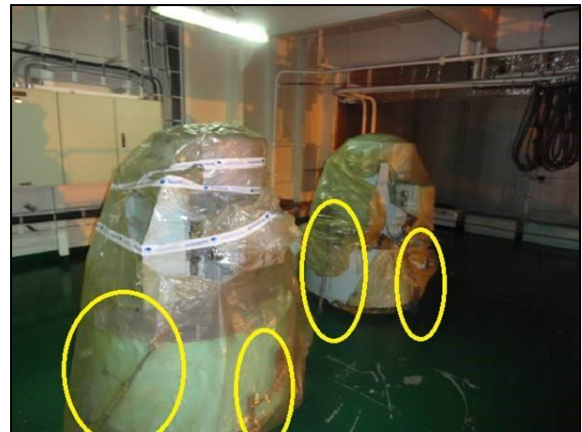
Each blower was placed among four steel angles, each 6.35 mm thick, welded to the deck. In addition, each blower was secured to the deck using four plastic sheathed steel cables, each having 6.35 mm diameter, which were fastened with turnbuckles connected to floor eyebolts. All lashing wires led up at angles of more than 60° from the horizontal. No dunnage was placed under the blowers (Figures 5 and 6).

**Figure 5:** Lashed spare auxiliary blowers in the engine-room

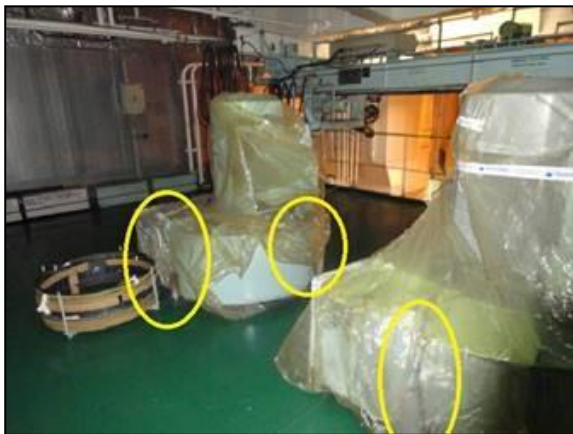
**Figure 6: Lashed spare auxiliary blowers in the engine-room**

As mentioned in the factual information section of this safety investigation report, dunnage was not placed below the blowers. Apart from the protection from moisture, dunnage provides an increase in friction.

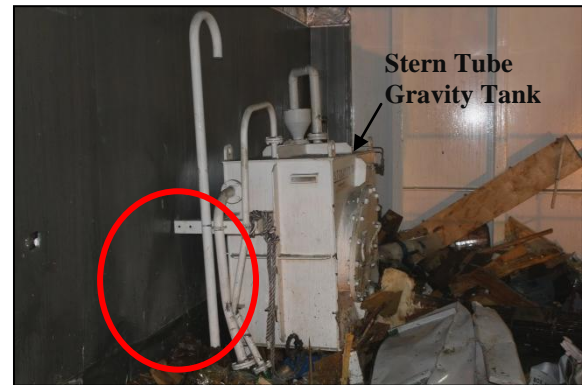
The oiler was pulled by the second engineer who also slipped in the process. The reefer technician pulled both, the second engineer and the oiler, to safety. However, the fitter, who was the furthest away from anyone's reach, was crushed between the bulkhead and one of the blowers, which rolled in his direction (Figure 7).

**Figure 7: Location of the accident marked in red**

As a result of the blunt blow, the fitter sustained multiple crushing injuries to his trunk and extremities and succumbed to his injuries soon after.

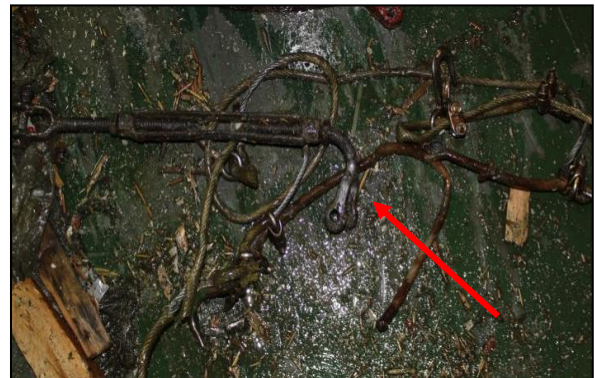
The blowers were secured with wires fastened using turnbuckles, at angles of more than  $60^\circ$  to the horizontal. This did not provide any opposing force to prevent them from sliding in adverse weather conditions. The safety investigation hypothesizes that the blowers broke off from their lashings, during one of the violent rolling motions experienced by the vessel, as the lashing in use at the time did not prevent them from sliding. The turnbuckle, shown in Figure 9,

may give an indication that the physical damage to it was caused due to the sliding movement of the blower, as it broke free.

**Figure 9: Damaged lashings of auxiliary blowers. Bent turnbuckle shown by the red arrow.**  
(Photo courtesy of the USCG)

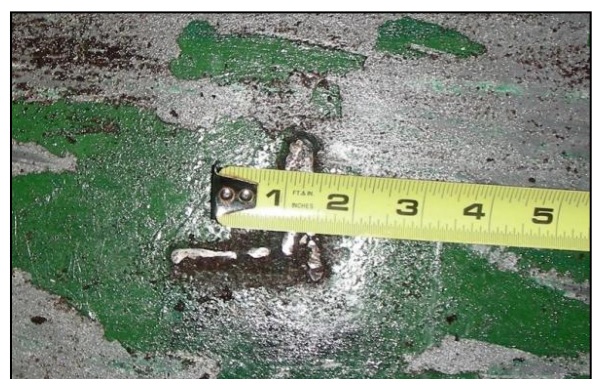
To help prevent sliding, each blower was placed in between four pieces of 6.35 mm thick, steel angles welded to the deck. These angle bars, however, seemed to have failed during one of the violent rolling motions of the vessel (Figure 10), and the first blower broke free from its lashings. The CSS Code recognizes that welded fittings may be used to prevent sliding, when lashings can only be set at large angles. However, the safety investigation was unable to determine which of the lashing equipment / items gave way first.

**Figure 10: The base of one of the failed welded angle bars**

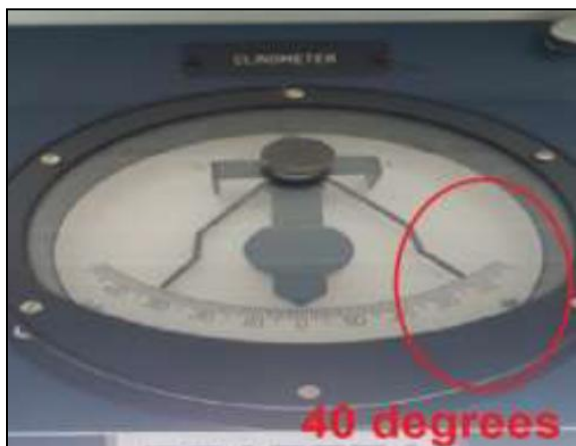
**Figure 11: Clinometer on the bridge indicating a roll of almost 40°**

The fact that the vessel was exposed to stern quartering seas, and that these violent motions had developed quickly was indicative that the vessel might have experienced parametric rolling.

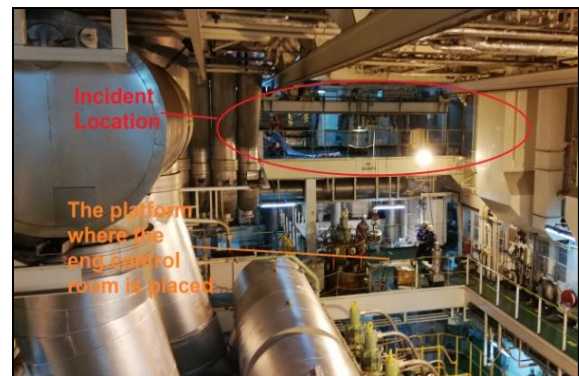
The place where the blowers were stowed was on a platform overlooking the engine-room that was level with the main deck (Figure 13).

Figure 13: Platform where blowers were stowed (red)

It would appear that the concern that the loose items could damage the railings, fall to the lower decks, and potentially cause further damages to the equipment and machinery below, convinced the crew members to intervene very quickly, in a bid to regain control of the situation. That condition exposed them to further risks as it necessitated that they approach the hazard on the platform.
