Crew member fatality on board *Toucan Arrow*

Portland, Victoria | 7 October 2013

ATSB Transport Safety Report
Marine Occurrence Investigation
303-MO-2013-010
Final – 16 June 2014

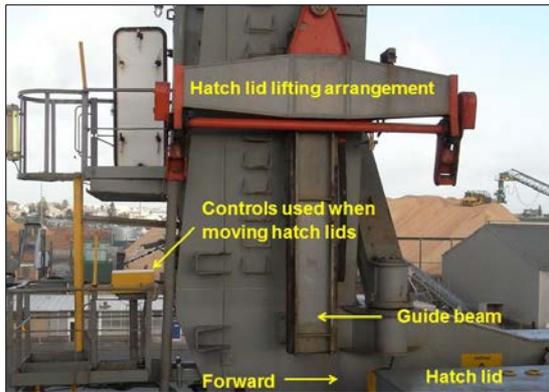
Figure 4: Hatch lifting assembly and guide beam shown next to a single stacked hatch lid

Attached to the two aft legs on each gantry crane was a separate, hydraulically operated, lifting arrangement (Figure 4) which allowed a hatch lid to be lifted and stacked on top of another hatch.

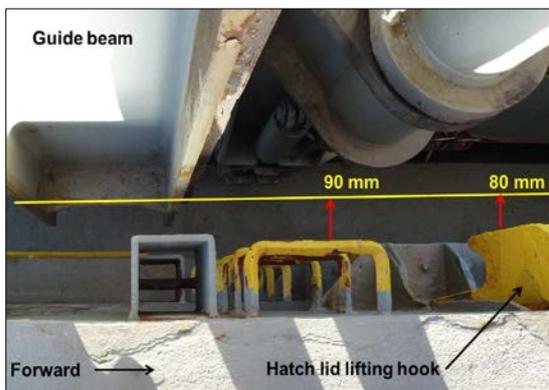
Figure 5: Guide beam shown next to double stacked hatch lid.

The design of the hatch lids and the gantry cranes was such that there was little clearance between the guide beam on the aft leg of the gantry cranes and fittings on the hatch lids. When the hatch lids were double stacked, this clearance was reduced further (Figure 5).

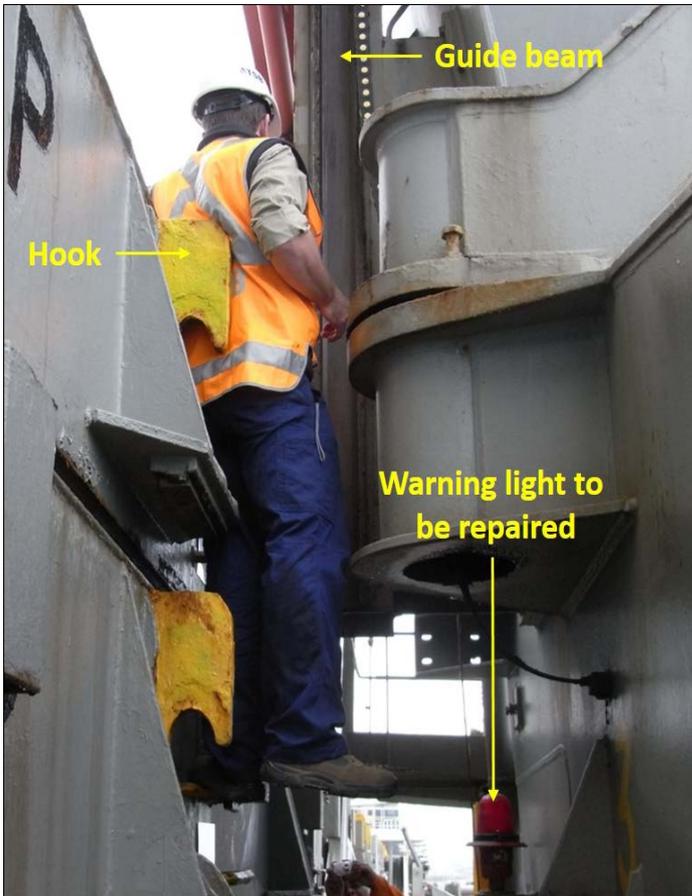
Figure 6: Likely position of the assistant electrician.

There were no witnesses to the accident. However, the available evidence indicates that the assistant electrician was probably standing on the hatch access ladder when he was crushed between the hatch lid and the gantry crane guide beam as the crane travelled along the deck.

The investigators found a small piece of the assistant electrician's clothing stuck to the aft lifting hook of the number six hatch lid. At the time of the accident, this hatch lid was stacked on top of the number seven hatch lid. This indicates that the assistant electrician was near the top of the ladder at that time of the accident (Figure 6).

Therefore, it is possible that the assistant electrician did not hear the gantry crane move. Since the warning light at his location was not operating, he was not provided with any visual warning of the gantry crane's movement.

Furthermore, the injuries he suffered indicate that he was probably facing towards the hatch lid, before being forced off the ladder and trapped between the lifting hook and the passing gantry crane guide beam.

However, a bag of electrical tools and a new warning light were found near the scene. It was later determined that the warning light fitted to that leg of the gantry crane was not operating. Therefore, it is likely that the assistant electrician was preparing to replace the faulty warning light.

The faulty warning light was repaired before *Toucan Arrow* departed Portland and the volume of the warning sirens was subsequently adjusted.
