Report on the investigation of
wave damage to the
passenger cruise ship
Oriana
in the North Atlantic Ocean
28 September 2000

Marine Accident Investigation Branch
First Floor
Carlton House
Carlton Place
Southampton
United Kingdom
SO15 2DZ

Report No 36/2002
November 2002

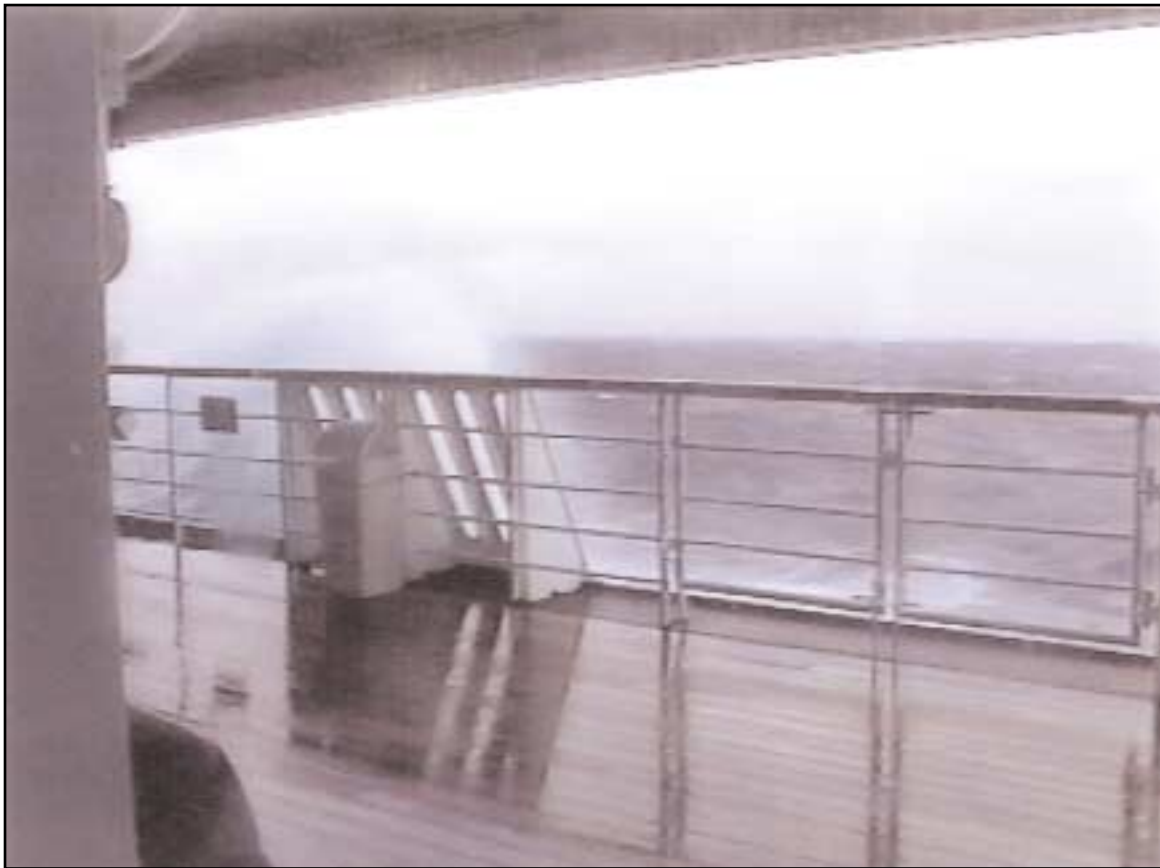
Figure 10

Photograph of a plume of spray at deck 7 probably resulting from a wave impacting on the port side

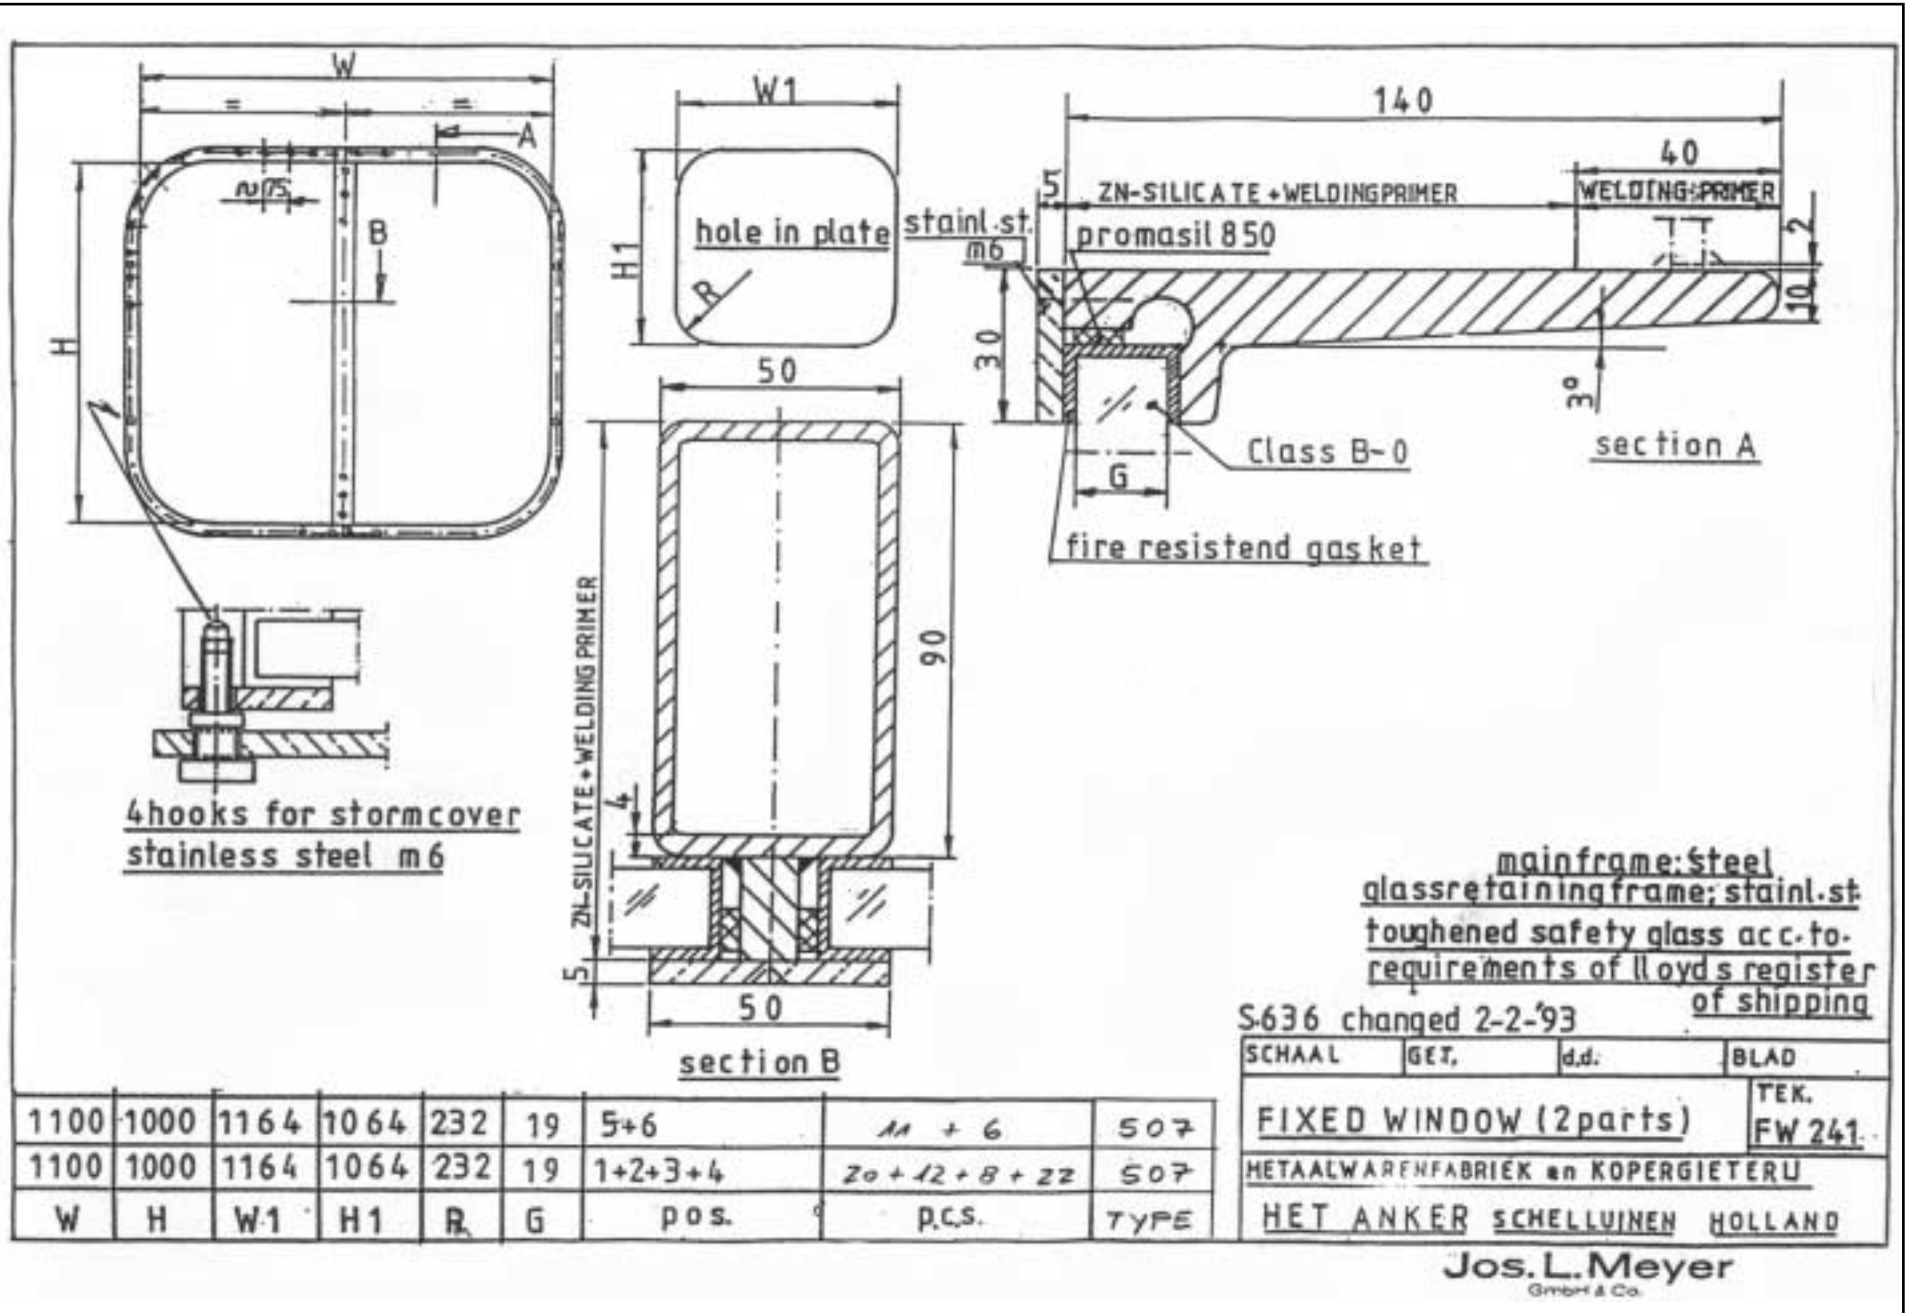
The damaged windows on deck 5 were Het Anker Type 507 (**Figure 14**). These windows had a clear light height and width of 1000mm and 1100mm respectively. The windows were divided in two by a 50mm wide mullion, with 'D' shaped glass panes made from 19mm, B-0 fire rated, toughened safety glass fitted on either side. They were designed to withstand a static pressure head of water of 8.83m.

The designed height and width of the openings cut in the ship's side for the windows was 1064 and 1164mm respectively. A 30mm stainless steel glazing strip was fitted on each side and this, plus an allowance of 2mm all round for welding the window frame into the opening in the ship's side plating, accounted for the difference between the clear height and width, and the size of the openings.

The glass was fixed into a recess in the steel window frame. A fire resistant gasket was fitted over the glass where it was in contact with the frame and the stainless steel glazing strip. **Figure 14** shows that the gap between the frame and the fire resistant gasket covering the edge of the glass was designed to be filled with chocks made from Promasil 850, which kept the glass central to the frame. The glazing strip, which was located on the inboard side of the window, was 30mm wide by 5mm thick and was screwed into the window frame by M6 stainless steel screws spaced 71mm apart. The glass, therefore, was secured in its frame by the force of the screws, acting on the glazing strip. The glazing strip was 50mm wide in way of the mullion.

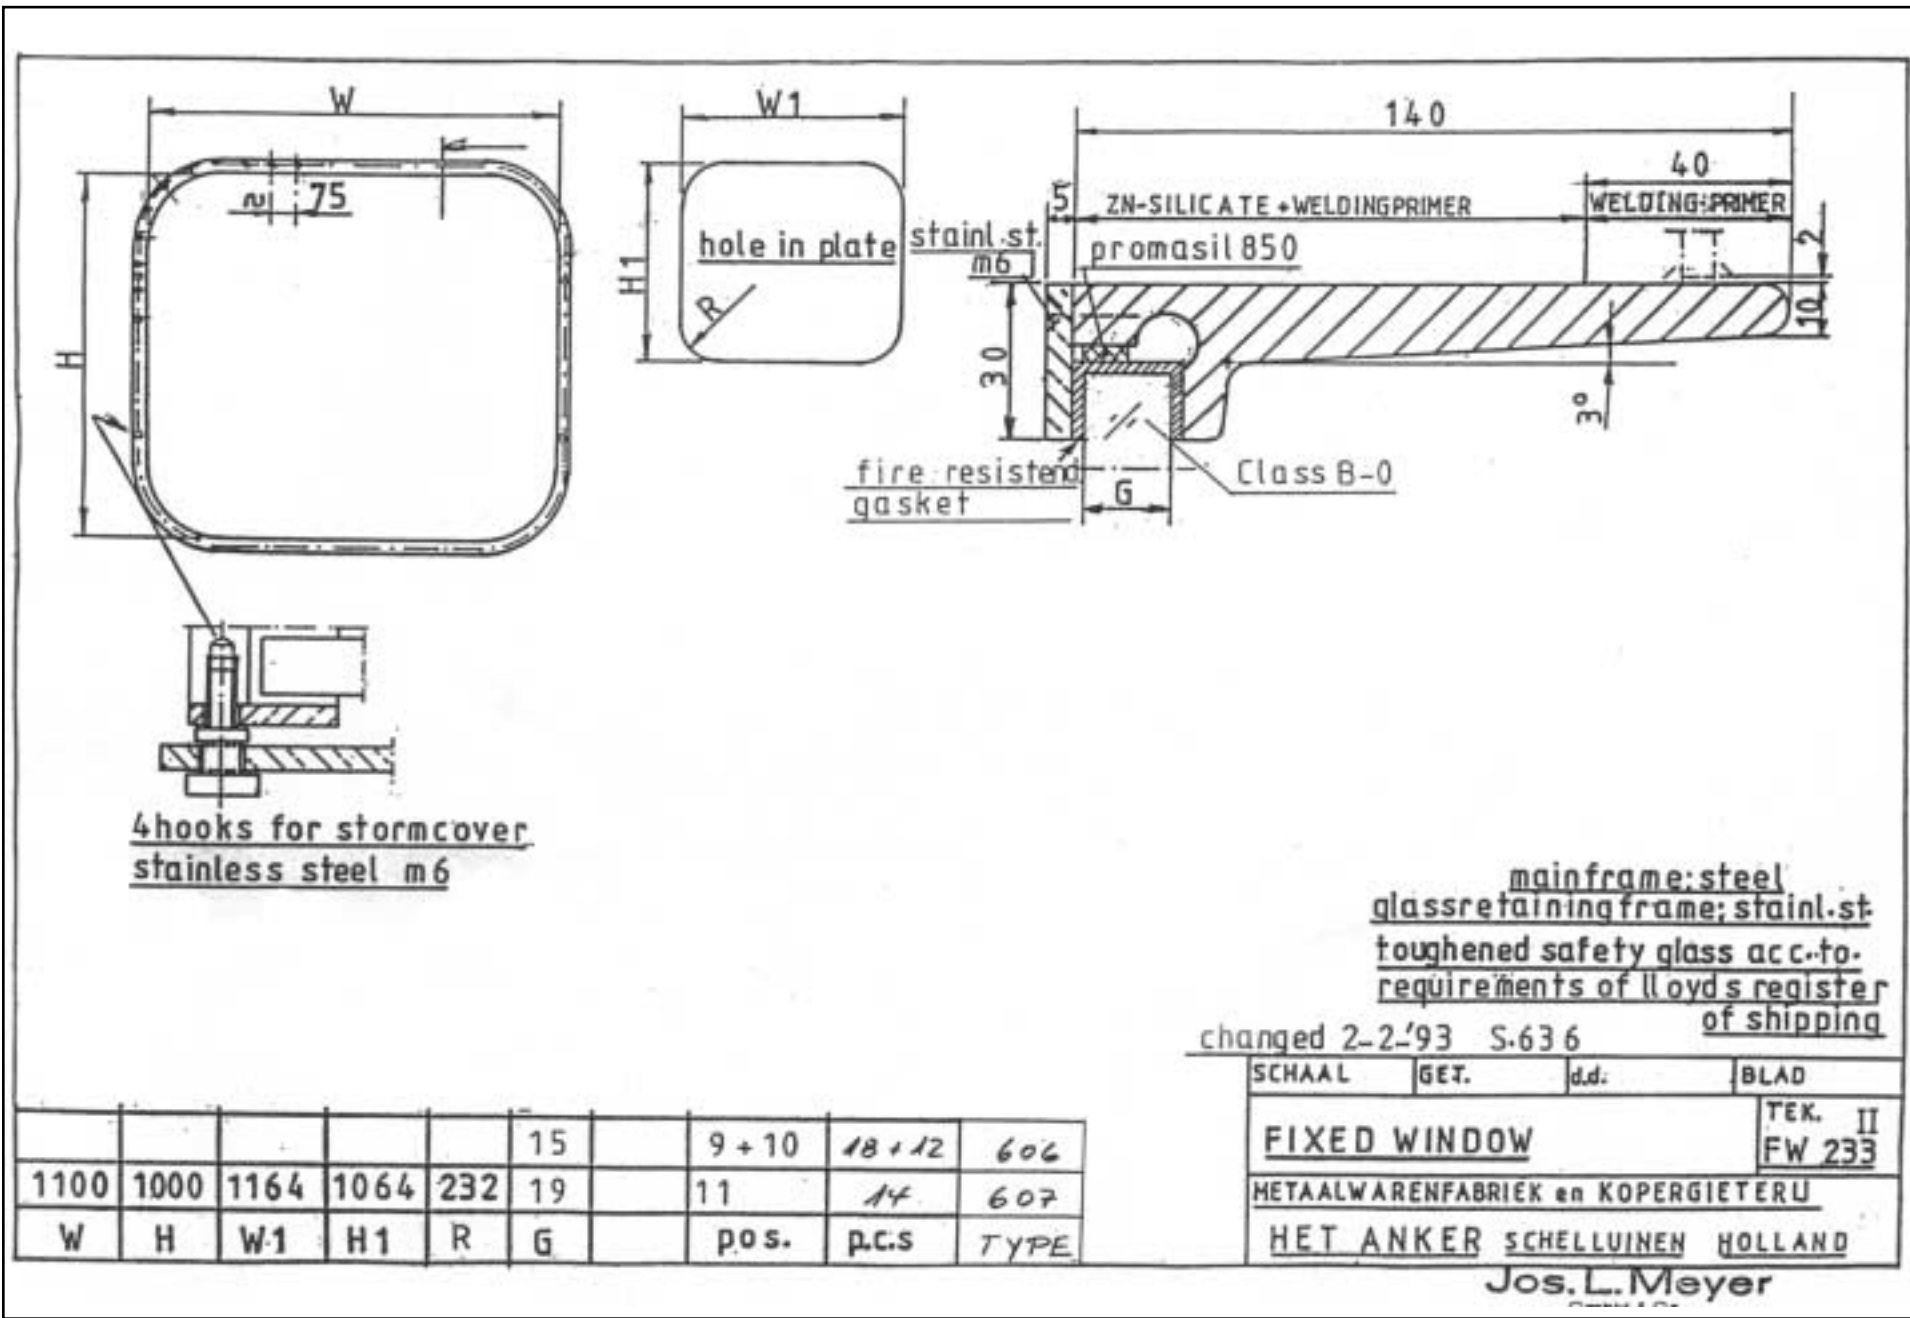
Figure 15

The damaged windows on deck 6 were Het Anker Type 606 (**Figure 15**). These windows are the same as those fitted on deck 5, except that there was no mullion and the single pane was made of 15mm monolithic glass with four rounded corners. These were designed to withstand a pressure head of water of 2.77m.

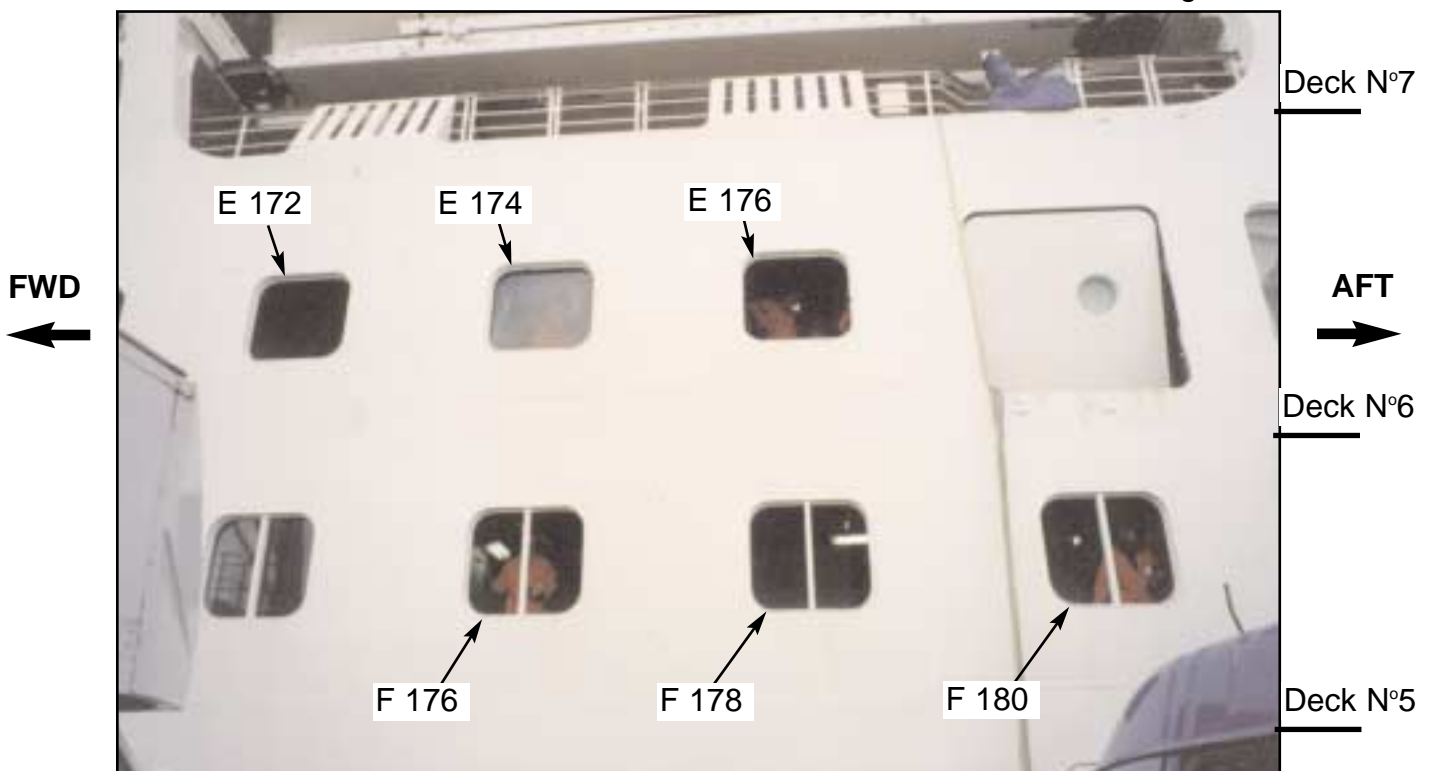
Figure 17

The position of the damaged windows is shown in **Figures 1 & 17**. The cabins affected were F176, F178, F180, E172, E174 and E176, all of which were situated approximately amidships on the port side (**Figure 18**).

Photograph showing position of damaged windows

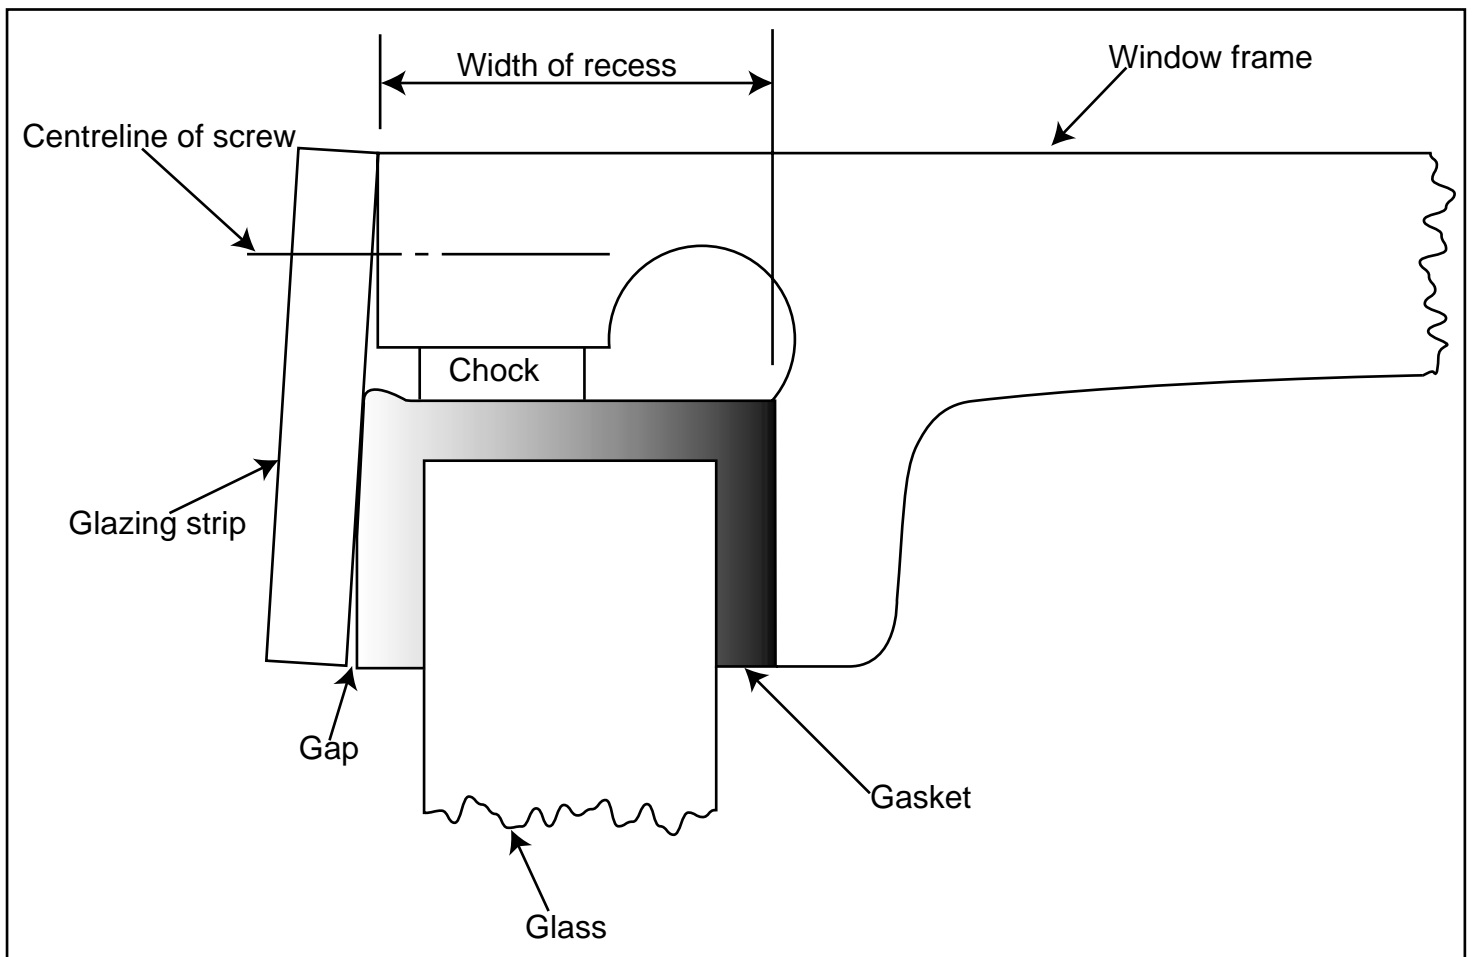
Figure 21

- f. Some gaskets looked different to others, and the hardness appeared to differ. Some windows were fitted with plastic chocks and some were not. It was assumed that the chocks were made from Promasil 850.
- g. Some stainless steel glazing strips were deformed. Where the gasket was too thick for the recess, tightening the screws tended to deform the strip, leading to a gap opening up on the inner edge (**Figure 21**). Consequently, with a gap at the inner edge of the strip, the glass was not clamped properly on the frame.

Diagram showing gap caused by poor fitting gasket
