National Transportation Safety Board

Marine Accident Brief

Allision of Bulk Carrier *Anna Smile* with Louis Dreyfus Grain Elevator

Accident no.	DCA14LM013
Vessel name	<i>Anna Smile</i>
Accident type	Allision
Location	Louis Dreyfus Grain Elevator dock, Woodhouse Terminal, Houston, Texas 29° 43.16' N, 95° 14.22' W
Date, time	July 14, 2014 0504 central daylight time (coordinated universal time – 5 hours)
Injuries	None
Damage	Grain elevator: approx. \$2.5 million <i>Anna Smile</i> : estimate not provided
Environmental damage	None
Weather	Light winds 4 knots, visibility 10 miles, air temperature 79° F
Waterway information	Houston Ship Channel

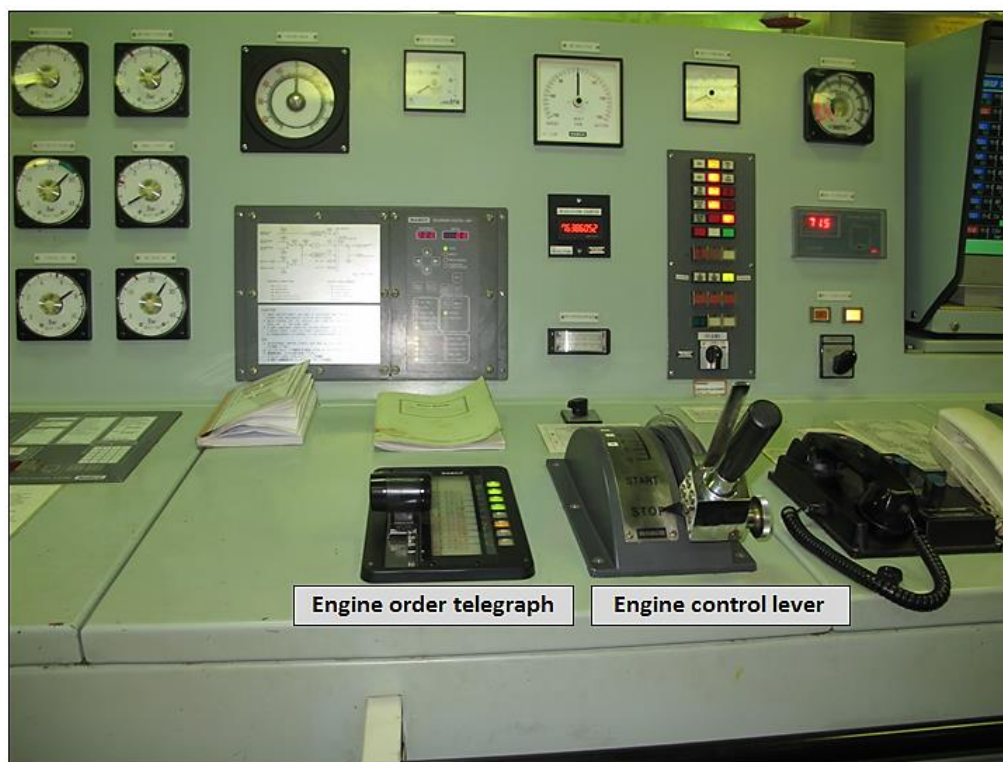
next order was dead slow astern, but when the chief engineer moved the engine control lever, the engine failed to remotely start as expected. Two more astern commands were given from the bridge—slow astern and half-astern—both with no response from the engine, despite the chief engineer's command inputs to the engine control system. The chief engineer did not advise the captain that he was having difficulty starting the engine.

Anna Smile ECR engine order telegraph and main engine control lever.

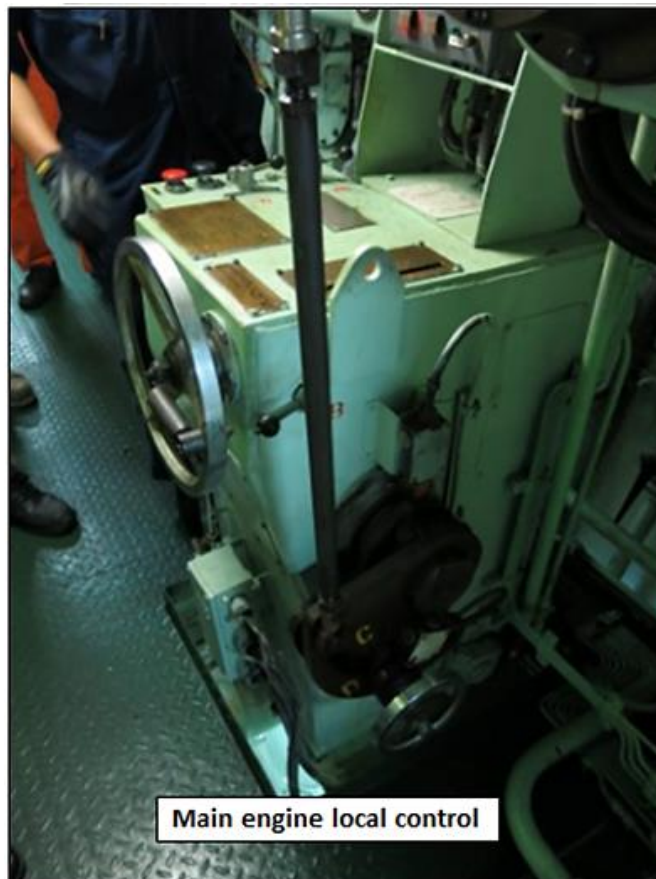
After completing the steps to engage the local control station, the chief engineer started the engine at the dead slow ahead speed of 40 rpm despite the current stop command. Dead slow ahead was the last command that he was aware of before leaving the ECR, but the command had changed from ahead to stop while he was changing the engine control mode. The engine continued to run in the ahead direction for about 1 minute until the chief engineer was told to stop the engine by the second engineer who ran down from the ECR and relayed the stop command he had received from the bridge via the ECR phone. When the chief engineer was asked why he did not use the local phone located directly behind him, he stated that the bridge called the ECR and it was too loud in the machinery space to hear the local phone behind the emergency control station.

Local control station at the side of the main engine.

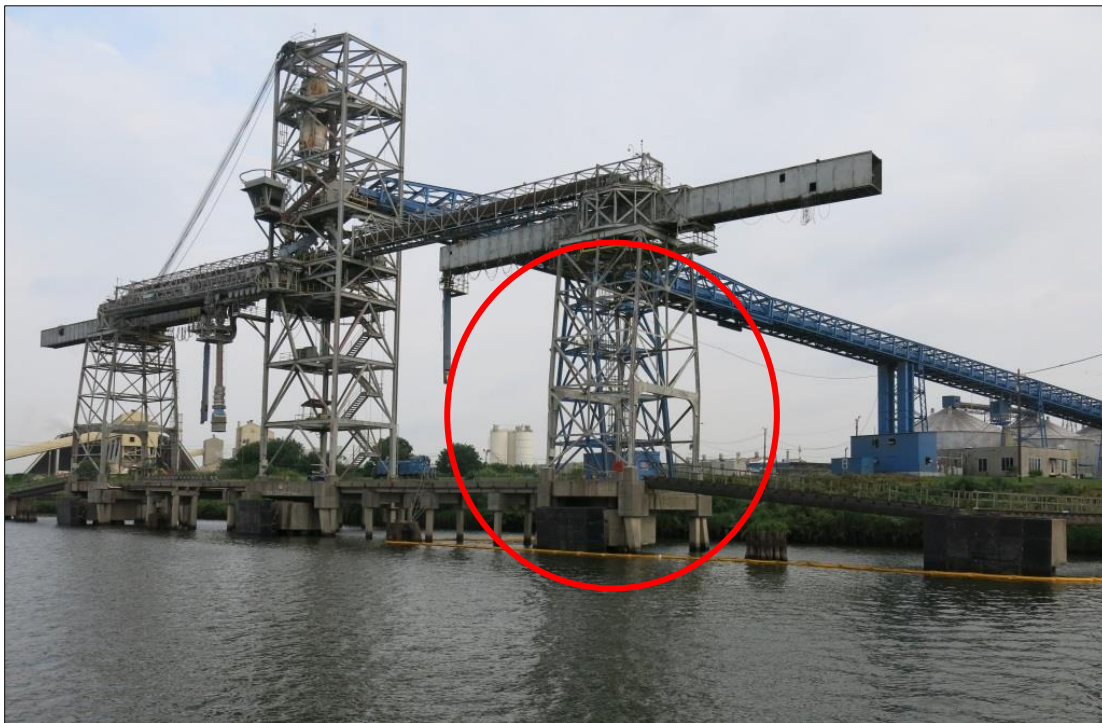
Damage to the grain elevator's east tower was estimated at \$2.5 million. Horizontal and vertical steel structural supports on the grain elevator's structure were damaged, concrete pads were cracked, and a rubber fender was bent from the impact. To repair the elevator tower, contractors were required to remove and replace the entire upper section of the tower from the base, including the conveyor and carousel; fabricate four new legs of the lower structure; repair the bent fender and bent steel in the upper section; and replace the damaged concrete pedestals and dock area.

Louis Dreyfus Grain Elevator east tower, which was damaged in the allision.

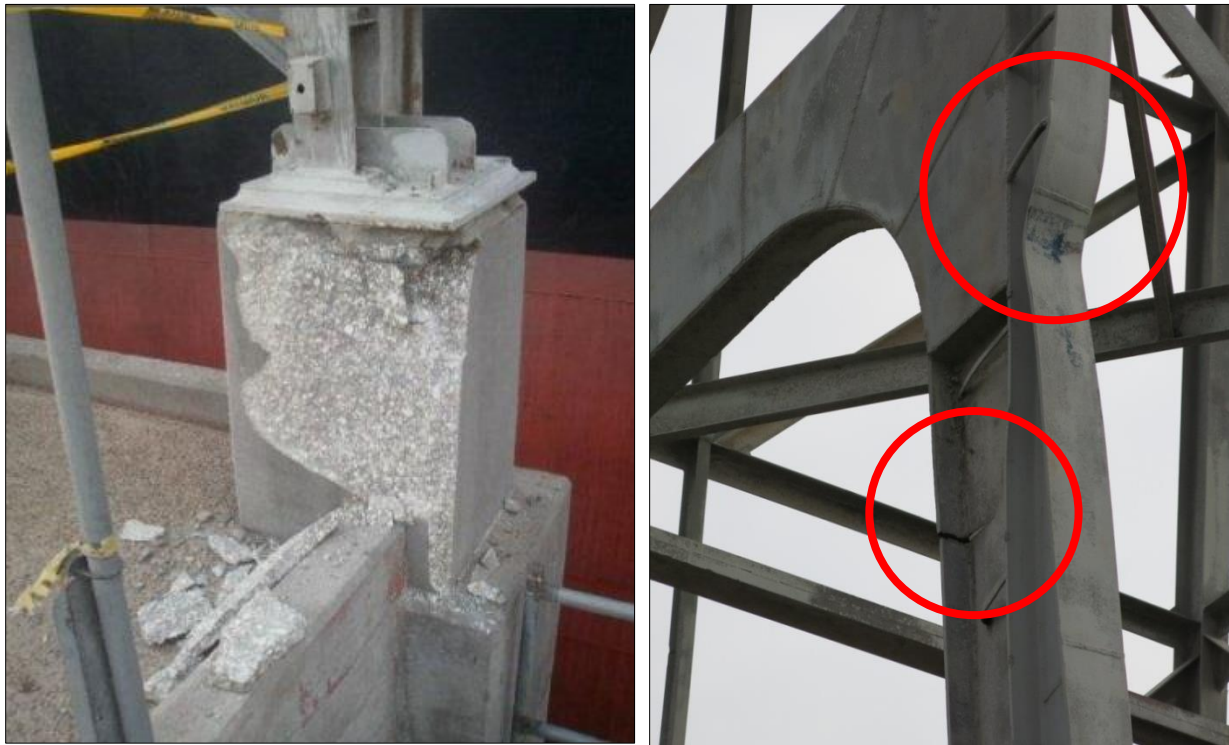
Close-up of a damaged concrete pedestal (left) at the Louis Dreyfus Grain Elevator and a cracked weld and bent I-beam on a vertical support (right). (Left photo by Coast Guard)

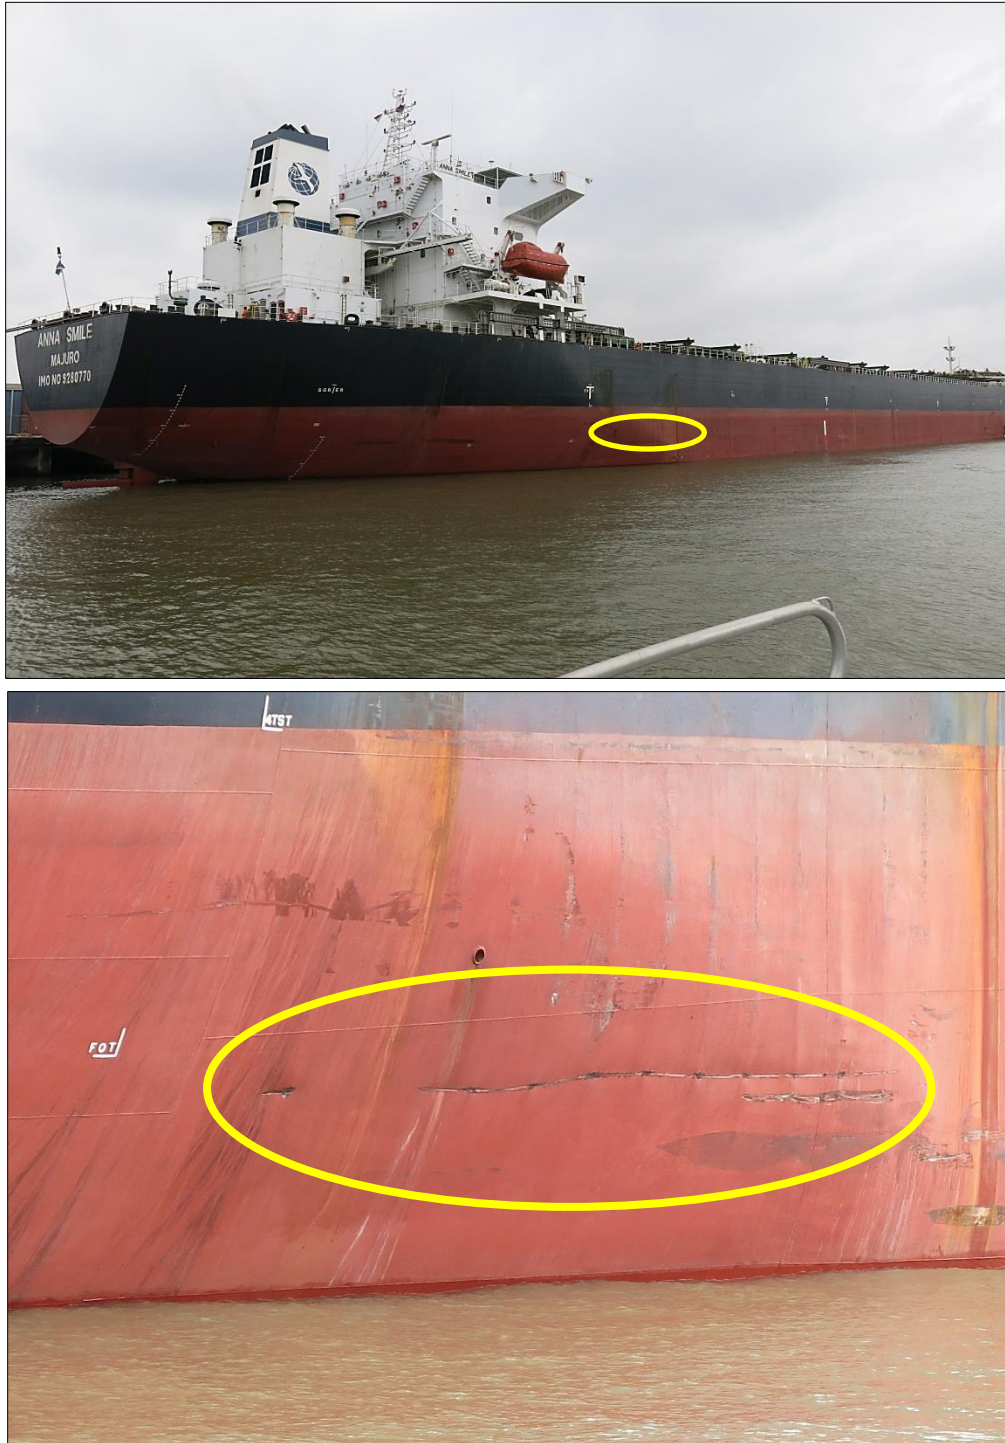
The *Anna Smile* sustained minor scraping and a 2-inch inset of the hull plating for about 11 frames (30 feet) as the ship moved forward while in contact with the grain elevator. The damage estimate for the ship has yet to be determined, but the classification society recommended that the insets be repaired by June 2017, which is the next regularly scheduled dry-dock period.

Damaged area of *Anna Smile* hull (top) and close-up of vessel frames 41–52.
