Seaways

The International Journal of The Nautical Institute

Mariners' Alerting and Reporting Scheme

MARS Report No. 307 May 2018

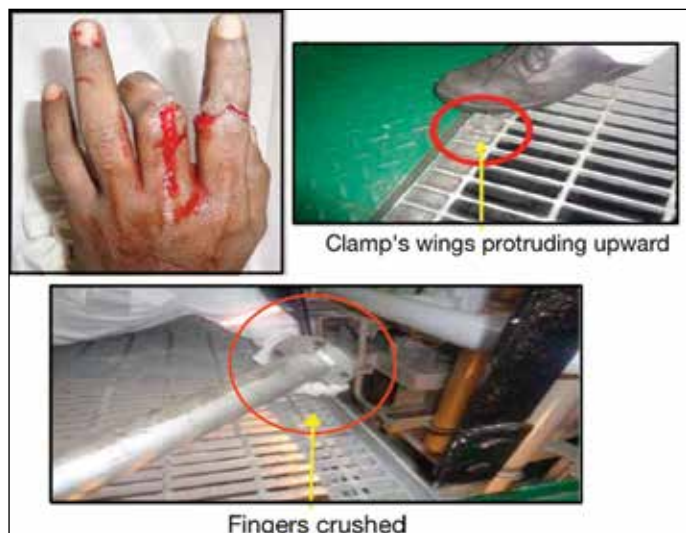
MARS 201828

Floor plate clamp tripping hazard

→ Two engine room crew were assigned the job of dismantling and repositioning a pipe approximately 2m long and 6cm in diameter while the vessel was at sea. The pipe was located at the bottom platform of the engine room.

While shifting the dismantled pipe, one of the crew caught his foot on an unsecured, protruding floor grating clamp. He stumbled and his fingers got caught between the pipe flange and the corner plate securing the floor grating. Even though he was wearing gloves, the incident resulted in a fracture of the middle finger and a deep cut on the index finger.

- Even the most mundane task can pose unsuspected risks if basic precautions are not taken. Tripping hazards should always be attended to in a timely fashion.
- Make a special effort to go over and around your vessel with fresh eyes; try to spot and eliminate tripping hazards.

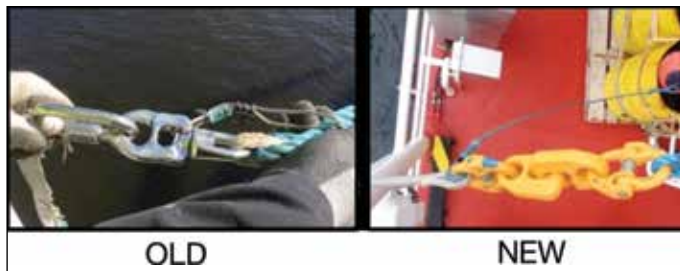
MARS 201829

Spring-acting FRC painter clip fails

→ Three crew members were in the fast rescue craft (FRC). During recovery the forward painter quick release parted just as the craft was lifted from the water. The FRC then swung to starboard, causing the stern to come into contact with the ship. The jet guard struck the side of the ship and then rode up into the ship's rescue zone, allowing the jet itself to strike the side of the ship. The FRC bucket was cracked, as was the jet inside the bucket and the jet guard was slightly bent. The FRC was recovered with no injuries to the crew members.

The painter quick release mechanism had been in use for the past two years. A previous near miss had occurred where the clip had parted, but

subsequent visual inspections of the outside of the quick release did not discern problems inside the clip where the spring mechanism is housed.

- Mechanisms containing moving parts that are hidden from view but exposed to the elements are hard to maintain and verify. Whenever possible, they should be replaced with more reliable substitutes. In this case, the clips were replaced with a G-link type clip without a spring mechanism.

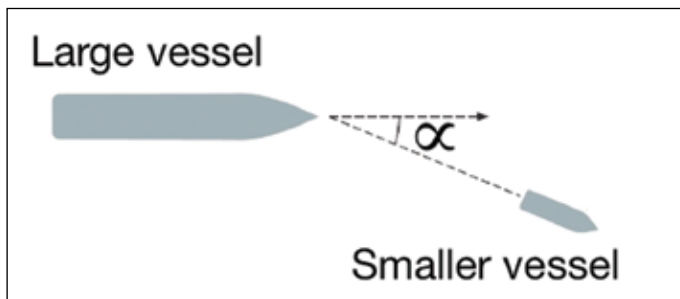
MARS 201830

Hydrodynamic effects create challenges

→ A laden tanker drawing 12.75m was inbound in a restricted waterway. It was being coned near the centre of the main channel at a speed of about 7.5 knots. On the starboard side, outside the main channel, was a secondary channel used by smaller vessels such as tugs and barges. The tanker's bridge team had observed, by radar, a tug pushing a barge in the secondary channel about 6 nautical miles ahead and they were due to overtake the tug in the near future. An agreement was reached between the pilot of the tanker and the tug Master. The customary arrangement is that the tug and barge assume an angle (α) with the channel as the larger ship overtakes in order to reduce hydrodynamic effects and retain manoeuvrability, as shown in the diagram below.

As the two vessels began to close, the tug and barge were seen to be at the limit between the secondary channel and the main channel (if not totally in the main channel), and the tug-barge combination had not taken the expected angle to reduce hydrodynamic effects. As the tanker approached, the tug Master reported difficulty steering. During the overtaking manoeuvre, the tug Master was unable to control his vessel and the barge. The units sheared to port and made contact with the stern of the tanker.

- Overtaking is a challenge in narrow channels; it requires proper planning well in advance, which should include contingency plans.
- The intensity and effect of hydrodynamic forces cannot be accurately assessed due to the nature of the channels and confined waters.
- In overtaking situations the difference in speed between the two vessels should be as great as safety and prudence will allow. This will reduce the time the hydrodynamic forces are acting on the vessels and negate the known 'trapping effect'.

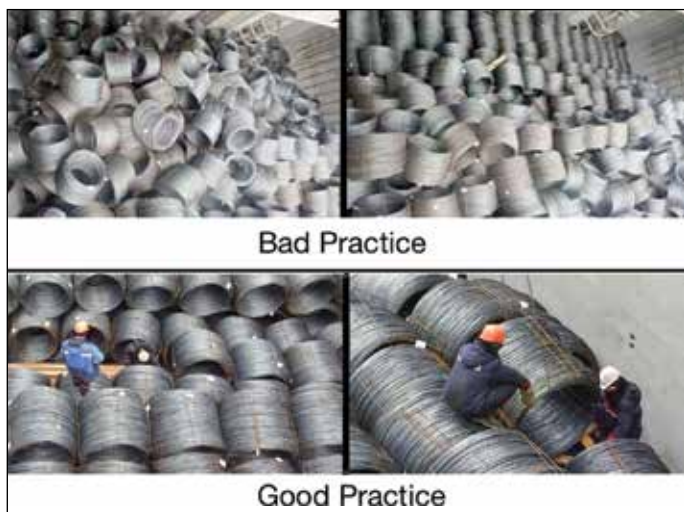
MARS 201831

Steel coil loading, dos and don'ts

➔ Some coils of wire rod have posed problems for proper stowage for the following reasons:

- Coil is relatively short in length: sometimes the length is equal to the coil diameter. This calls for extra care when stowing as the coil is unstable and may easily overturn.
- Some of these coils may have insufficient stiffness to retain their original shape in the course of cargo handling or when stored at port. The cylindrical form of the coils becomes skewed, with the windings shifted and inclined along the coil's axis instead of being perpendicular to the axis.

These characteristics can make it difficult to ensure a tight and uniform block stow when intact and deformed coils are loaded together.

- Improperly stowed coils may shift during transit and put the vessel at risk. Unsafe stowage may also trigger a claim from the unloading stevedores.
- If coils are not loaded in a tight, uniform block stow, suspend loading and issue a protest. The stevedores must accept the Master's requirement to re-stow any shifted or collapsed coils.
- Sufficient timber dunnage to level the stow and fill the gaps where necessary should be the norm.
- Be aware and vigilant during stowage, and keep a constant watch on the operation.

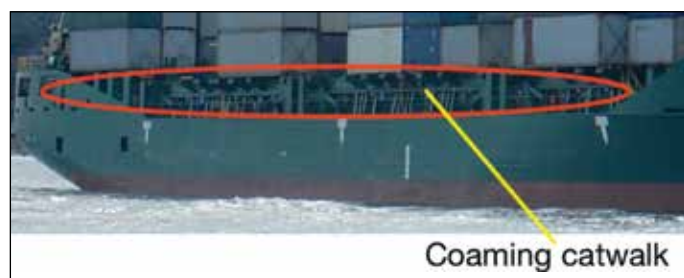
MARS 201832

Man overboard hazard goes unnoticed until deadly accident

➔ A small container vessel was underway in a coastal area at about 16 knots. At mid-morning an engine room crew member informed the other duty crew that he was going to open the steam line to the aft fuel oil bunker tank. This was done in a compartment between cargo holds no 2 and 3 on the main deck, which was accessed via a ladder from a coaming catwalk.

A little while later another engine crew member went out on deck to check on the first man. He found the hatch open and the steam valve manoeuvred, but no trace of the crew member. Once back in the control room he called the bridge and asked for a PA system announcement to call for the crew member. The man's cabin was also visited but found to be empty.

With the crew member apparently missing a ship search was initiated but he was still not found. The ship was turned around and a search pattern initiated some 90 minutes after the man was last seen. A VHF radio PAN PAN call was made and local SAR authorities contacted. The water was +2°; at this temperature a person who is not protected by a survival suit will suffer hypothermia and become unconscious within about 20 minutes. Extensive searching by several vessels and helicopters failed to find the missing man, who is presumed dead.

- The 'falling overboard' hazard existed for some time without raising any red flags. It took this accident for people to realise the danger.
- Extra bars were installed in the opening to provide better protection from falling overboard if someone were to lose their grip on the ladder while ascending or descending.
- Hazards exist on every ship but often are not recognised as such. People tend to accept their environment as it is, without thinking critically about potential hazards.

● As with the tripping hazard in MARS 201828 above, make a special effort to go over and around your vessel with fresh eyes; try to spot and eliminate 'falling overboard' hazards.

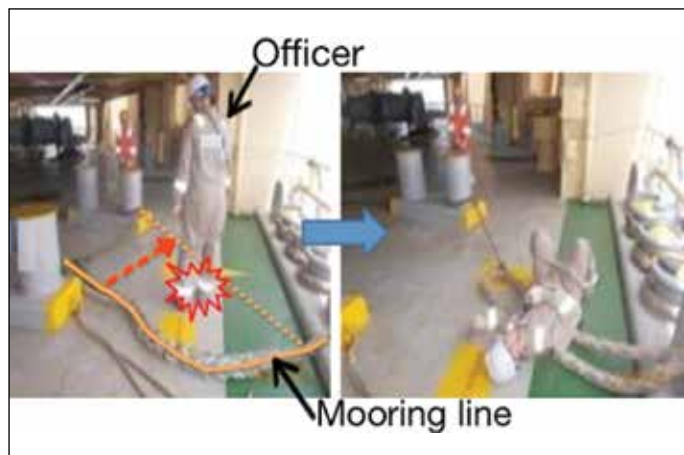
MARS 201833

Mooring line accident: watch where you are standing

→ A pure car carrier was departing port. After turning clear at the breakwater, the order to let go the aft tug line was given. The officer aft was holding the rope stopper and a crewman was holding the messenger line around the bollard to avoid excessive slacking off when letting go the tug line. Two other crew members removed the eye of the tug line from the bollard, and then the rope stopper was slowly released. Suddenly, the tug line came under tension and shifted the mooring line, hitting the legs of the officer and sending him to the deck. He injured his back and required an emergency medical evacuation.

- Treat mooring lines with respect; always keep in mind that they can come under extreme tension at a moment's notice.
- Even though this was a bad accident, it could have been much worse. Fatalities due to mooring lines are, unfortunately, significant in the marine industry. Past statistics have quantified mooring accidents as the seventh most frequent cause of personal injuries but the third most expensive per claim (UK P&I Club LP News, January 2009).
- The crew member overseeing the mooring operation should not be involved in manipulating lines, stoppers or winches. Their job is to oversee the operation, keeping a watch for dangerous developing situations.

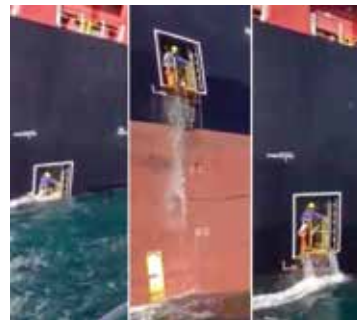
MARS 201834

Dangerous pilot boarding situation

→ A container ship was inbound with a heavy 3m swell near broadside, causing the vessel to roll heavily. As the pilot boat approached, the container vessel rolled sufficiently to flood the pilot boarding access portal twice. The pilot boat stood off until the container ship altered course sufficiently to stop the rolling and allow safe boarding.

Still images as seen on Twitter, #dangerousladders

- Ensure your vessel is ready to accept the pilot in every way, including making a lee for the pilot boat and reducing vessel rolling to a minimum.
- Know your vessel. In this case, given the open pilot boarding access portal, the roll angle created a dangerous situation for the vessel's crew standing by to receive the pilot.
- Obviously, this situation is also extremely dangerous for the pilot and completely unacceptable.

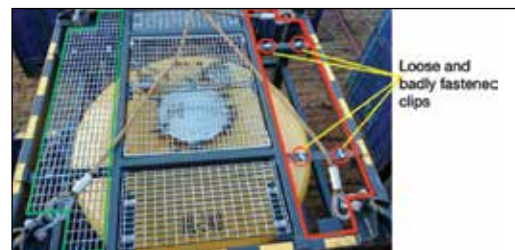
MARS 201835

Dropped object close call

→ A rig supply vessel was under a rig. A tank was being repositioned on the aft deck, using the rig's crane. During the repositioning, the bottom of the tank made contact with the cargo rail, tilting and rocking it. This caused one of the top gratings to fall from a height of about 6m on to the vessel's deck. Two deck crew were some 15m forward from the dropped grating, which weighed 17kg. The potential consequence of being hit by a 17kg object falling 6 metres is lethal.

The gratings are intended to be fixed in place with four bolts and butterfly clips. On subsequent investigation, it was found that all four clips appeared slack on the side the grating fell from. One of the clips was also bent.

- Always stand clear of lifted objects.
 - Check the load before lifting; is everything secure?
 - As the Drops Calculator* shows, even a mass as small as 1kg dropped from a height of about 12m can be lethal.
- * See the Dropped Objects Prevention Scheme at www.dropsonline.org
- The Drops Calculator has some important caveats:
- It is a guide, a cursory indication of a possible outcome
 - The calculator is best employed proactively during risk assessments/ task planning/time outs
 - Assumes blunt force trauma, so not compatible with sharp objects
 - Assumes full PPE is being worn
 - The height of an individual should not be subtracted
 - Never assume dropped objects will always strike the head.
