# Mariners' Alerting and Reporting Scheme

MARS Report No. 308 June 2018

## Approaching port, CPP stuck at 50% ahead

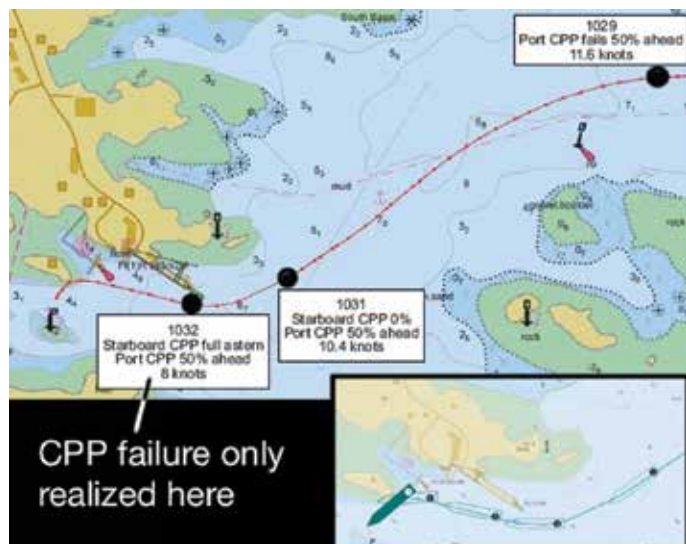
The Master initially thought that the ferry's slow response to the pitch adjustments was due to the ferry's trim. The OOW looked at the CPP indicators on the centre console and saw that the pitch on the port CPP was still at 50% ahead. He immediately advised the Master, who set both the port and starboard CPPs to 100% pitch astern. The starboard CPP pitch moved to 100% astern but the port CPP pitch remained at 50% ahead.

The ferry was now less than 200 metres off the pier breakwater, its bow starting to swing to starboard due to the twisting moment of the propellers. To counteract the swing, the Master set the bow thrusters to 100% thrust bow to port. At this point the Master decided against using the anchors to slow the vessel in view of the relatively high speed and the risk to the forward mooring party.

- Pivotal to the mechanical failure was the lack of service instructions on board the vessel concerning the actuator's inspection and maintenance for reference by the service personnel.
- The pitch control system had not been upgraded to incorporate a pitch deviation alarm and/or an automatic clutch-out capability as recommended by its manufacturer.
- It took the bridge team two minutes to realise that control of the port CPP had been lost. By then, the ferry was less than 200m from the pier roundhead and was still making 10kt.
- The ferry's speed when approaching the port was too fast to stop the ferry in safe water.

- For emergencies, practise, practise, practise. In this case, the ferry's teams were not sufficiently prepared or practised to deal quickly and effectively with the loss of pitch control in the confined waters off this arrival port.
- Changing desired thrust on the motors, as when giving helm orders, has immediate and important consequences. Always confirm to see if your desired input is actually being applied.
- Even if you are confident of the manoeuvre and the ship's capabilities, put in a safety factor that will work in your favour if things go awry. One of the easiest – slow down.

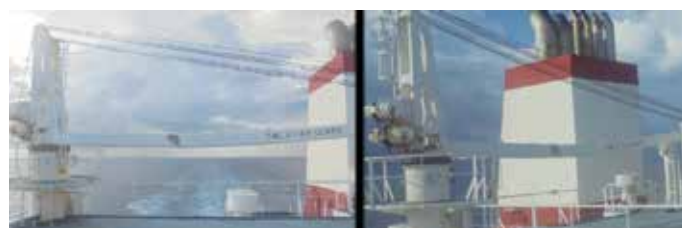
➔ The Master of a bulk carrier, newly arrived on board, noticed the starboard provision crane was not straight but slightly bent upward. A closer inspection showed cracks on the paint surfaces of the stoppers. Additionally, limit switches were found in disrepair; the crane had obviously been misused.

It appears that the damage had occurred some time earlier but had not been reported.

- Limit switches should always be operational and tests should be done by a competent person in line with the vessel's PMS.
- Within a strong safety culture, immediate and transparent reporting of incidents should be the norm.
- Leaving equipment in less than optimum state endangers crew and is negligent behaviour.
- Crane operators need to be given the proper training before they use lifting equipment.

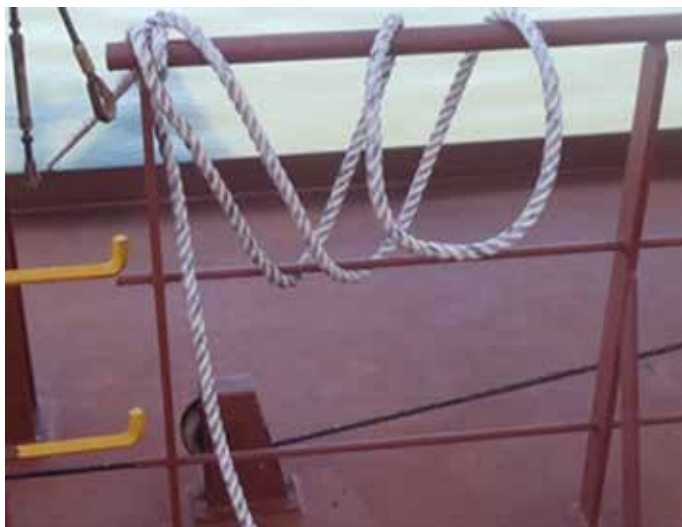
Unapproved secondary means of support tied to non-loading bearing part of accommodation ladder and vessel structure

According to AMSA, in many cases the secondary means of support are inadequate for their intended purpose and in fact introduce unacceptable hazards and risks. The inadequacies include:

- Connections to vessel's cranes or davits with insufficient safe working limit (SWL)
- Attachments to non-load-bearing parts of the accommodation ladder and vessel structure
- Inadequate tensile strength of ropes, wires, pulleys and fittings.

- If a secondary means of support is desired, a risk assessment should be undertaken on board in line with the vessel's safety management system.
- Procedures for the fitting, maintenance and operation of the secondary means of support arrangements should be included in safety management system procedures and crew should be inducted and trained in the use of these arrangements.
- Good seamanship and reasonable judgement is a standard in itself.

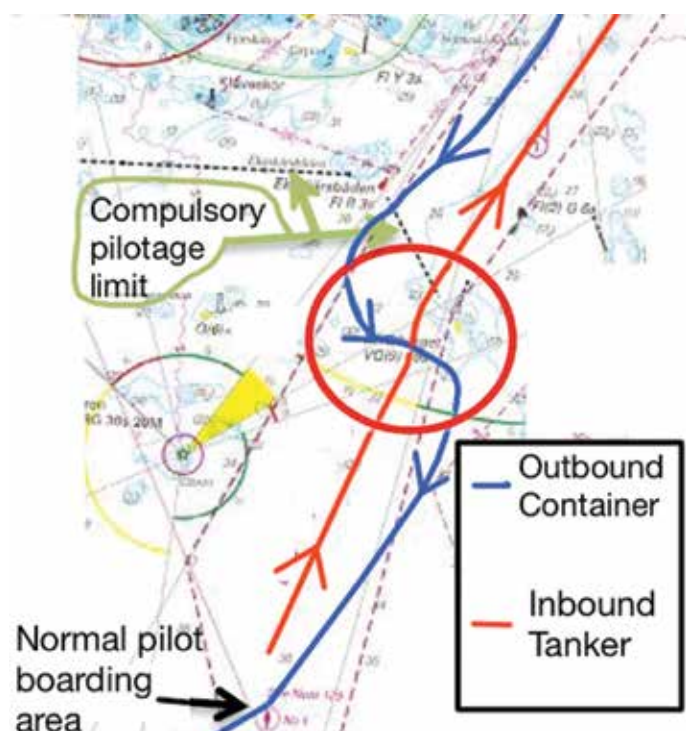
Radar recordings show that container vessel initially turned a little to starboard after the pilot had disembarked. According to the Master, he perceived the proximity situation with tanker as critical and decided to turn to port instead, increasing speed at the same time, choosing a starboard to starboard meeting instead of port to port because, in his opinion, the situation now called for this action.

Meanwhile on the container vessel, the OOW arrived back on the bridge and the Master told him to take the helm. The tanker continued running its engine full astern and the bow propeller full to port while the container vessel increased speed and passed just ahead of the tanker, at about 100m.

- If you change the agreed plan, make sure you tell the other party. In this case the Master of the container vessel changed the plan without notice and only the vigilance and actions of the tanker Master averted disaster.

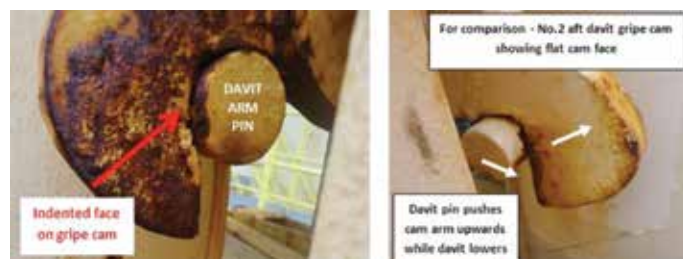
➔ Crew were intent on lowering the lifeboat. Initially the davits failed to lower as the gripe cam remained secured. To complete the lowering, the fall wires were tensioned using the manual hoisting handle. This reduced the force between the davit arm pin and the gripe cam, allowing the gripe cam to be manually moved clear. The lifeboat was then lowered normally.

After investigation, it was found that an indentation had been worn on the face of the gripe cam due to oxidation and long, continuous contact from the davit pin. This resulted in the davit arm pin being engaged in the cam rather than moving the cam arm away as the davit was lowered. The cam consequently acted as a hook, preventing the davit arm from moving from the stowed position. The wear had not been identified during previous routine weekly lifeboat lowering exercises.

- Check, recheck and re-recheck your safety gear.
