Mariners' Alerting and Reporting Scheme

MARS Report No 326 December 2019

Fixed CO₂ system with mixed messages

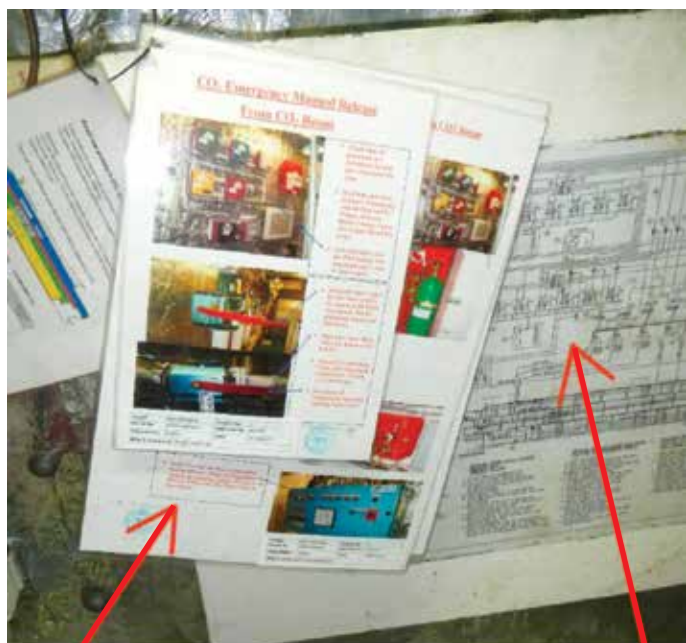
It was decided to use the CO₂ fire suppression system to combat the fire. Once it was confirmed that all crew were accounted for, the chief engineer initiated the extinguishing system. However, because there were two different versions of the activation procedure posted – one from the manufacturer, one from the ship – he found the instructions unclear. After about five minutes, he was finally able to activate the system, some 26 minutes since the fire alarm had first sounded.

Ship's operating instructions

Manufacturer's operating instructions

- Are there confusing, contradictory or competing procedures for CO₂ activation (or other actions) on your ship? Correct the situation before an incident occurs.
- Calling for help (PAN-PAN or distress message) is always a good idea when a fire breaks out. If it is brought under control you can always cancel the message.
- Always ensure all crew are accounted for before CO₂ is activated.
- Always check before and after CO₂ activation that all ventilation to the space is well and truly closed.

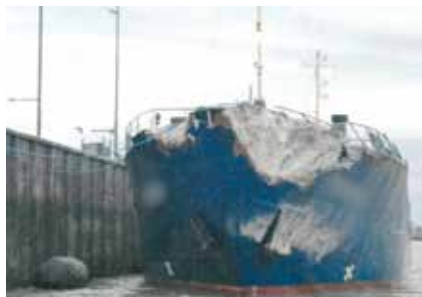
After the accident, a service company discovered that the contacts of the steering switch were loose and corroded. Accordingly, in addition to the primary means of steering, the backup means of steering also failed.

- When the steering fails in restricted waters, time is of the essence and the stress on watchkeepers can be intense. Practice drills involving scenarios of this kind should be undertaken to help crew prepare for such eventualities.
- With only four crew on this vessel it is hard to imagine how a full and effective response to the steering failure could have been undertaken in time.

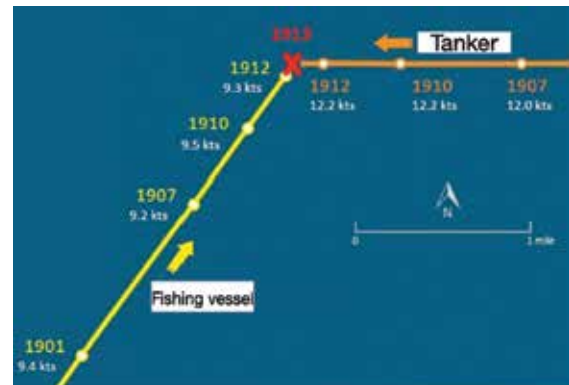
Meanwhile on the fishing boat, the lone watchkeeper had been cleaning when he heard a metallic sound, which turned out to be the first contact of the fishing vessel's outriggers with the side of the tanker. He tried to turn the vessel but it was too late and it made heavy contact with the tanker.

Fishing vessel

Tanker

- Many collisions can be attributed to ineffective lookout and low situational awareness. This accident is yet another example.
- Never assume the give-way vessel will pass ahead or astern; plot the targets and follow the situation until all clear.
- Undertaking other duties that distract from your navigation responsibilities, as on the fishing vessel in this instance, is a recipe for an accident.

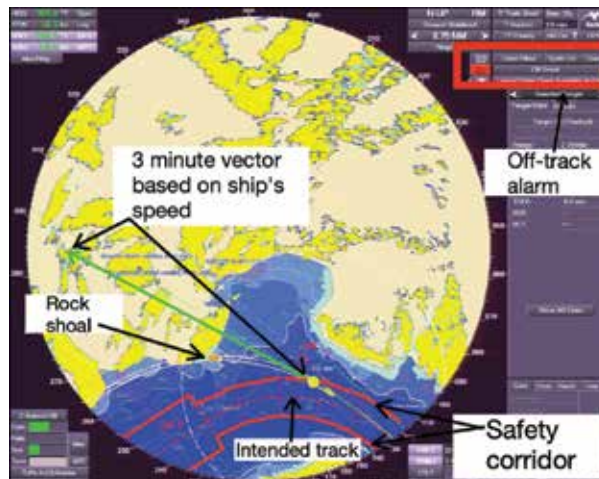
Under the pilot's con, the first alteration of course to port was initiated using three degrees of port helm. At this time the vessel had a speed over ground (SOG) of nearly 18 knots. The initial helm order was followed by successive increases to five and then 10 degrees of rudder. About one minute after the initial three degree port helm order an off-track alarm flashed on the ECDIS, but this information was not brought to the attention of the Master or the pilot. The alarm appeared only as a visual indicator on the radar screen because its audio had been muted prior to the ship entering the channel (see VDR screen capture).

Yellow dot ● shows position of vessel when off-track alarm flashes

- Plan safely and then execute safely. In this case the intended route, as entered in the ECDIS, was a good plan, but it was not adhered to.
- Muting alarms on an ECDIS is not considered industry good practice.
- If conditions allow, consider reducing speed for manoeuvres in restricted waterways. This will give more time for the bridge team to react to deviations in the plan.
