# Mariners' Alerting and Reporting Scheme

## MARS Report No 327 January 2020

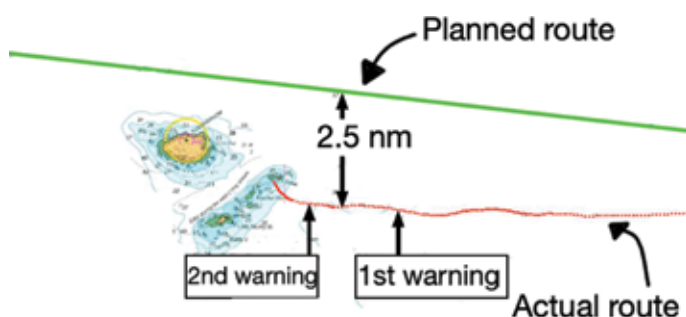
During this conversation with the VTS officer, the OOW reduced the range scale on the port radar and added a chart overlay to the display. He then realised that his plan to pass between the two islands was unsafe, because there was a shallow reef between them. He quickly selected hand-steering and put the rudder full to starboard in an

attempt to steer away from danger. The vessel grounded nonetheless at a speed of 7kt. Seconds before grounding, the ECDIS depth alarm sounded as the vessel crossed over the 10m depth contour.

- A planned route is usually safer than an improvised one. Stick to your planned route.
- Avoid distractions while on watch – navigate your vessel.
- If a shore authority calls your ship to say you are running into danger, call the Master immediately and evaluate your position with care.

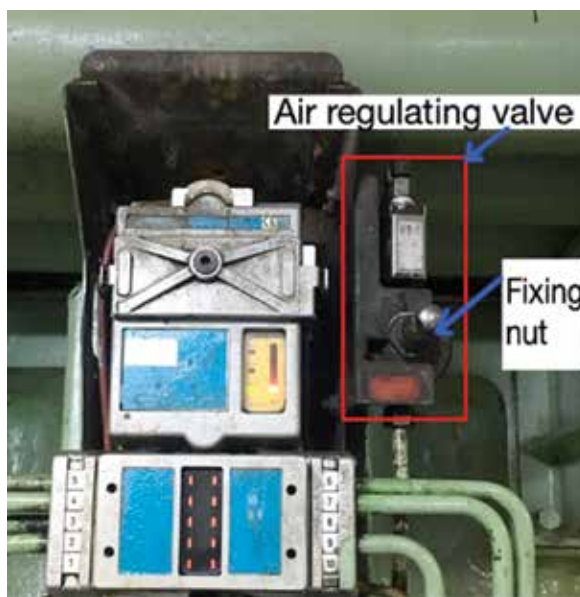
While these preparations were in progress, the engine team checked the oil mist alarm system. It was found that the air feed flow into the oil mist detector was not operating according to specification. A loosened fixing nut on the air regulating valve was causing a false alarm.

The system air pressure was immediately increased to normal level, the fixing nut was tightened and the oil mist detector was re-set. The main engine was quickly restarted and the vessel was able to continue the voyage without suffering any negative consequences or needing to drop anchor.

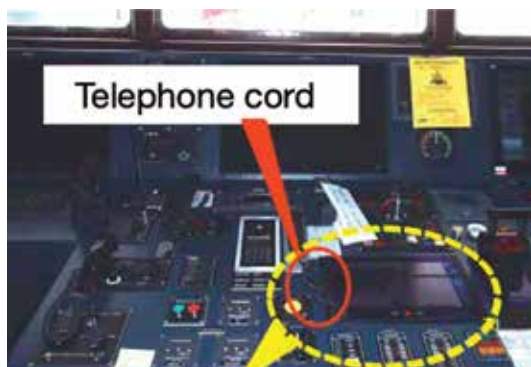
Touch screen control interface

The investigation found that the main engine shutdown feature on the touchscreen integrated alarm monitoring and control system had inadvertently been activated. The touchscreen was mounted horizontally in the centre bridge console, close to other controls such as steering and propulsion. At the time of the loss of propulsion, four crew members were within 2m of the touchscreen. Tests showed that the touchscreen was reactive to a variety of inputs – including the telephone cord situated next to it.

When the main engine shutdown button was activated on the touchscreen, a generic and ambiguous system status message appeared on the screen. The message did not specify that the engine was about to shut down, nor did it indicate how the shutdown was activated or from where (bridge, engine room, emergency stop etc).

A plastic cover was placed over the touchscreen to prevent another inadvertent shutdown. After a thorough review, the equipment manufacturer disabled the main engine shutdown function on the touchscreen and the plastic cover was removed. In case of an emergency, the main engine can still be shut down from the bridge via the traditional shutdown button.

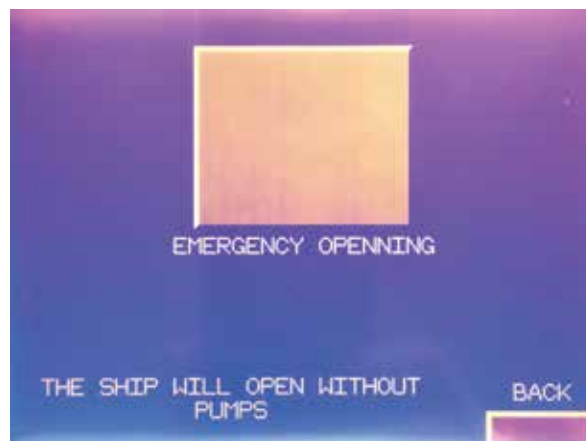
The investigation found that the 'virtual button' on the touchscreen control panel for the emergency open had been activated by the operator while he was dusting the screen. This button was only one level deep in the touchscreen menu control. Two unintended touches with the duster, one to reveal the 'emergency opening' button and one to activate it, had opened the vessel.

- This incident and MARS 202003 demonstrate that touchscreen devices, which are increasingly common on ships, have introduced new risks. These devices can control a wide range of vessel functions. Crew need to have a thorough understanding of the particularities and sensitivities of each touchscreen device.
- For touchscreen applications on control panels, procedures and protections should be implemented to protect against unwanted activations and their consequences.

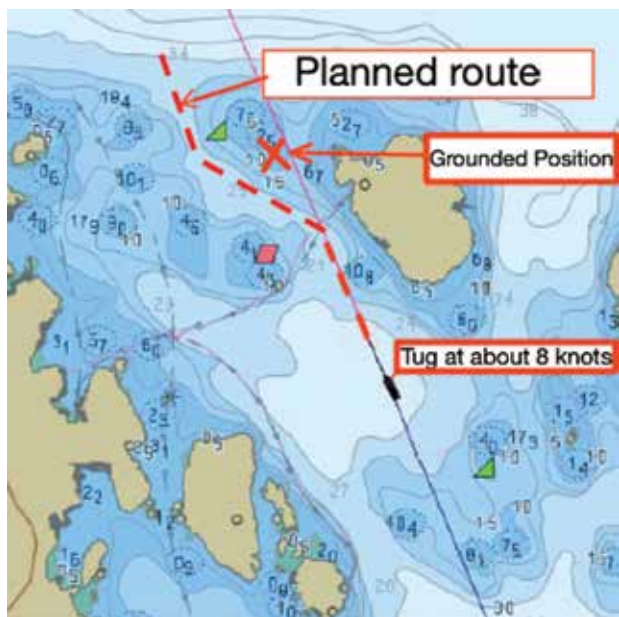
At one point, the OOW switched on the searchlight to see the reflectors on two navigation markers that indicated some reefs. When the OOW saw that he was abreast of the red marker (see image), he moved the autopilot control stick a few 'clicks' to port. Although the OOW later stated that the vessel did not change course, the AIS signals show that the vessel's course changed by 6° to port during the final 31 seconds before the grounding.

The OOW stated that he then wished to put the vessel into manual steering, but the vessel ran aground before he could do this, and he was thrown violently forward.

- In restricted waters, close attention to navigation is needed to avoid negative consequences.
- Contrary to the rules, there was no dedicated lookout on duty. A dedicated lookout might have been able to assist the OOW in his situational awareness and could have helped prevent the accident.

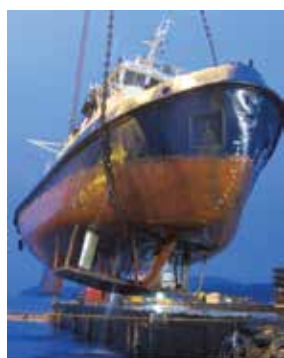
The OOW immediately tried to reverse the grounded vessel off, but found that the vessel's propulsion system did not respond. Not long after the grounding the vessel slipped off the rocks, drifted and then sank about 40 minutes after grounding. The crew abandoned ship and were later rescued.

Tug during salvage operation

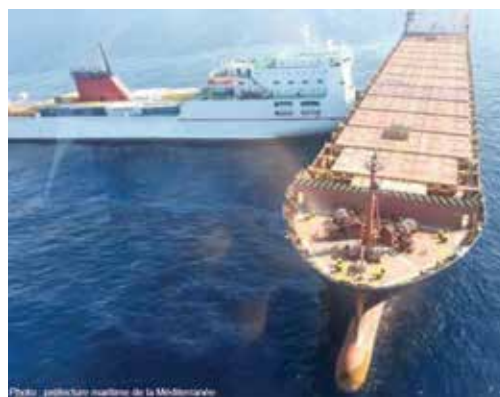
About nine minutes after the alarm appeared on the radar screen the ro-ro vessel collided with an anchored container ship at an angle of almost 90° and became wedged into the side of the anchored vessel. The personnel on the bridge of the container vessel did not see the ro-ro approaching and took no action to warn it.

The investigation was not able to determine why the OOW did not see the anchored container vessel in time to prevent the collision. Fatigue,

complacency, distraction or lack of properly prioritised jobs could have played a role. The lack of a proper lookout on both vessels was undoubtedly a substantial contributing factor.

- Permanently muting alarms is not best practice.
- The best 'screen' to be viewing when visibility is good is the bridge window.
- Bridge personnel on vessels at anchor have a duty to survey the traffic and take appropriate action if collision is imminent.
