Mariners' Alerting and Reporting Scheme

MARS Report No 328 February 2020

Grounding was not in the plan

Edited from official TAIC (New Zealand) report MO-2018-203

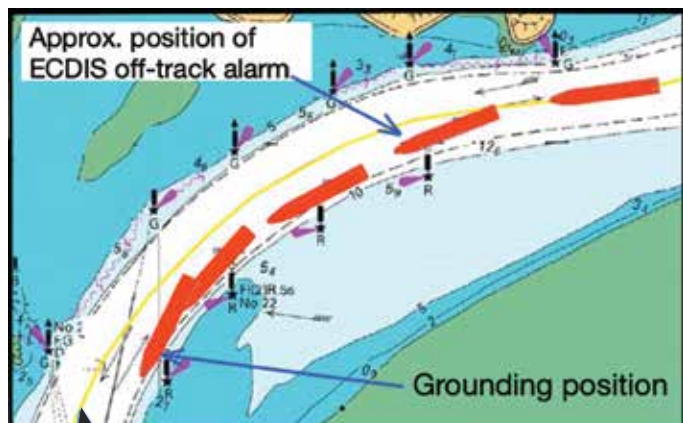
By this point, the ship was already to port of the planned track. Despite this, the pilot gave a succession of large helm orders to port (between 20° and 35° rudder angle). As the vessel responded to the port rudder, the deviation to the left of the planned track increased, activating the off-track alert on the ECDIS. The alarm was acknowledged but the information was not passed on to the other members of the bridge team.

The vessel gradually slowed as it made the turn to port, deviating ever further to the left side of the channel. Now, at a speed of 2.5 knots, the bridge team felt the ship heel over to starboard. At that point the Master asked the pilot why the engine was still on dead slow ahead. The pilot ordered the engines to increase to slow ahead. However, the ship continued to lose speed and soon stopped altogether. The bridge team now realised the vessel was aground.

Yellow = middle of the channel

The official investigation found that, among other things, the grounding demonstrated why it is not always appropriate to use visual navigation exclusively when manoeuvring large ships in narrow channels, especially at night. The accuracy of electronic navigation aids such as PPUs and ECDIS could have added value; the ship's departure from the intended track would have been readily apparent in time to avoid the grounding.

- The real-time instantaneous position information given by ECDIS and PPU equipment should always be put to good use in restricted pilotage waters, particularly when in darkness.
- When under pilotage, don't leave your BRM techniques in the classroom. Challenge the pilot if there is divergence from the planned route.
- In order to raise a challenge if need be, you have to know the plan and follow its execution.

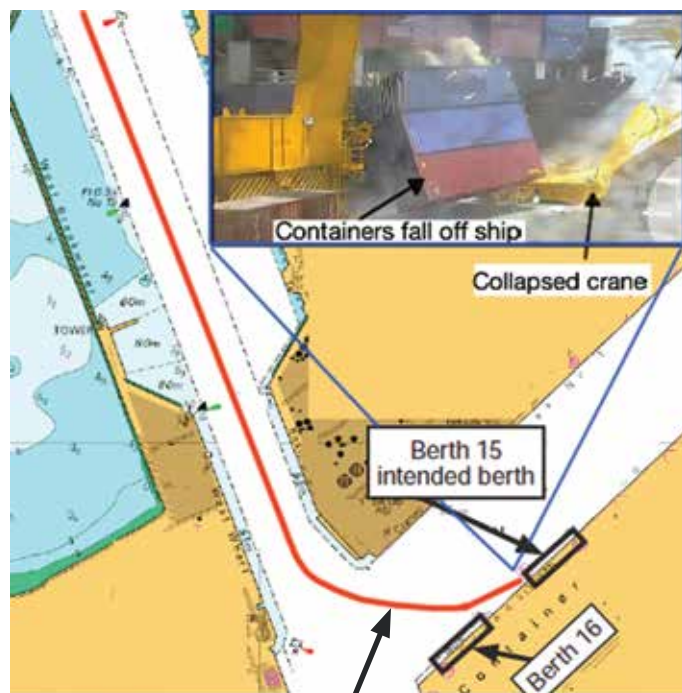
Vessel's approximate trajectory

While turning to port, the vessel was also setting laterally to starboard towards the container ship crane at berth 16. The pilot ordered hard to starboard and the Master stated 'This is no good'. He then telephoned the engine room, advising them to prepare for an emergency. After several other fruitless manoeuvres the vessel struck berth 15 at a speed of 5.3 knots, hitting two shore cranes, one of which immediately collapsed. Several containers fell from the ship on to the quay as a result of the impact.

- The plan was to berth port side to at section 15. Instead, the vessel made heavy contact with the berth on its starboard side. This is a classic case of too much speed for the desired manoeuvre in the given space. If ever in doubt, slow down.

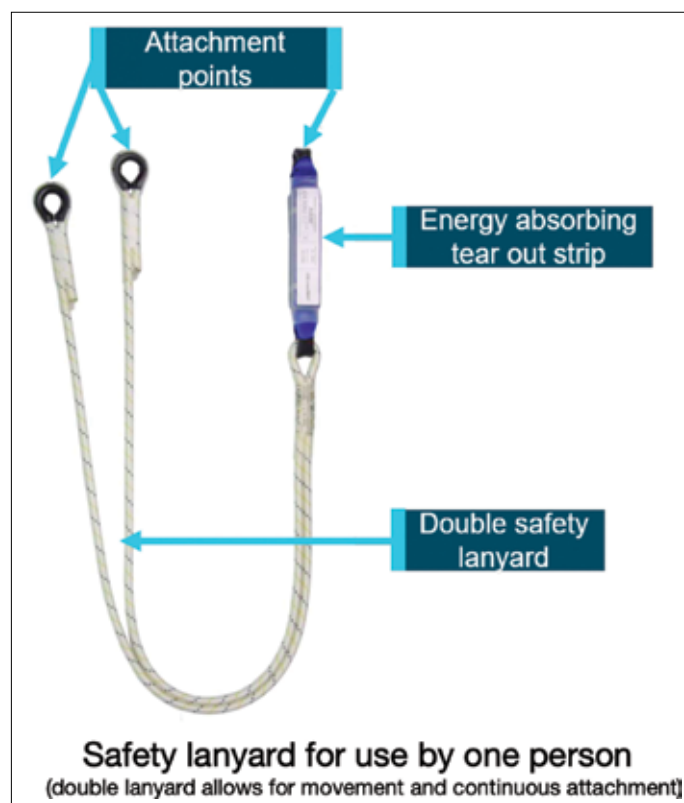
In preparation for the painting, the gangway was rigged with additional ropes to secure the open ends of the gangway. Slings were fastened either end for lifting and suspending it from the crane. Tag lines were connected to the underside of each end of the gangway and run to the hold bottom where they were to be used to control the motion of the suspended staging by two crew. Two other crew donned safety harnesses and attached themselves to the double safety lanyard on the fall arrest line – which was designed for one person – one to each attachment point.

The free end of the fall arrest safety line was tied off to one of the crane hook shackles, clear of the staging slings and the hook itself. The two ABs boarded the staging on the main deck. Because the improvised arrangement had limited stability, the ABs stood one at each end of the staging to balance it. They were to work from these positions and limit their movement so as to not upset the staging and equipment on board.

- In this accident, the list of improvised procedures and less than adequate working conditions is long. If you find yourself improvising, stop! Consult with your office and do a proper risk assessment.
- Only lift people using gear that has been approved for that purpose. In this case, the gear was not approved for this kind of activity.
- Never bypass safety switches. They are there for a reason.
- Learn how to use your vessel's safety gear. In this case it appears the crew were not only improvising, but were unaware of the correct way to use the double lanyard.

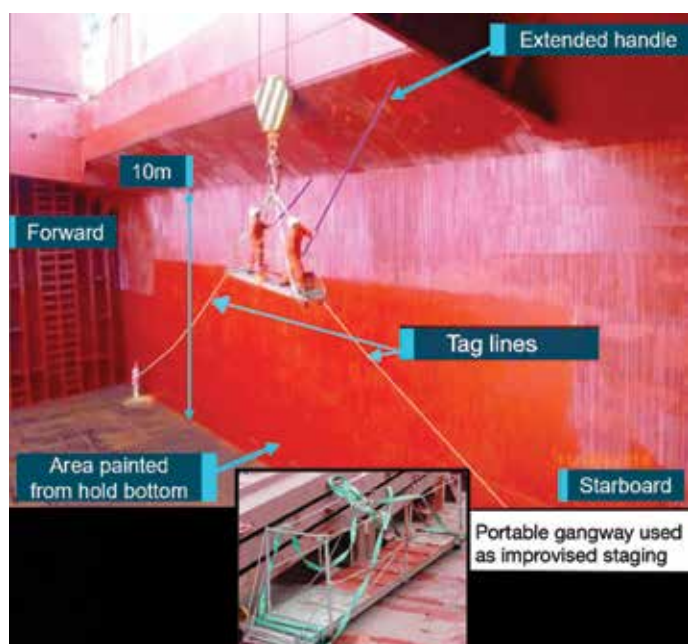
To enable the crane to reach over the hatch coaming and into the hold, the crane driver had to bypass the crane's lower luffing limit protection. The crew members on the staging and in the hold were unaware of this – the only person who was aware was the crane driver.

One of the crew on the staging signalled to the crane operator to move the hook by luffing the jib up. As the crane jib was raised, the falling block also rose and caught on the lower edge of the hatch coaming. This went unnoticed by the work team. As the jib was raised further, the block suddenly came free of the coaming, sending an unexpected heavy shock through the staging, upsetting it and its load. Both crew were knocked over on the staging, landing heavily on their knees and lower body. The severity of their injuries meant the crew members had to be taken to hospital.

- The task was not conducted in accordance with company safety management procedures or industry best practice with regard to risk management and working aloft permit requirements. Machinery and equipment were used in a way they were not designed or approved for, making hazard identification difficult and exposing the workers to increased risk.
- The fall arrest equipment was incorrectly attached. Both workers were attached to the same device, which was designed for only one person. Had either of them fallen from the platform the equipment would not have worked correctly, resulting in serious or fatal injuries.
