Mariners' Alerting and Reporting Scheme

MARS Report No 329 March 2020

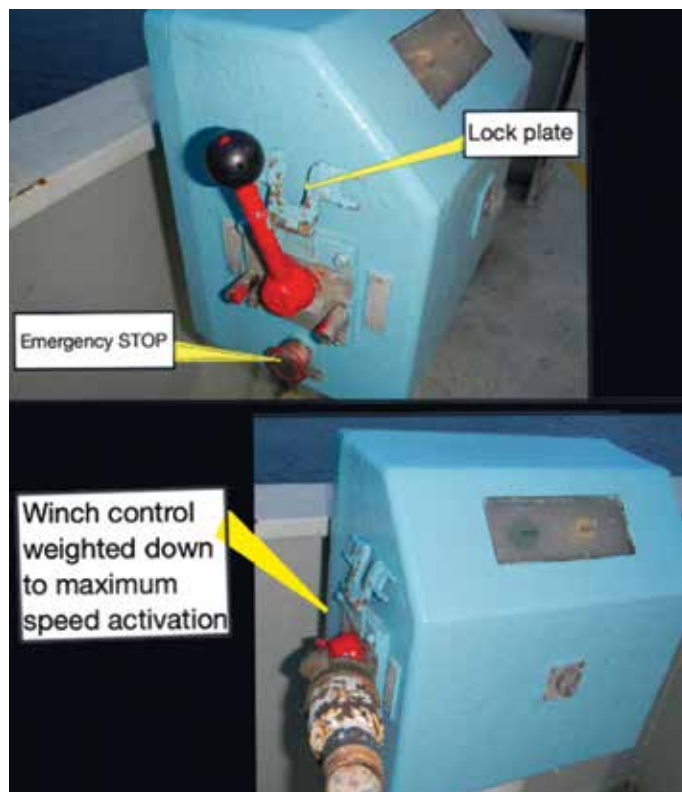
The crew member found his colleague pinned to the mooring winch by one of the lines that he had been winching inboard, unresponsive and bleeding heavily from several places. The control lever for the winch was held down by a weight to keep it in the position for maximum winch speed. He immediately called for help and engaged the emergency stop on the winch.

- The crew member working the lines on the poop deck was working alone on a slippery deck.
- The two aft lines were winched home simultaneously with the winch control lever locked to high speed, probably because the victim wished to stow them at the same time as winching in.

- Ensure sufficient crew are present during mooring operations to guarantee safe working conditions. This will usually require more than one person at each mooring station.
- The winch operator must have full control of all activity as ropes are taken in on the winch drum. When using a winch drum with a loose rope, one person must be at the end of the drum and another person must be standing at least one metre behind to manage the slack. With the winch operator, this makes three.

- Deck surfaces where mooring activities are carried out must be slip-resistant.

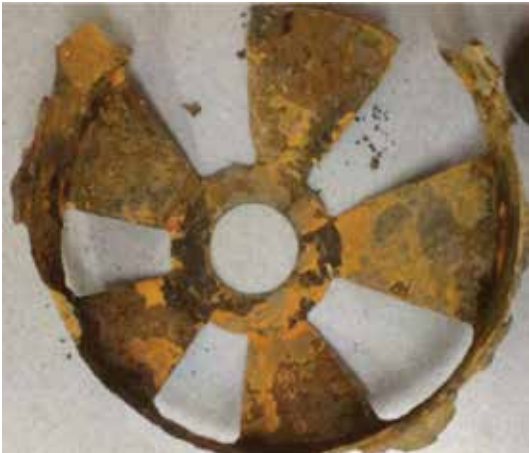
During the damage survey, the spool piece was found to be severely corroded. The diffusor necessary to dilute the acidic outflow of the

scrubber wash water and ensure compliance with the emission regulations was also found to be heavily corroded.

Even though the spool piece was made to an approved design (steel piping with epoxy coating), the acidic wash water managed to make

Corroded diffuser

contact with the steel pipe and react with it. This was probably due to a flaw in the application of the epoxy coating or the coating being damaged during installation. There have been several other instances of overboard piping connected to SOx scrubbers experiencing leaks.

- These incidents highlight the need to select both a suitably durable material for scrubber parts and a robust design.
- Until the industry converges on reliable design(s) and material(s) for the overboard piece, a yearly inspection of the spool piece is recommended. Particular attention should be paid to the bottom part of the pipe closest to the valve flange, since many incidents indicate that this is the area most affected by corrosion.
- An alternative to yearly inspections is to install a leakage indicator to the spool piece.

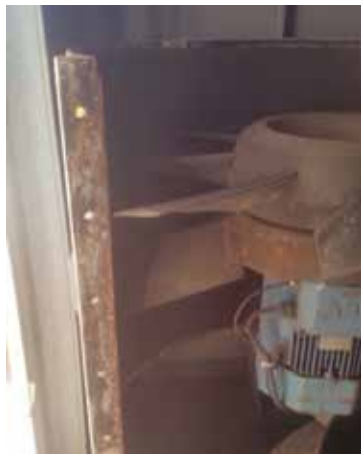
After a briefing by senior staff on the work to be done, the two men isolated the motor's electric circuit and did a lock-out. The fan-motor unit was located in a small deck house and was accessed through a cover built into the ventilation ducting. As they pulled the cover off, part of the gasket became detached. The engineer instinctively tried to grab the gasket but in doing so his right hand struck the edge of the immobile fan blades inside the ducting.

Even though he was wearing gloves, the impact caused a deep wound on his second finger. After first aid, he was sent ashore for further medical examinations. He received three stitches and was declared unfit for duties for 20 days.

- Working in cramped and difficult areas brings its own risks. Be aware of these possibilities and adjust your work style accordingly.
- Even seemingly minor injuries can have repercussions that last for some time. In this case the victim was unfit for duty for 20 days.

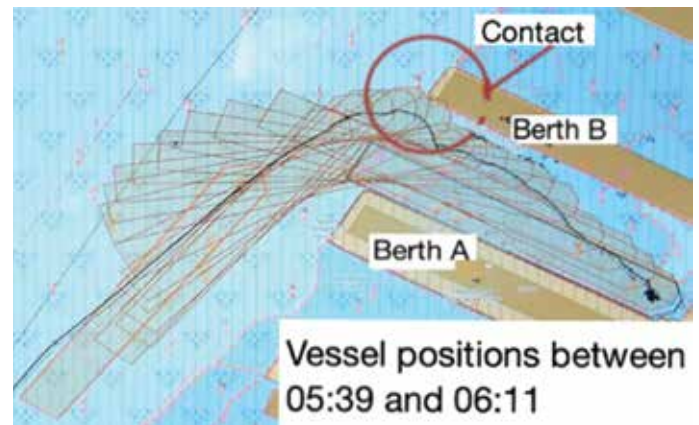
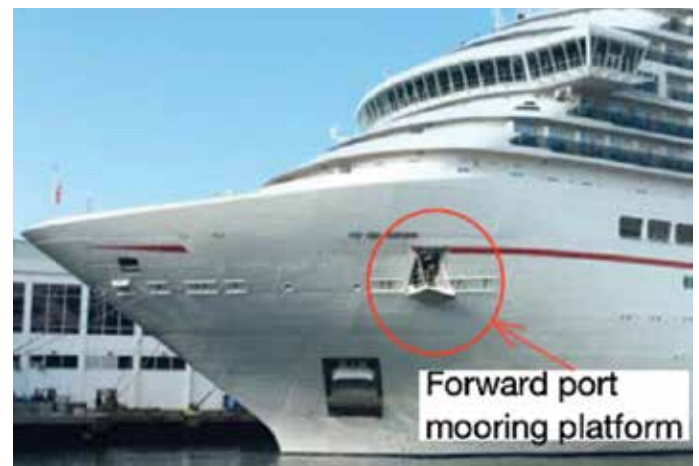
The tug was positioned on the starboard side, without lines, to act as a pivot point for the starboard turn into berth A. The pilot gave helm and thruster orders and the Master complied using a controller. With the vessel's speed at about 1.4 knots, the bow began approaching berth B. The officer forward gave a warning. The bow soon made contact with berth B, causing significant damage to two levels of the shoreside vehicle parking area.

- Minimum safe distances had not been set out during the docking discussions, so there was no shared mental model of where the threshold was.
- There was little evidence of the bridge team practising the technique of 'thinking aloud' that would have allowed for verbally sharing the mental model of the current and future situations.
- Members of the ship's bridge team were not engaged effectively in helping the pilot and Master execute the manoeuvre.
- The officer at the forward mooring platforms had no view of the tip of the bow, which made contact with the parking structure. Also, he was doing double duty alternating from port to starboard, which reduced his effectiveness.

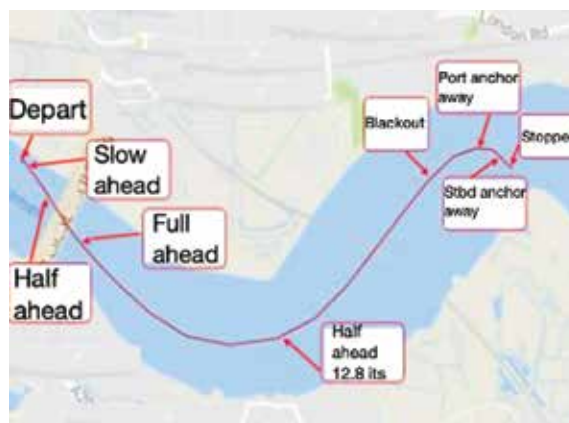
→ A tanker in ballast left its berth in a river estuary under pilotage. After leaving the berth, speed was gradually increased and then adjusted until a speed of nearly 10 knots was achieved. Some 18 minutes after departure a power blackout occurred. Power could not be regained and the vessel's speed began to slow so much that steerage became difficult. The port anchor was dropped (vessel speed 5.3 knots) and about two minutes later the starboard anchor was also let go (vessel speed 3.8 knots). The vessel stopped safely within a few minutes.

Soundings were taken around the bulbous bow and confirmed the vessel had not grounded. No changes were observed in the vessel's tank soundings and no spill or leakage was observed.

- Have your anchors at the ready when navigating restricted waters.
- Be aware that anchors can be pulled from the ship if the speed is too high.
- If emergency anchoring is necessary, ensure the crew are well clear of the chain as it pays out.
