# Mariners' Alerting and Reporting Scheme

MARS Report No 330 April 2020

## Symphony of errors leads to collision

As edited from official AIBN (Norway) report 2019/08

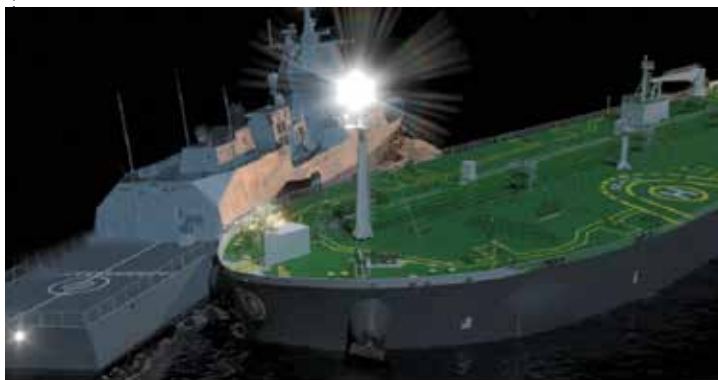
Simulated image of collision

The OOW on the frigate suddenly realised that the 'object' that was giving off light was moving and that they were on a direct collision course. Seconds later, the pilot on the tanker ordered full speed astern on the engines but the two vessels collided nonetheless. The tanker's starboard anchor ploughed into the starboard side of the frigate causing extensive damage.

2min 8 sec before collision

X Approximate position of collision

- Small course changes are to be avoided if you want to signal to an oncoming vessel, via radar and visual aspect, that you are changing course.
- Darkness and/or poor visibility changes everything. Would this have happened in daylight?
- Radar targets that are not emitting AIS signals should always be plotted.
- Never assume. Establish the facts.

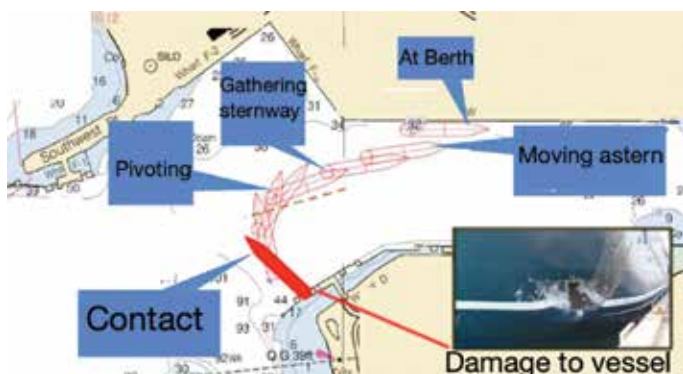
As the vessel gathered sternway, it contacted the dolphins aft. The investigation found, among other things, that the Master's abilities were probably negatively affected by alcohol consumption.

Although the major contributing factor to this accident appears to be alcohol abuse by the Master, several other factors conspired to allow the mishap. Had proper BRM been applied, the single point failure of the Master may have been avoided.

- The bridge team, including the pilot, should all be on the same page. To accomplish this a plan should be agreed and implemented and a common language used.
- Closed-loop communications are an essential part of good BRM.

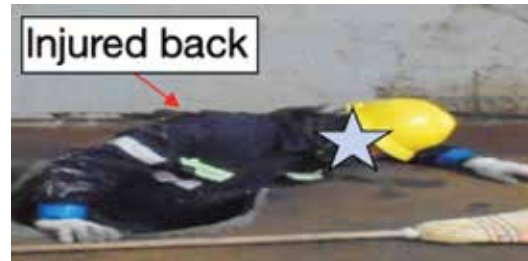
→ While at sea, deck crew were sweeping the empty hold of a vessel. The bilge well covers had been left open and were without barriers or guards. One crew member was near the bilges. Concentrating on his sweeping, he forgot that the bilge well covers had been removed. He stepped back and fell into one of the bilges. He was immediately helped out of the bilge well and given a physical evaluation. No apparent injuries were observed but the next day he complained of mild back pain. On arrival at port, he was sent to the shore doctor for further evaluation and medication.

- In this case the injuries were not severe but they might well have been. Always protect unattended open manholes with guards or barriers.
- Practise on-site risk assessment to identify all potential hazards at the work site and implement the necessary risk reduction measures.
- Stay aware of your environment – situational awareness is your best friend.

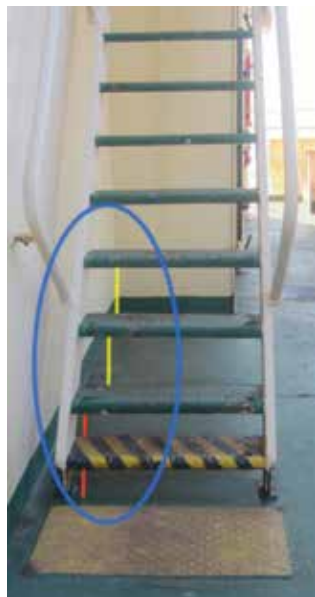
→ A visitor on a vessel almost fell as he descended the last steps of the exterior accommodation ladder. The last two treads were not equidistant from the rest of the stairs. This appeared to be an 'as built' construction issue but was clearly a tripping/fall hazard that had not yet been identified by the crew. Although the upper and lower steps of these stairs were nicely tiger-striped to identify them, the stairs themselves were not totally safe.

- As a design principle, stair treads should always be equidistant.
- We often become accustomed to hazards in plain sight; sometimes visitors are more likely to identify these than crew. Try taking a walk about on your vessel and look for hazards with 'new' eyes.
- Always have at least one hand on a railing when using stairs.

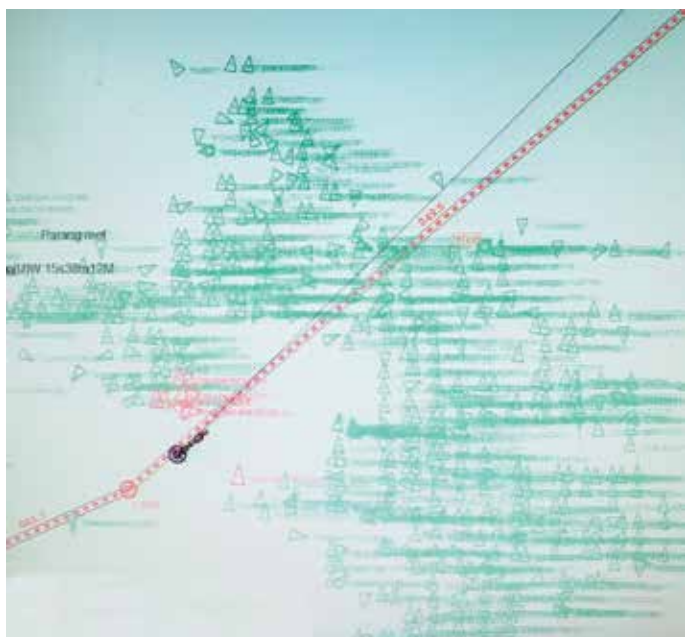
→ The AIS-equipped fishing net problem seems to be increasing exponentially. The picture below was taken on a recent trip from Shanghai to Busan showing a multitude of AIS targets, most of which are fishing nets. The vessel's recent-model AIS receiver can show up to 1,000 contacts, but still it is overloaded. It appears that these 'smart' fishing nets are now hailing ships by call sign and/or MMSI number over VHF channel 16, with an automated voice giving its bearing and position and telling vessels to keep clear. But which AIS target is it?

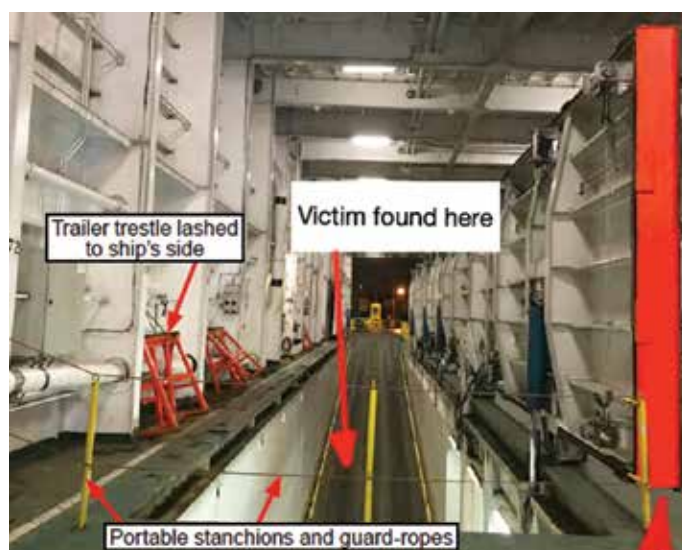
Task: Paint end of ramp hatch

→ An experienced deck crew member was tasked with painting the end of a raised car-deck ramp hatch while a ro-ro was at dock. He was attending to this work alone when several other crew heard a loud crash in the vicinity of the ramp. The other crew found the victim lying on the inboard side of the ramp, some 4.5m below the main deck, with a trestle lying on its side and across the lower part of his right leg.

- The victim crossed a safety barrier and fell 4.5m from the main deck on to the ramp.
- The victim's task did not require access to the unprotected deck edge beyond the rope barrier. It is not known why he entered the hazardous area.
- Work practices adopted by other deck ratings during hatch cover maintenance two days earlier indicated that adherence to the vessel's safety procedures was more a matter of routine and compliance than of understanding and conviction.

- Experience does not give one a free pass to short-circuit safety procedures.
