# Mariners' Alerting and Reporting Scheme

MARS Report No 331 May 2020

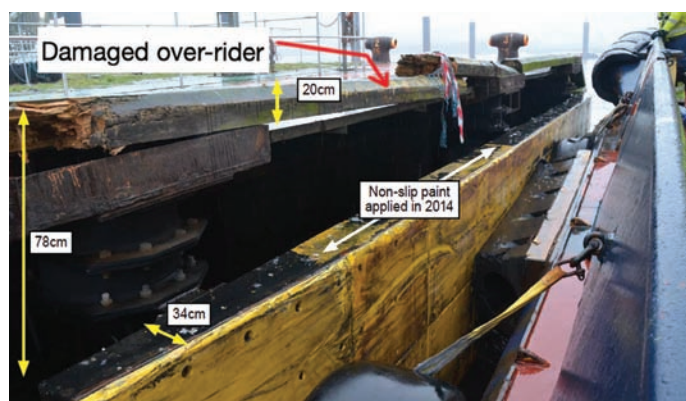
→ A tug was about to depart a berth that it often used. One crew member was on the dock to let go the lines. He was wearing a full set of personal protective equipment (PPE), including an auto-inflating lifejacket with a personal locator beacon (PLB) and crotch strap, which was fastened. Once the lines had been let go aft, he went forward and released them. He then walked back towards the tug's bulwark gate, which was now aligned with the centre of a berth fender. The over-riding was damaged, and as he stepped over it and lowered himself onto the top of the fender, he fell into the water.

- Concerns regarding safe access to and from the tugs at this berth had been raised at safety committee meetings and during company inspections many times prior to this accident.
- Non-slip paint was applied to the fenders in 2014, following tug crews expressing their concerns about hazardous boarding practices at the berth. This had the effect of legitimising these practices.
- The crew had not been fully prepared to deal with the emergency situation, and were unfamiliar with the use of the tug's MOB rescue-sling. The records indicated that this crew held only one MOB drill in the last year.

- Even a cursory view of the berth, with its uneven surfaces, broken over-riding and lack of hand-holds, indicates the area is not suitable for boarding. It would appear the crew were tolerating this situation against their own better judgment as this issue was raised at safety meetings. If you think something is unsafe, do not relent; make it safe.
- Beware of half-measures, such as the application of non-slip paint in this instance. When applying risk reduction measures, always make risks As Low As Reasonably Possible (ALARP).
- Practising MOB events develops critical skills you may need to save a life.

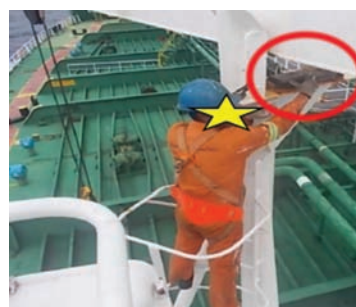
→ Two crew were tasked to secure the hose handling crane jib in its cradle support. One crew operated the crane while the other signalled. As the crane jib was lowered, the signaller attempted to manually align the wooden block over the jib cradle support. He held the block and signalled to the operator to lower the jib. He did not notice that his own finger was positioned under the block. When the jib was lowered into position, his fingertip was crushed between the crane jib and the wooden block.

- Crane operations are inherently risky. Excellent communications and situational awareness are essential for everyone involved.
- Crane operations need a dedicated crane operator and a dedicated signaller. If other manoeuvres are needed, a third person should be employed.

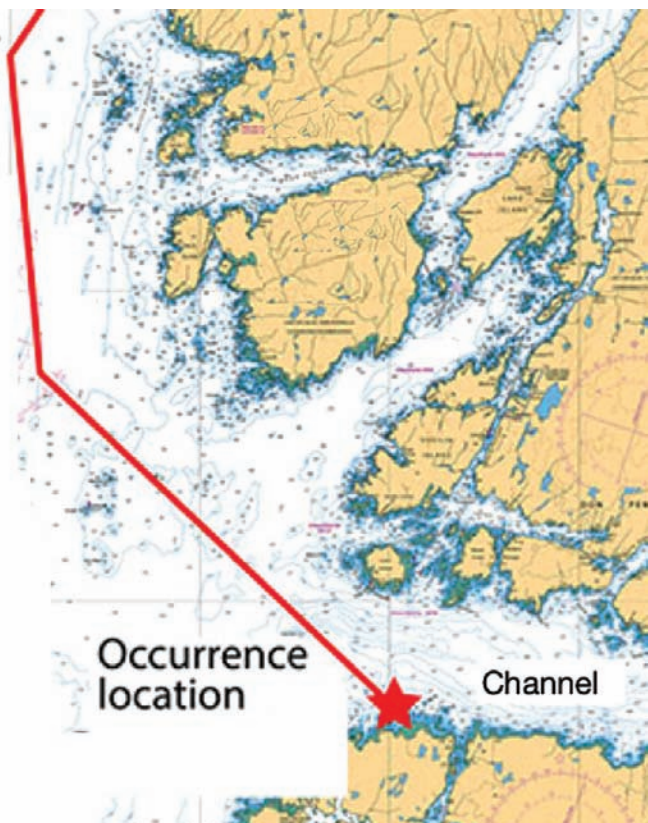
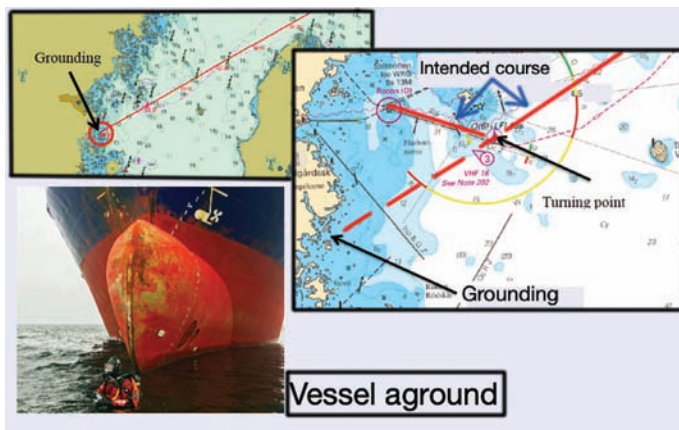
At one point the Master altered course toward the destination port. The next thing he remembered, he was woken by a call on the VHF radio. The call came from the pilot boat at the arrival port, asking if everything was OK because the vessel seemed to be in shallow water. The Master answered that everything was fine – but within a few seconds of the call, the vessel grounded. The vessel had passed straight by the arrival destination without turning to port and had continued on until it grounded.

- The BNWAS was not turned on;
- The Master was probably fatigued himself due to the two watch system;
- The Master was probably under the influence of alcohol during his watch;
- There was no lookout on the bridge during the transit.

- A 'dry' ship is a safer ship. Alcohol and ship work do not mix well;
- As in MARS202027, a BNWAS can be a helpful tool to help prevent sleep related accidents;
- As in MARS202027, being alone on the bridge at night is not best practice;
- Even though this vessel was manned according to its safe manning certificate, it was evidently understaffed for the job it was required to do in the time that was expected. So, why did the Master leave port if everyone was fatigued?

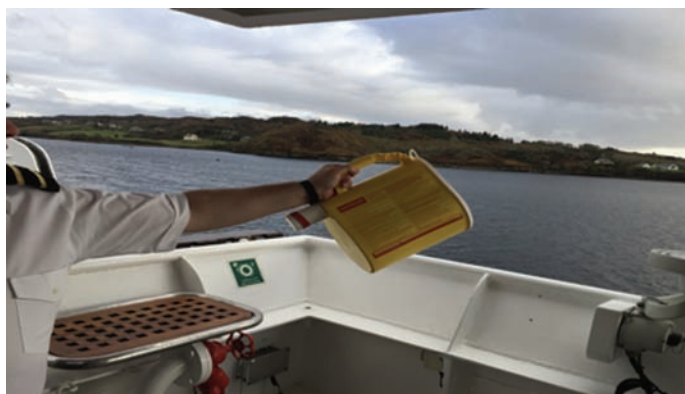
After the first LTA was discharged, it was noted that there was a danger that the line could become fouled in the ship's propellers after falling into the water. As a solution, a senior crew member suggested catching the line on its descent to speed up recovery. Unfortunately the designated crewmember caught the line too early – on its ascent. The speed and trajectory of the line caused it to cut through the victim's glove and cause a minor friction burn to a finger. The victim was immediately given first aid treatment.

The victim was new to the ship and relatively inexperienced. The suggestion of catching the line on its descent was made by a senior member of the crew and taken as an order by the inexperienced crew member.

- Young or old, experienced or not, the practice of good seamanship is often just a matter of common sense. If a suggestion or order does not make sense then it should be questioned immediately.
- Senior or more experienced seafarers must remember that they have a responsibility to supervise less experienced crew members in the practice of good seamanship and be aware that suggestions can sometimes be regarded as orders.

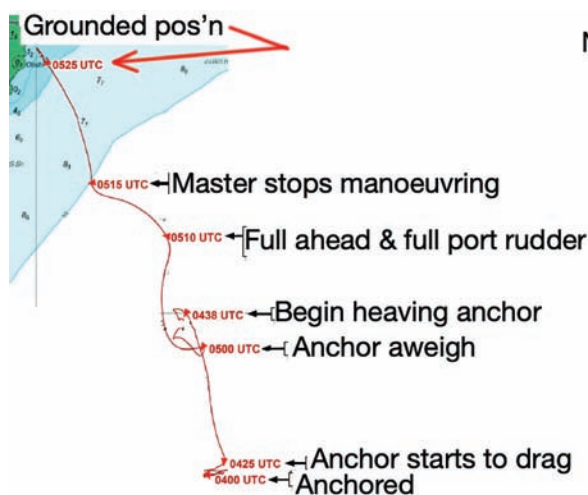
The anchor was brought in with difficulty. About 35 minutes after the initial dragging it was aweigh. The vessel started to fall beam to the wind and the Master's attempts to keep the bow into the wind and check the leeway by intermittent use of the engine were unsuccessful. When the anchor came into view an abandoned chain was seen snagged across its flukes. Once advised that the anchor was fouled by another chain, the Master stopped manoeuvring. An attempt to clear the chain by dropping the anchor and heaving it in again was unsuccessful.

By 0510, the vessel was approximately six cables off the coast on a heading of 274° and making over 2kts leeway to the north. Running out of sea room, the Master applied full port rudder and put the engine to 'full ahead' to try to turn the vessel into the wind. Five minutes later, the Master assessed that the vessel would not clear the point, which was only 0.5nm to the west, and stopped the engine. With the vessel within two cables of the shallows, the Master ordered the port anchor let go. The vessel grounded on the coast at 0525. The vessel was later refloated but had sustained significant damage.

- Anchoring on a lee shore with expected high winds should be avoided;
- The Master's decision process had possibly been influenced by the fact that the vessel was low on bunkers, another situation to be avoided;
- In situations such as these, fast and decisive action is needed. Better to lose an anchor than a ship.
