Mariners' Alerting and Reporting Scheme

MARS Report No 332 June 2020

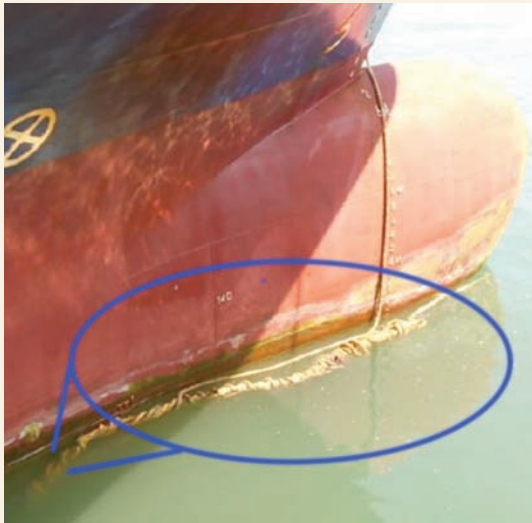
Bow thruster sucks two lines

To begin, forward and aft springs were set using the bow thruster at 70%, with the rudder at port 20° and the main engine running ahead as per pilot's instructions, in order to keep the vessel close to the berth. Next, the three head lines were passed to the line handling boat forward. Two of the head lines slipped off the bollard and more slack was payed out than needed. The lines floated on the water. Before they could be mastered by the launch personnel, they were entrained into the starboard inlet of the thruster tunnel, fouling the propeller blades.

- Due care must always be taken with lines near a working bow thruster. Ideally, lines should not be allowed to float near a working bow thruster.
- Vessels in ballast have their bow thruster tunnels nearer to the waterline than loaded vessels and are at increased risk of mooring lines being sucked in.

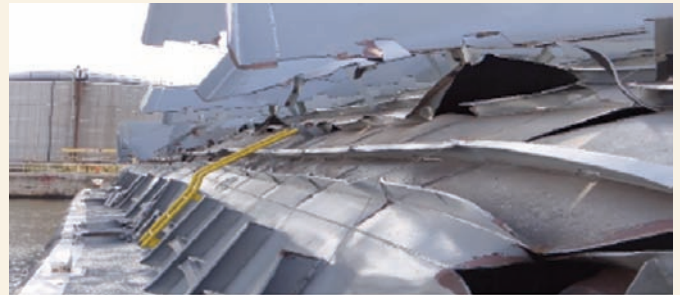
The air blowers that were recovered from the exploded tank barge had either missing or improperly maintained bonding (ground) wires. This was likely the cause of the explosion.

Breached cargo tank

- All personnel should be aware of the critical importance of bonding (grounding) air moving equipment such as blowers or fans before commencing gas freeing operations.
- Proper bonding means the contact point to the vessel or barge is clamped to bare metal, not a painted surface. Simply resting the blower/fan on bare metal is NOT an adequate means of bonding.
- Clamps used with the bonding wire or strap should be free of corrosion, with sufficient tension to ensure a tight connection when clamped to the vessel structure.
- Fans or blowers should be properly secured to prevent movement due to vibration.
- Inspect all air moving equipment before first use each day and ensure that all attached accessories (cones, ducting, etc.) are tightly connected to the blower/fan.

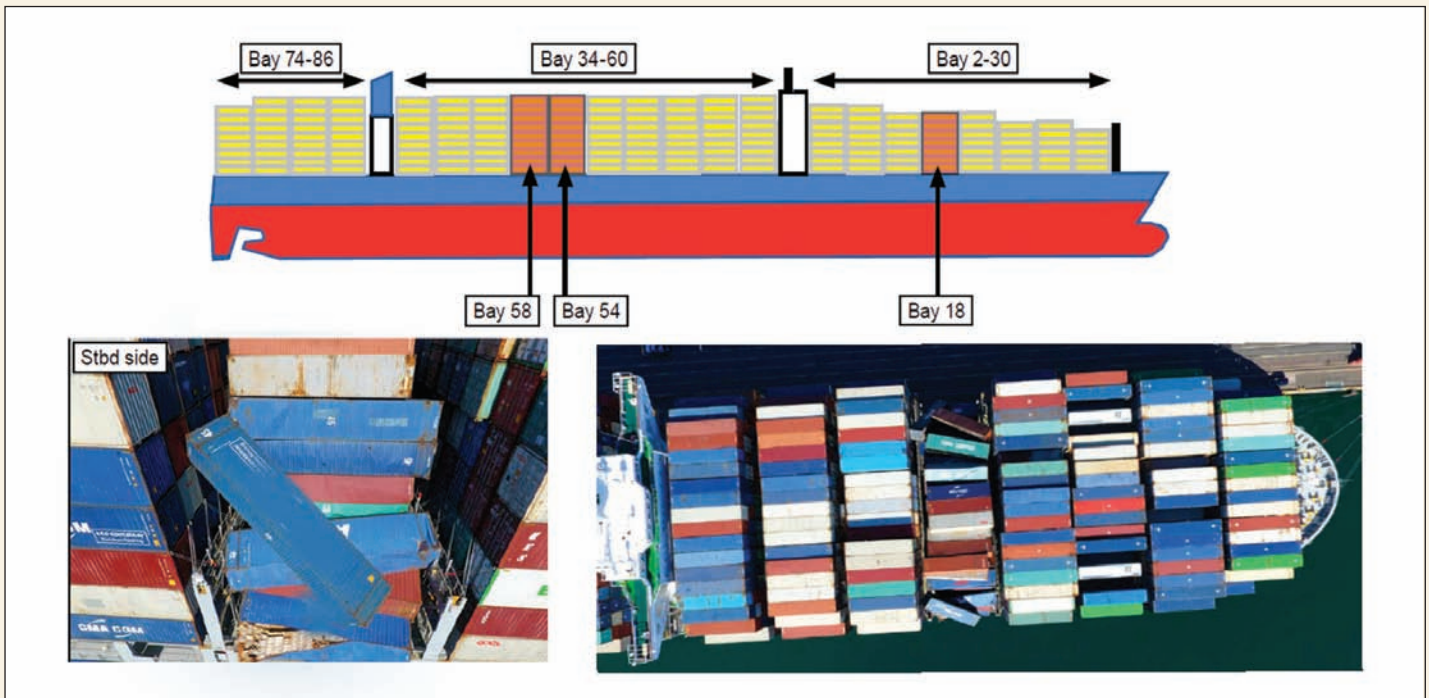
The deck lights were turned on after the large roll, but no damage was seen from the bridge and the container stows appeared to be intact. At daylight, an officer went to the weather deck with the bosun to investigate. They found that bays 18, 54 and 58 had collapsed. It was later determined that 137 containers had been lost overboard and 85 damaged.

- It is likely that the forces generated when the vessel rolled 20° to port and starboard initiated the collapse of the container stows at bays 18, 54 and 58.

- The amplitude of the ship's rolling exceeded the limits set by the company for the class of vessel.
- It is almost certain that the vessel experienced parametric rolling prior to and at the time of the container collapses.

- The cause of the collapse at bay 18 could not be determined. It is most likely that this collapse was initiated following the structural failure of one of its containers, brought about by a combination of factors including: excessive stack loads as a result of mis-stowed or overweight containers; excessive racking loads or contact between containers due to loose lashings; and/or existing damage or poor material condition of a container.

1. the wave crest amidships and the bow and stern in wave troughs.
 2. the ship is supported by a crest at the bow and stern with the trough amidships.
- IMO guidance suggests that parametric rolling may occur when either the period of roll equals the period of encounter, or the period of encounter is approximately half the roll period.
 - The risk of parametric roll in a following sea is very sensitive to minor changes in the relative direction of the sea. Large container ships are particularly vulnerable to parametric rolling due to their length and fine hull form.
 - If you work on a vessel equipped with a motion monitoring, forecasting and decision support tool, ensure you are fully conversant with its functionalities.

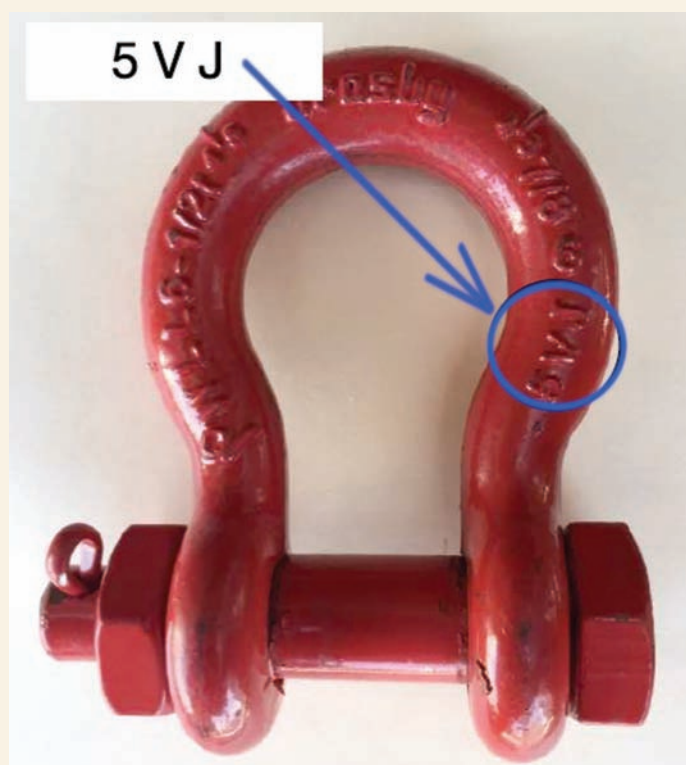
→ The Crosby Group has determined that certain shackles have a condition that can reduce the ultimate load capacity from the published catalogue values. Continued use of these shackles may result in unexpected failure. These products are 7/8" 6.5t shackles with Production Identification Code 5VJ, as illustrated below. These products should be taken out of service immediately.

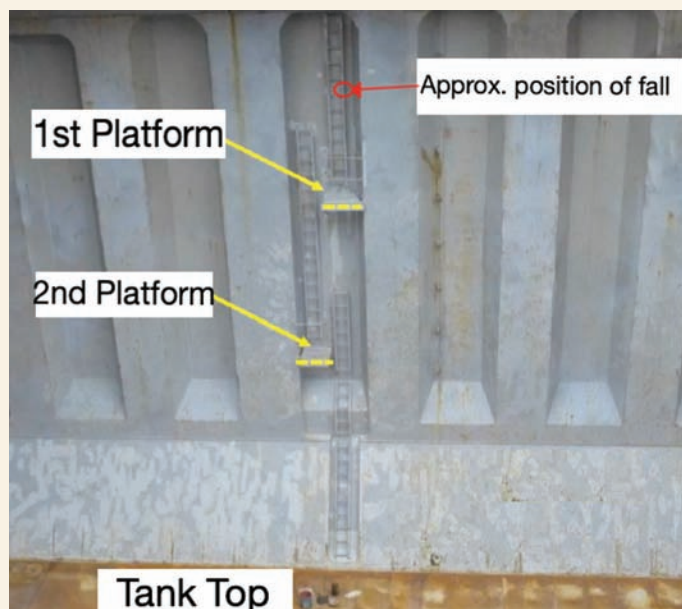
The washing team completed the cleaning of holds one and two by the end of the first day without incident. The next day, washing of hold three was commenced. A crew member standing on the first platform started climbing up the vertical ladder to reach the main deck. He slipped and fell to the bottom of the cargo hold, about 12 metres below.

The investigation found that there was no securing arrangement to which to fasten a safety harness lifeline. Because of this, it was common practice for the crew to climb up and down the ladder without securing the safety harness lifeline to any point and without any fall arresting device. A damp and wet cargo hold, wet gloves and a ladder slippery with seawater from the wash were probably contributing factors to the fall. The risk assessment carried out for cargo hold washing operations did not identify the risk of falling from height during climbing up or down the vertical ladder.

- As is often the case, hazards remain in plain sight but go unseen by crew who have become desensitised to them. In this case it was accepted practice to climb up and down the hold ladder, which was not fitted with a cage, without fall arrest or safety lines.
- Another indicator of this particular fall hazard going unseen by crew: the hold washing risk assessment did not mention this risk.
