Mariners' Alerting and Reporting Scheme

MARS Report No 333 July 2020

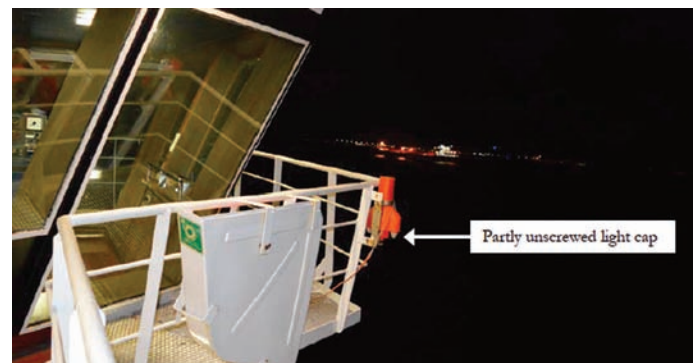
The investigation determined that the slipper that was found beside the starboard side lifebuoy release station belonged to the OOW. The other slipper was not found. The light cap on the lifebuoy was partly unscrewed. One of the light caps and two O-rings from the port side lifebuoy were found on the chart table on the port side of the bridge. The light bulb was mounted on the smoke signal and showed no sign of being defective.

The guard rail at the lifebuoy release station was 103 cm in height with two intermediate bars set at a distance of between 20 and 30 cm below. The buoy was mounted on a steel bracket by the passageway on the outside of the guard rail stanchion, which made it inconvenient to access. The only way to get a complete view of the lifebuoy was either to lean over the guard rail or to kneel on the grating to look between the intermediate bars.

The OOW was 173 cm tall, which would make it difficult for him to lean over the guard rail without stepping up on the intermediate bar. It is therefore likely that the OOW stepped on the intermediate bar and leaned over the guard rail in order to loosen the light cap to inspect the light. In doing this he most likely lost his grip and fell overboard.

The investigation found that there was no readily available way to check the functioning of the buoy without dismantling it from the bracket. The lack of instructions or guidance from the preventive maintenance system meant that the OOW had to use his own judgement to carry out this task. The OOW presumably decided to inspect the light and smoke signal in place as removing it involved a certain risk of dropping the lifebuoy overboard, particularly when working alone.

- As a matter of course, all maintenance tasks should be the subject of a risk assessment and the actions necessary for such maintenance should be documented in a procedure.
- Never work alone if there is even the slightest chance of falling overboard.
- Wearing slippers while on watch is not a best practice. Not only do they give less than adequate traction and protection, but an emergency could be declared at any time and a watchkeeper should be properly dressed and ready to respond.

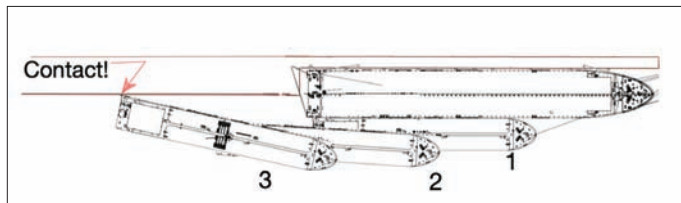
➔ A small tanker was port side to, secured alongside another larger berthed vessel (position 1). The tanker was to shift to the berth just aft of the larger vessel under the guidance of a pilot, a manoeuvre the vessel and crew had performed numerous times in the recent past. On the bridge at the time were the Master, helmsman, lookout, cadet and pilot. As the manoeuvre began, the vessel remained on the bow spring, with the rudder hard to port and the engine dead slow ahead in order to open the stern from the other vessel.

Once a gap astern was established the bow spring was released and the vessel started to go astern with the bow thruster running at 50% to starboard with engine dead slow astern and rudder midships (position 2). Suddenly, a gust of wind arose from the starboard side and the tanker’s bow was pushed towards the berthed vessel. In reaction, the bow thruster was put to full to starboard and the engine slow ahead and then half ahead with rudder 20° to starboard. However, the vessel’s stern was now too close to the pier and contact was made at about one knot (position 3).

- Use of tug?
- Allow more of a gap to develop between the vessels before coming astern?
- Less speed astern?

Hindsight is 20-20. Try and envision your manoeuvre before you undertake it, be conservative and expect the unexpected.

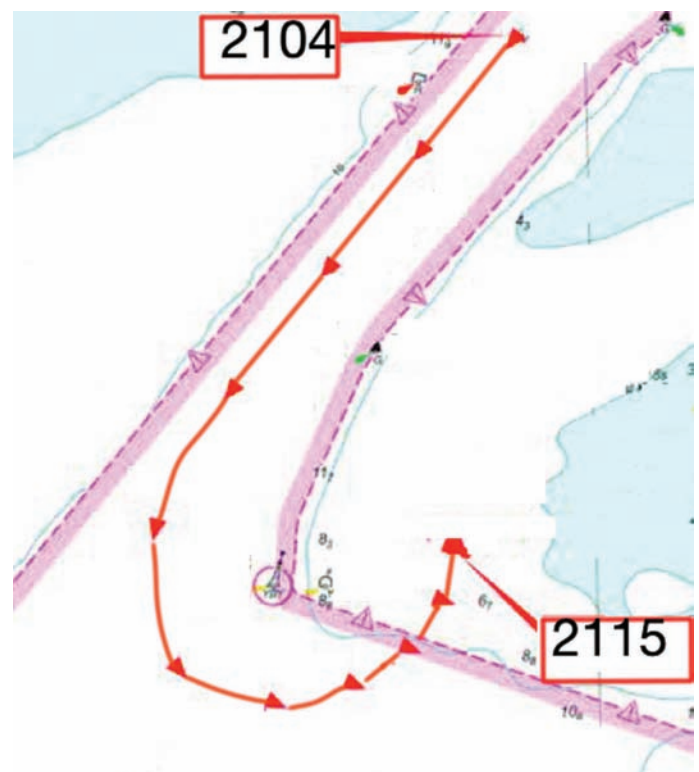
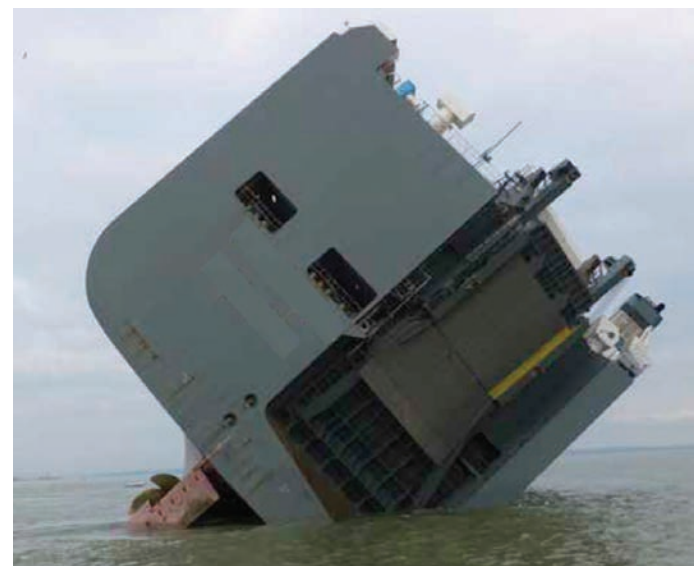
The pilot ordered 'hard a starboard' and 'stop engines'. He inquired about the vessel's GM but it was already too late. The vessel blacked out and the starboard list continued to increase as the ship swung to port and grounded, (top left) its rudder and propeller now clear of the water (bottom left). Rescue and salvage operations were subsequently undertaken.

- The vessel had inadequate residual stability to survive the port turn at 12 knots and did not comply with IMO stability requirements.
- The vessel's actual cargo weight and stowage were significantly different from the final cargo tally supplied to the ship.
