Mariners' Alerting and Reporting Scheme

MARS Report No 334 August 2020

Premature brake release spills two crew into water

Car carrier goes sideways

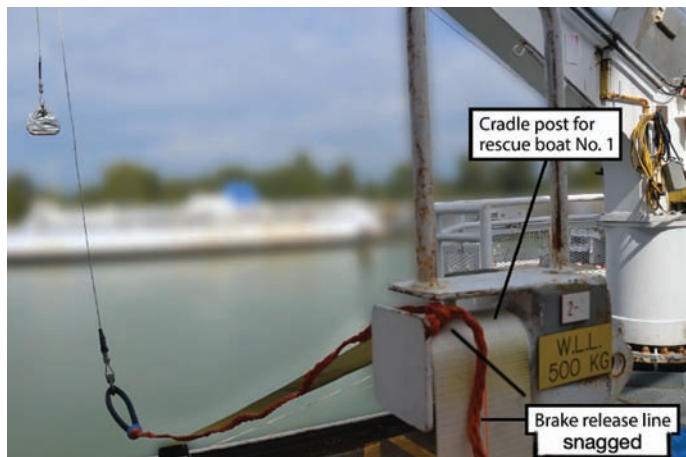
The two deckhands boarded the rescue boat, placing the brake release line bag on the deck of the ferry. They then signalled the davit operator to raise the boat from its cradle. When the boat had sufficient clearance from the cradle, the coxswain pulled the self-slewing line hanging above the rescue boat to slew the davit arm outboard. Approximately 15 cm of brake release line uncoiled from the storage bag on deck as the arm slewed. Then, the brake release line snagged on a vertical section of the cradle post creating tension on the brake release line.

As the davit arm slewed further outboard, tension on the brake release line increased sufficiently to release the brake. The rescue boat dropped, its hull hitting the raised edge of the outboard deck. It then tilted outboard to such a degree that the two men in the boat fell overboard. One fell approximately 14 metres into the water below, while the other managed to grab hold of the rescue boat's painter line four metres above the water, but eventually let go and dropped approximately two metres into the water. The rescue boat reached the water level soon after.

- The new rescue boats that had been installed on the ferry were of a greater height than the original rescue boats. Some of the rescue boat crews had developed an informal practice of removing the rescue boat's brake release line bag from its on board storage container and leaving it on the deck when the rescue boat was not self-launched.
- When the crew removed the brake release line storage bag from the rescue boat, there was no one available to take the bag from the crew, so it was left unattended on the deck.
- Although the coxswain assumed the responsibility of officer in charge of the rescue boat, his ability to supervise the launching operation was limited while he was actively engaged in his duties as coxswain.

- Any time you improvise or deviate from established procedures, risks can increase.
- Keep a keen eye for the signs of developing informal practices which insinuate themselves into established routines.

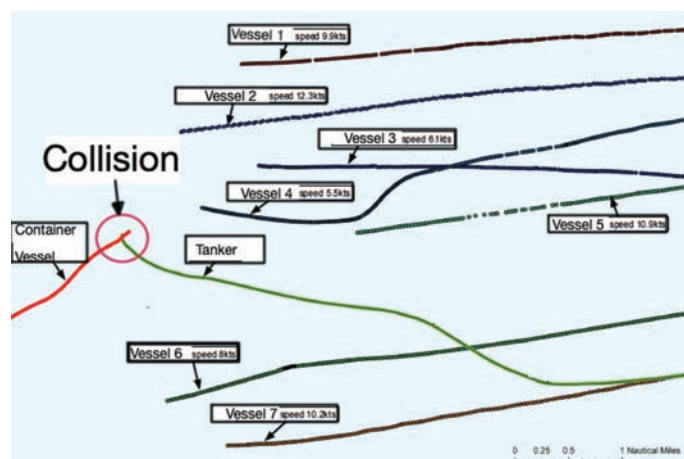
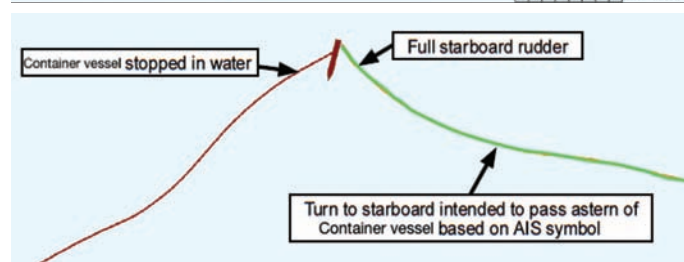
The Master also observed that the container vessel's AIS navigational status was 'underway using engine'. The tanker's OOW was monitoring the situation and noted that the container vessel's predicted closest point of approach (CPA) was 0.3 nm on the tanker's starboard side. In reality, however, the container vessel was stopped in the water on a heading of 197°. Due to the north-easterly current, its course and speed over the ground was 060° at 2.2 knots.

Just moments prior to collision, both the Master and the OOW of the tanker saw the superstructure deck lights of the container ship emerging from the foggy darkness ahead; the lights were spotted very close on the port bow. The tanker's port bow struck the container vessel's port quarter. None of the container vessel's bridge team saw the tanker, including the deck cadet, who was on the port bridge wing.

- Whether you are at anchor or drifting, don't assume other vessels will stay clear of you.
- Always keep your AIS navigational status up to date to reflect your vessel's actual condition.
- It would appear that many of the vessels in the vicinity of the collision, including the tanker, were proceeding at speeds that were arguably not really safe given near zero visibility and the density of the traffic.
- Paradoxically, even the container ship, which was drifting, could be considered as not proceeding at a safe speed because this gives very limited options for manoeuvring at a moment's notice.
- While AIS data can certainly enhance situational awareness, radar target and ARPA data should always be used in preference to AIS to determine if risk of collision exists.
- As OOW, if you perceive danger or have concerns, always call the Master regardless of the hour.

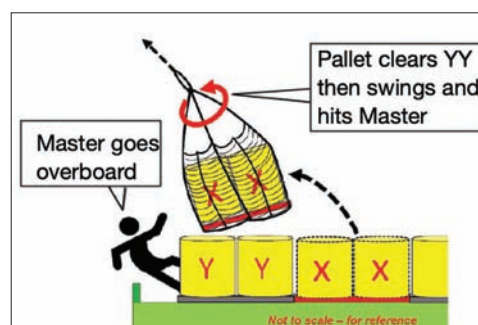
The re-supply boat came alongside the tanker and, without any lines attached, the tanker's crane's hook was lowered and the first pallet (XX in the diagram) was hooked on and the lift started. As the lift started, the re-supply boat began to veer away from the side of the tanker. The pallet, now partially lifted, was caught by another pallet (YY) on the deck of the re-supply boat. A crew member ran to the re-supply boat's wheelhouse to inform the Master to put more helm towards the tanker. The Master said he had done that, and suggested that the sheer was due to the lift coming clear of the boat's deck.

The Master then left the wheelhouse to try and help the deck crew clear the lift. The re-supply boat was still moving away from the tanker and the Master realised they needed to abort the lift. Before the lift could be lowered to the deck, it came free from the YY pallet, swinging toward the tanker and knocking the Master overboard.

The investigation found, among other things, that neither the deck crew nor the Master were wearing personal flotation devices, even though the gunwale was only 0.5 metres high meaning there was a considerable risk of falling overboard.

- The decision to transfer stores while making way at four knots was questionable. It certainly comprised more risks than stopping and allowing the re-supply boat to secure lines fore and aft to the tanker before the lifts began.
- Leaving the wheelhouse unattended to help on deck was another questionable decision. The vessel was underway at four knots and in close proximity to the tanker.
- Working on the deck of the re-supply boat, which had very low gunwales, without personal flotation devices was a clear oversight in risk appreciation – another example of 'risk in plain sight'.
