Mariners' Alerting and Reporting Scheme

MARS Report No 336 October 2020

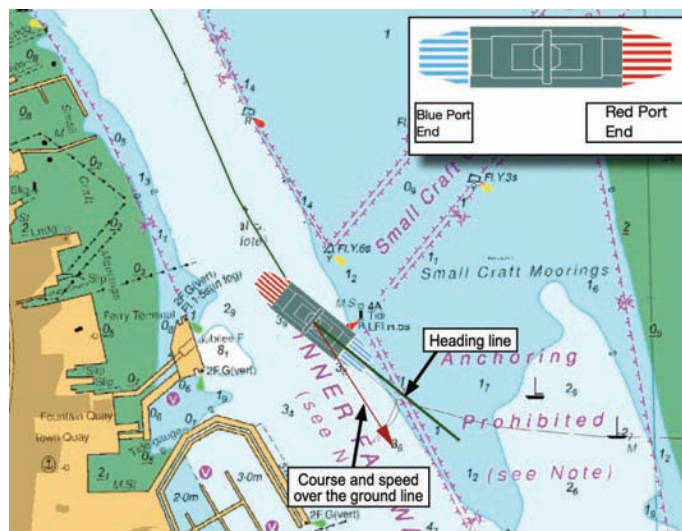
Diagram 1

As the ferry approached Blue port, the helmsman was having difficulty maintaining the required course, and the ferry started to swing to port in the channel. He immediately raised his concerns and the Master decided to take control of the vessel's steering and propulsion (diagram 1). As he did this, the visibility reduced to less than 200 metres. The assisting officer remained at the other end of the bridge and continued to relay positional information and messages from the deck lookout, whose radio calls were becoming more frequent and urgent.

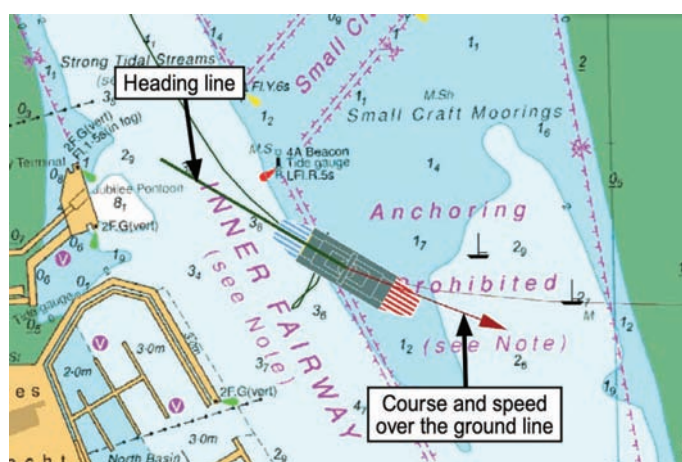
The Master managed to arrest the vessel's swing briefly but the ferry started to swing to port once again and the ferry left the inner fairway to the east. At this point the visibility reduced still further and the bridge team were no longer able to visually identify the shoreline or navigation marks. By now the vessel had turned through about 220° from its original heading and was stopped very briefly in the water, as in diagram 2.

Diagram 2 Ferry now turned 180° but heading indicator has not changed

- The electronic chart system relied on a manual switch to provide correct heading information (to properly show which end is the bow). This switch was not operated by the Master as he rushed from the Blue end console to the Red end console.
- Overcome by tasks and disorientated, the Master focused on the ECS and used the information displayed as a basis for his decision-making. The erroneous heading information being displayed supported the Master's belief that the ferry was headed back into the channel.

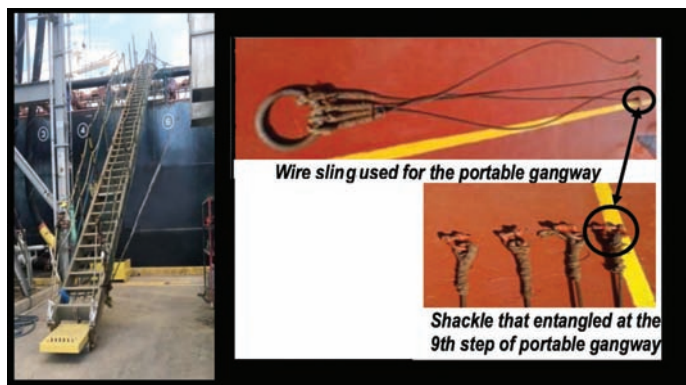
➔ A tanker was port side to at a dock and crew were installing the portable gangway. Once the gangway was in place between the ship and the dock, a crew member walked to the middle of the gangway and removed the four wire slings, motioning to the crane operator to heave up the rigging, which was connected to a single lifting ring. During the lift, one of the loose slings became entangled between the steps of the gangway resulting in its sudden movement. The crew member immediately signalled to the crane operator to cease heaving, which he did. The wire sling was removed from the step and the slings were recovered without further issue.

- Even the most common, banal tasks can harbour hidden hazards. Vigilance and attention to detail are your best defences against unwanted consequences.
- Good visual contact between a crane operator and the signaller is always a best practice.

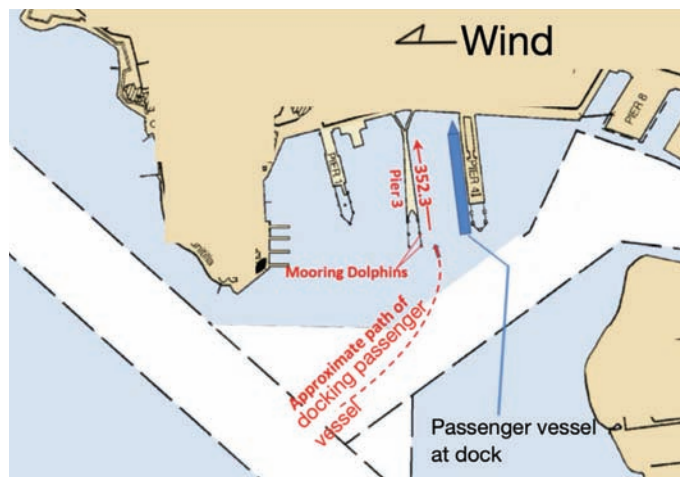
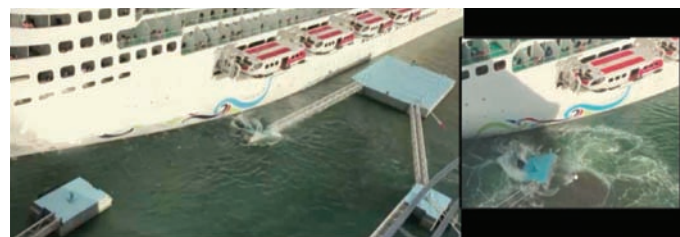
Two tugs were made fast on the starboard bow and quarter. As the passenger ship started the turn to port its speed was less than 3 knots and the Master, as planned, took the con for the docking. As the turn progressed, the pilot told the Master he would order the tugs to pull away from the dock to slow the approach. The Master was using bow and stern thrusters to manoeuvre into the space, as well as helm and the starboard engine, but sometimes these movements were in contradiction to the tug's efforts. Within about nine minutes of the Master taking the con the port side of the vessel touched the extended mooring dolphins at the south end of the pier and the catwalks that were in place there collapsed into the water.

The official report stated that the major contributing factor to this accident was a lack of communication and co-ordination between the Master and pilot.

- Difficult, tight manoeuvres are hard to accomplish at the best of times but especially when combined with a turning component. When conditions permit, vessel movements should be kept as lateral as possible.
- Although both the pilot and the Master were under the impression they had a clear, mutually understood docking plan, in reality they did not.

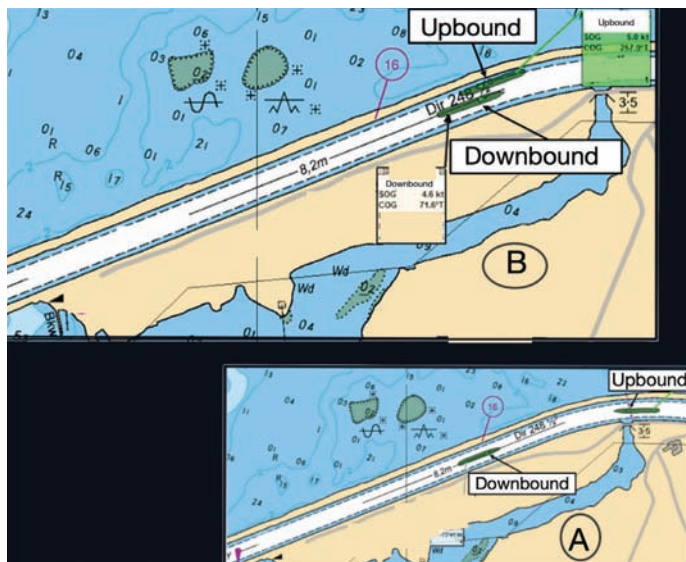
→ The bridge teams of two vessels, one down-bound and one up-bound in a narrow channel, had agreed to meet just upstream from a curve. Some time later, while rounding the curve, the up-bound vessel proceeded close to the north bank and then deviated towards the centre of the canal, as in diagram A. To correct the deviation, the bridge team altered course to starboard.

As the two vessels came abeam each other, as in diagram B, the up-bound vessel was slowly changing course to port, towards the centre of the channel. The down-bound vessel was still positioned close to the channel centre-line and maintaining its course. While manoeuvring, the up-bound vessel's starboard quarter came within approximately 7m of the north bank of the channel and made bottom contact.

- Meeting in very narrow channels takes special procedures whereby each vessel is on a steady course and almost pointed at the other. A successful meeting relies on bow pressure waves and hydrodynamics to keep the vessels apart.
- While it was mutually agreed to meet above the curve, the actual location of the meeting was arguably too close to the curve to give the up-bound vessel enough time to stabilise in a correct meeting posture.
- Once the stern of a vessel becomes close to a bank, hydrodynamic suction (bank suction) will bring the stern even closer and make bottom contact hard to avoid.

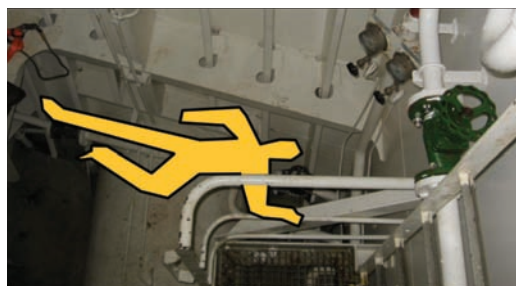
Representation of victim in BT compartment

- At the time of the accident, the bow thruster compartment's characteristics were similar to those of an enclosed space without being declared as such.
- The isolation of the bow thruster compartment's electrical supply resulted in the ventilation of that space being switched off, compromising the supply of fresh air inside.
- Although the autopsy was not available to investigators, suffocation due to lack of oxygen was deemed the most probable cause of this accident.

- Some spaces, although not officially an enclosed space, can assume those same dangerous characteristics if certain conditions are present – especially lack of air circulation.
- NEVER rush into a space that has a collapsed crew member inside. Muster the emergency team and enter with BAs.
- Practise confined space emergency procedures on a variety of compartments on your ship to determine which ones will be problematic.
