Mariners' Alerting and Reporting Scheme

MARS Report No 337 November 2020

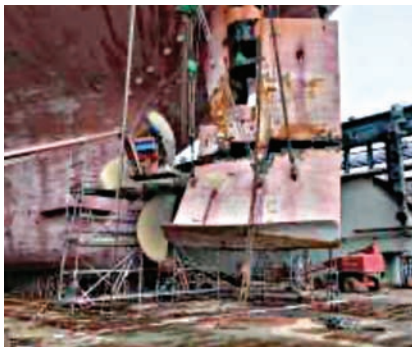
Some time later the wind reached B10/11. Crew were using the main engine to try and keep the vessel on station but they were dragging anchor nonetheless. Shore authorities were advised and tug assistance was requested. Although the tug arrived soon afterwards the Master deferred immediate assistance. The tug remained in standby mode for the next seven hours as the vessel drifted, coming ever closer to a lee shore. Finally, an attempt by the tug to pull the vessel away from shore failed with the rupture of the tow line and the vessel grounded.

Damaged rudder from grounding

- Time and again groundings from storm anchorages occur because too much time was lost before lifting anchor and putting to the open sea.
- Good seamanship means, among other things, putting the safety of the ship and crew before all other considerations.
- A vessel in ballast condition should be ballasted to its maximum before bad weather is encountered to reduce pounding and augment steerage.

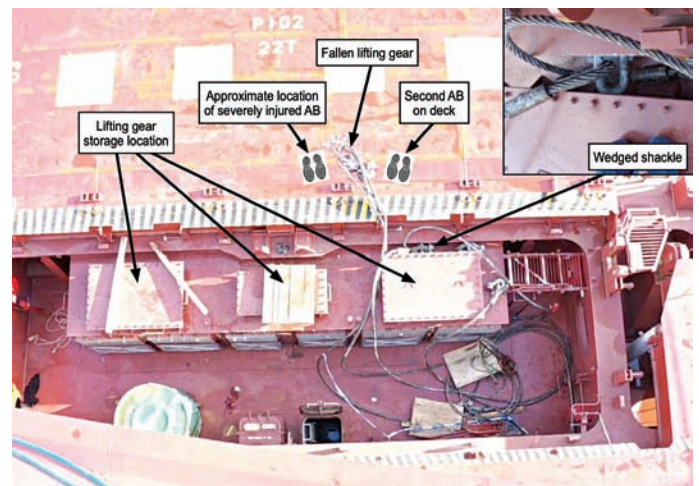
Shortly after the lifting operation recommenced, a shackle at the lower end of the load snagged on a ventilation trunk coaming. The crane operator was ordered to stop, but at the same time the fibre sling parted and the lifting gear fell to the deck, striking both crew. One suffered only minor injuries while the other suffered major head injuries and had to be hospitalised and repatriated.

- Do not stand under a load or in the fall zone!
- In this instance it appears the hazard of snagging gear was well known but crew had not addressed the hazard at the source, deciding to 'work around' the hazard at each instance. It was only a matter of time before an accident happened.

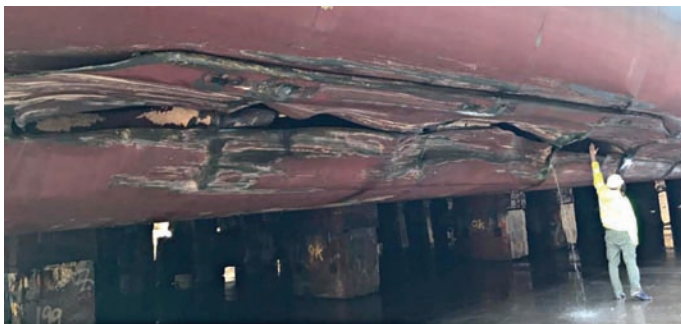
The Master applied 10° of starboard helm and the ferry started to turn to starboard. He assessed that the ferry was turning too quickly and put the helm to midships. The OOW then reported that the ferry was clear of the buoy on the port side. At about the same time, the Master realised that the vessel was further to the north than he intended. He applied starboard helm in increasing amounts to keep the ferry within the buoyed channel. Shortly afterwards, a prolonged loud noise and a shuddering vibration was heard and felt throughout the vessel (point 7 in the diagram). An inspection later determined that there was significant damage to the ferry's port side, including a 10 metre tear near the turn of the bilge; adjoining spaces had flooded to the waterline.

Bottom damage from touching channel side

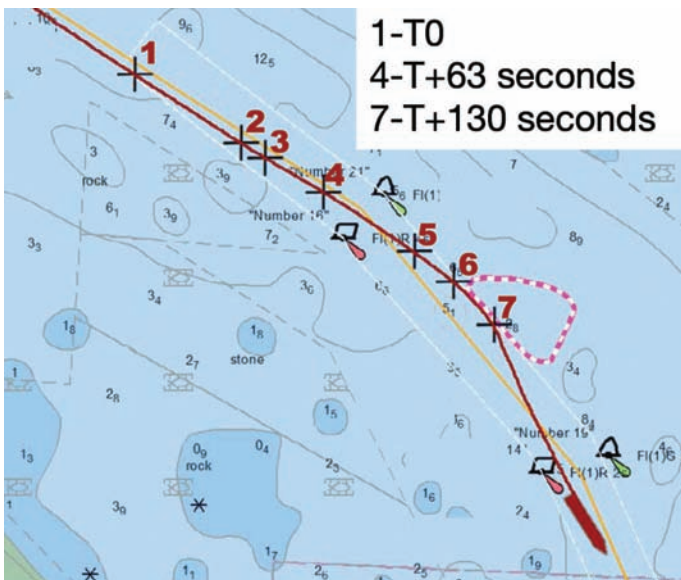
The official investigation found, among other things, that the turn to starboard was late and the Master had insufficient support from the bridge team even though they had recently completed BRM training. Additionally, the Master himself was steering by hand, which reduced his ability to maintain an overview of the situation. The lack of support from the bridge team made him a single point of failure. The navigational practices being used by the bridge team did not fully incorporate the electronic aids available and were insufficient to assure the vessel's safe nighttime outbound passage.

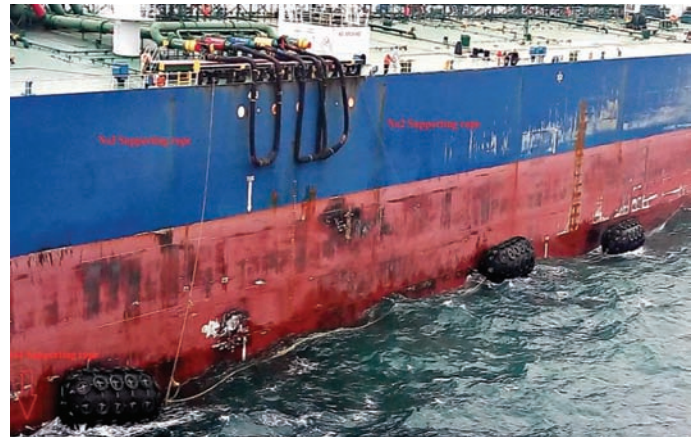
Fender arrangement

➔ A suezmax came alongside a docked VLCC to carry out a STS operation. While the hoses were being connected, a supporting rope on one of the four fenders broke. The Safety Inspector was informed, and immediately carried out a visual inspection together with vessel's staff. The vessel requested to suspend operations in order to evaluate the situation; the terminal suggested that they should continue with making hose connections as the situation was under control.

As the hose connections were being completed a second supporting rope broke. This was rectified and cargo transfer operations took place without further incident.

The investigation found that the supporting ropes for the fenders were in doubtful condition.

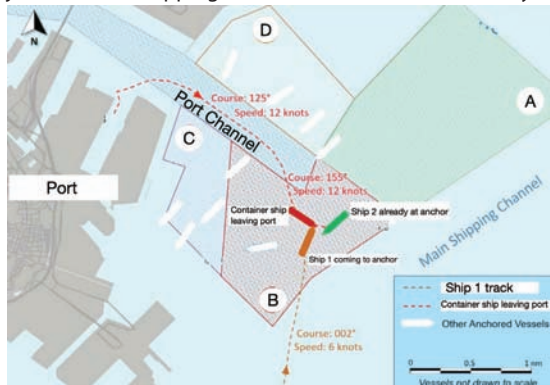
Not only were there several ships already at anchor in this area, but another vessel, 'Ship 1', was making way at about six knots from the south on a course of 002° and preparing to let go anchor. The Master's intention was to pass starboard to starboard with the approaching Ship 1 and between two other anchored vessels, one of which is 'Ship 2' (see diagram).

By now the outbound container vessel had come to port and it was obvious a collision would occur. Both vessels' bridge teams took evasive actions but to little effect. The outbound vessel hit the inbound and then careened off and collided with the anchored 'Ship 2' as well. No injuries were reported, but damages to all three vessels were over \$1 million.

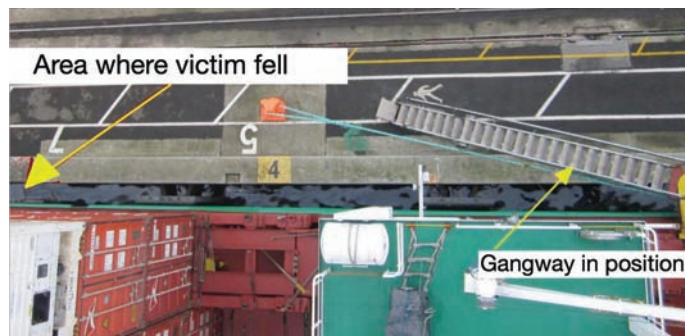
visitors attempted to disembark by stepping over the bulwark, which was almost at the same height as the quay. One of the persons fell into the water in the gap between the vessel's side and the quay. Two life-rings were quickly thrown into the water and a monkey ladder and life-lines were rigged on the vessel's bulwark.

- The visitors were tempted to step ashore by the near equality of height between the berth and the bulwark. This false sense of security and overconfidence cost a life.
- Rigorous management and control of embarkation/disembarkation is of the utmost importance.
