Mariners' Alerting and Reporting Scheme

MARS Report No 338 December 2020

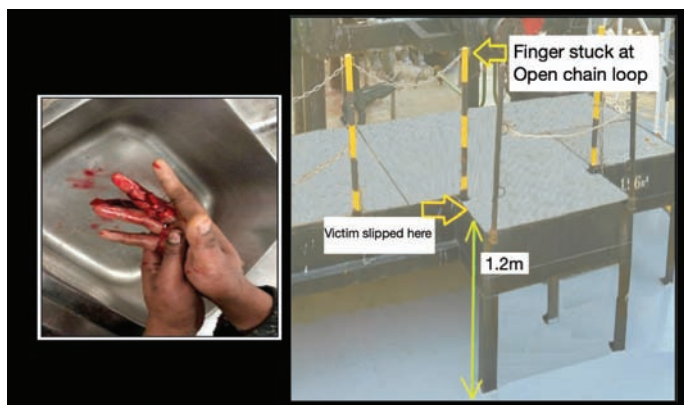
➔ On a tanker, two deck crew were given the job of re-adjusting the cargo hose. One crew was operating the hose handling crane while the other, standing on the covered cargo manifold drip tray, was guiding the suspended hose. A safety chain had been removed in order to allow the cargo hose and supports to pass through.

While adjusting the suspended cargo hose, the belt sling shifted and the crewmember tried to hold the belt in place. He was standing near the edge of the cargo manifold drip tray, and his actions caused him to lose balance. The safety chain was not in place, so to avoid falling he tried to hold on to the closest stanchion and then leaped down to the main deck about 1.2 metres below. In doing so, his right-hand middle finger got stuck in the open half link that served as a support for the safety chain. He suffered a deep cut and was given first aid and sent for shore medical assistance. The victim was repatriated for further treatment as per shore medical advice.

- Had the victim been wearing safety gloves at the time the injury could have been avoided or much reduced.
- Sometimes, safety equipment itself can be a hazard. In this case, open half-links were used to support the safety chain on the stanchions, but these can be a snag hazard. Closed loops with shackle connections would be a safer, non-snagging option.
- Do a safety audit around your ship today. Are there any hazards 'built-in' to your safety gear?

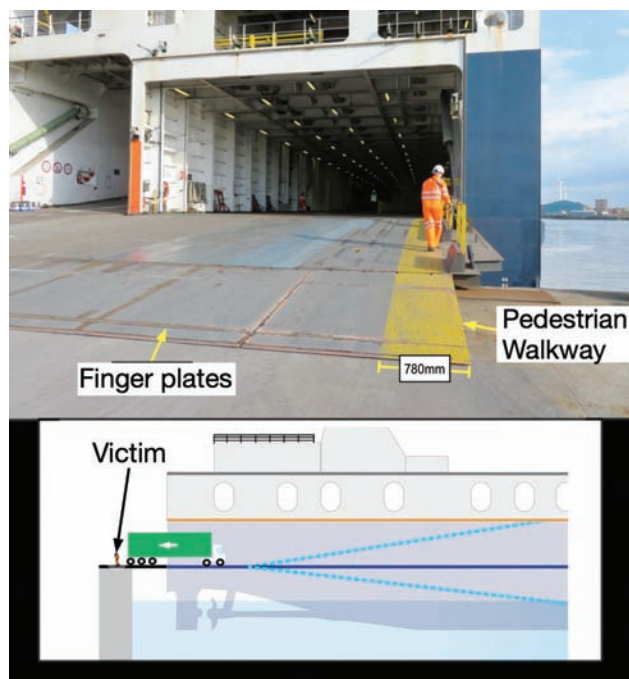
As the officer talked on his phone, he remained standing on the stern ramp's starboard side, gradually moving down the ramp towards the quay with his back to the vessel. Meanwhile, the semi-trailer being pushed down the ramp was approaching. Another tractor driver, in his cab on the quay, saw the danger and sounded his horn to give warning. Approximately three seconds later, the rear of the semi-trailer struck the victim, fatally injuring him.

The official investigation found that the tractor driver's view ahead was blocked by the semi-trailer; the victim would not have been visible to him. Furthermore, he was not expecting pedestrians to be standing on the ramp directly ahead of his vehicle. The victim had probably not heard the semi-trailer approaching as the sound of the tractor's reversing alarm and its engine would have been masked by the ambient noise of the vessel. Also, the reversing alarm would have been absorbed or reflected to some degree by the semi-trailer between the tractor and the victim, to say nothing of the victim holding a phone to his ear and being absorbed in a conversation.

- Relying on a strategy of ‘see and be seen’, with the onus on pedestrians to keep out of the way, has fundamental weaknesses. Among other things, it does not take into account the limited visibility from a cab pushing a semi-trailer or the potential for distractions.
- The potential for mobile phones to cause distraction in onboard workspaces has yet to be fully recognised and addressed by the marine industry.

- Updating loading procedure for the lower vehicle decks to ensure that discharge from the lower hold is by forward driving only.
- Updating company guidelines to prohibit pedestrians, including crew members, from being on the stern ramp at the same time as moving vehicles unless actively engaged in the loading/unloading of abnormal loads or vehicles with low ground clearance.

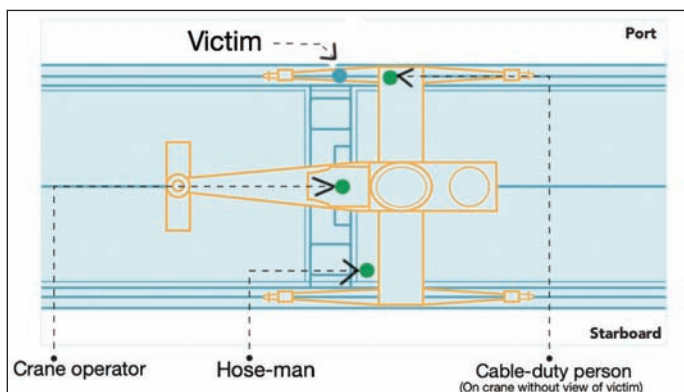
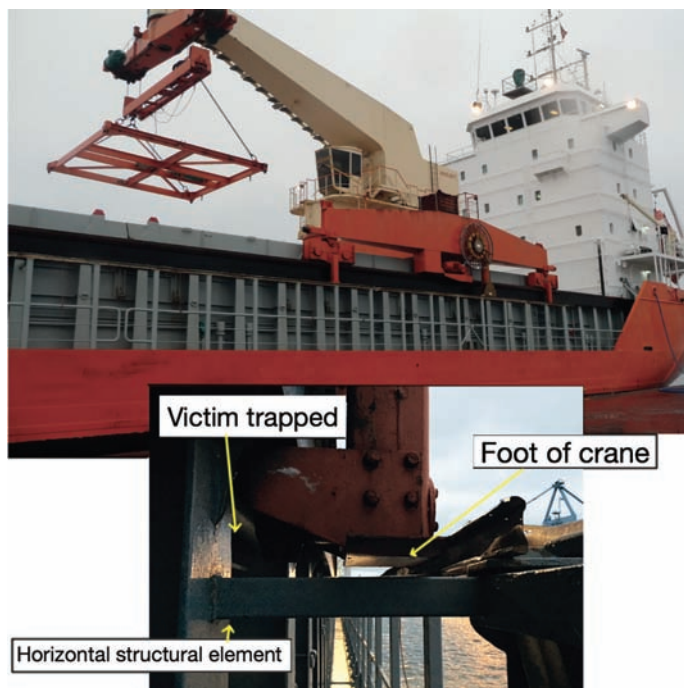
The port side was cleaned without incident and work started on the starboard side, proceeding from aft to forward. The crane operator was looking astern and the hose-man on the crane was spraying the coaming on the starboard side. The hose guide had last been seen extending the hose on the starboard side. He was contacted via his VHF, but he did not respond. Shortly afterwards, the hose guide was found lying on the deck on the port side, having been struck by the crane. Assistance was given but the victim succumbed to his injuries.

The official investigation found that it was probable that the victim had been seeking to close the cap on the hatch coaming drainage pipe, and had been struck by the moving crane in the process. The investigation was unable to establish why the victim had climbed up at exactly the moment the crane passed by.

- An audible gantry crane alarm, such as the one in this accident, is not a guarantee that all will go according to plan.
- Gantry crane operators are essentially driving blind as they often cannot see if the track is clear of personnel.
- This is not the first gantry crane accident and unfortunately probably not the last. Some additional safeguards appear necessary during gantry crane operations for the situation to become safer. Some past MARS reports can be found at 201525, 201460 and 98058.

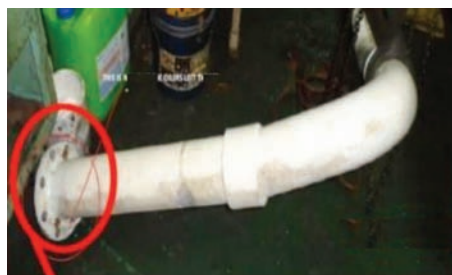
The attending crew attempted to shift the pipe to pass between the other pipes. One crew was standing in an awkward and improvised position, holding the pipe to maintain his balance. When the pipe swung clear, the flange crushed his left thumb. The victim was taken to the ship's hospital for first aid but quickly transferred to a shore hospital. After several days he was repatriated.

- Additional hazards for heavy lifting procedures in confined spaces were not accounted for as the victim was maintaining his balance in an improvised manner.
- No extra ropes were used to control and support the pipe, leading to the uncontrolled movement of the heavy pipe.

Flange / Pipe hit thumb

- Manipulating heavy objects in awkward positions requires good planning and execution to avoid bad consequences.
- 'Hands on Handle Only' (that is: only objects that have handles are to be lifted/moved by hand): other loads can be guided using tag lines and/or push pull sticks.
- This was a simple task that nonetheless resulted in a repatriation. No task is too simple to take for granted!

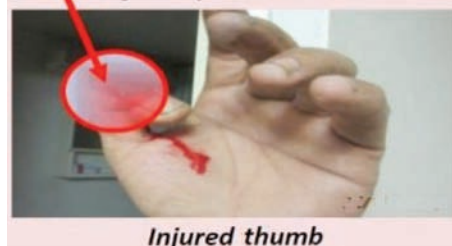
Injured thumb

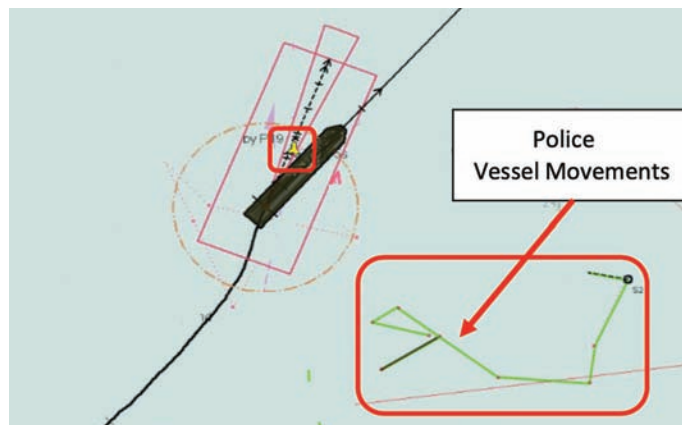
Speed was further reduced and soon the STS Mooring Master arrived along with two tugs. The tanker, now almost stopped, was affected by the NW current. Shortly after the STS Mooring Master had boarded, the tanker's port side lightly made contact with an anchorage buoy. The buoy slid aft along the hull and its chain became entangled with the vessel's propeller and rudder. The mooring and STS operation was aborted and the tanker anchored with tug assistance. The chain was cleared with the help of divers. Some minor damage to the propeller was recorded.

- Even in perfect weather conditions and full daylight, a bridge team can lose situational awareness. It is possible that the boarding of the STS Mooring Master combined with the erratic movements of the police boat and other congestion preoccupied the bridge team and caused the tanker's movement towards the buoy to go unnoticed until it was too late.
- One bridge team member should be tasked with overall situational awareness at all times, but especially when in congested waters and under close manoeuvring.

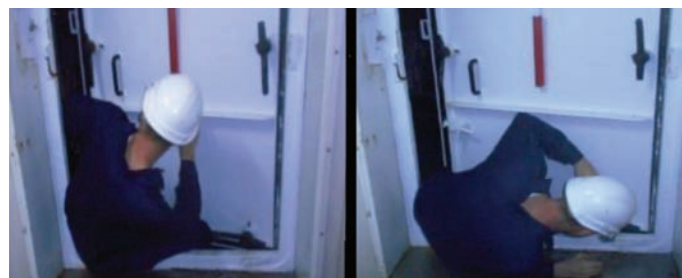
Simulation

➔ A vessel was en route in heavy weather and high winds. A crewmember attempted to exit the accommodation from the port side accommodation door on the upper deck, but had chosen the weather side of the ship. As he opened the door and stepped outside, the strong winds pushed the door back against him.

The door hit the victim in the face and he lost his balance and fell down. Two other crew observed the incident and immediately proceeded to help the victim, who was transferred to the hospital, where first aid was provided. He had sustained a gash of approximately 4cm across his face.

- Weather conditions affect almost every activity on board. Be aware!
- Always try and use the doors that are in the lee, protected from the wind.
