Mariners' Alerting and Reporting Scheme

MARS Report No 339 January 2021

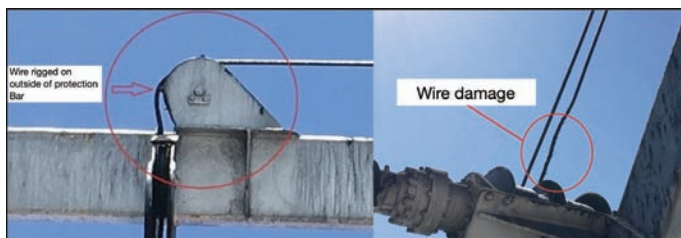
→ The vessel was at anchorage and a lifeboat drill was scheduled. The boat was lowered to the water and completed manoeuvres, the boat crew exited the lifeboat and recovery commenced. As the lifeboat was raised an officer noticed damage to the davit wire near the port side upper sheave.

The investigation found that the davit's wire had been incorrectly fitted to the davit sheave. It had been fitted on the outside of the sheave protection bar instead of between the protection bar and the sheave. This defective rigging had caused the wire rope to rub against the bar, which resulted in damage.

The lifeboat davit wire ropes had been installed two months earlier in dry dock. The defect had gone undetected during the load-test after installation and the boat had not been lowered since the test.

- As lifeboats are raised or lowered it is always prudent to sight the wires and check for defects.
- During dry dock maintenance many projects are often in progress simultaneously and at a rapid pace. In many cases, jobs are undertaken by shipyard crews who have less experience than vessel crews. These factors increase risks, so extra prudence is needed on board in the weeks and months after a dry dock.
- To minimise risks during drills, lifeboats should be raised without crew whenever possible.

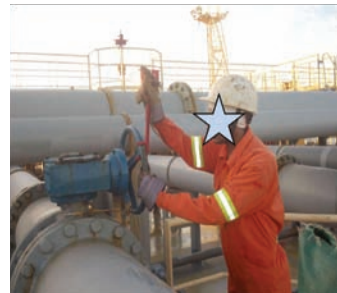
→ A berthed tanker was discharging cargo and a deck crew member was assigned valve operation duties at the manifold. While applying force using an 'f-spanner' on one of the valves he slipped. His face hit the valve spindle with some considerable force causing an injury to his upper lip.

Opening the valve

Slipped

The company investigation found that, among other things, he had not assumed the proper position for the task. This was linked to his lack of experience and inadequate training for this particular job.

- When investigating for cause, always go deeper than the unsafe act. In this case the unsafe act of not being properly positioned was linked to the unsafe condition of inadequate training.
- All hazards related to a particular task should be explained to new crew. Proper training would include the execution of the task while under supervision.

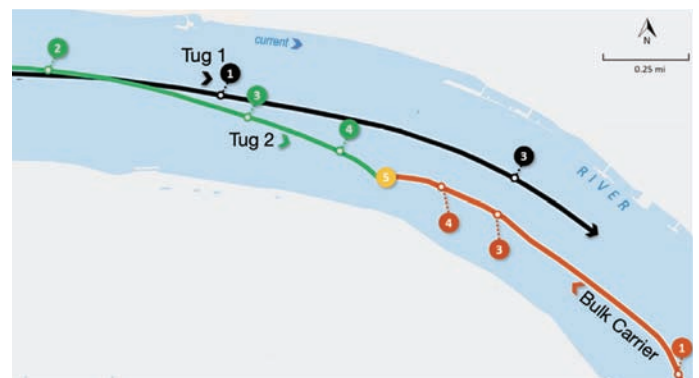
On the bulk carrier, the pilot assumed the second down-bound tug would require the same meeting as did the first, that is starboard-to-starboard. However, this was not the intention of the tug operator and he did not call the bulk carrier to make his intentions clear. For the next

85 seconds the situation continued to develop in an ambiguous manner until the bulk carrier pilot called the tug to confirm what he thought would be a starboard-to-starboard meeting.

The tug operator was taken by surprise by this suggestion, as he had assumed a port-to-port meeting. In his opinion the vessels were now too close to execute a starboard-to-starboard meeting safely. He initiated an emergency avoidance manoeuvre to starboard without informing the bulk carrier's pilot. About 30 seconds later the two vessels collided.

- This is one more example of a vessel operator making an assumption about the intentions of another vessel operator which has led to a bad outcome. To reduce risk in this sort of situation, clear and unambiguous communication is essential.
- Follow the rules! In this case the operator of the second tug should have called the up-bound bulk carrier and confirmed the manner of passage. Had he done so in a timely manner the collision would have been avoided.

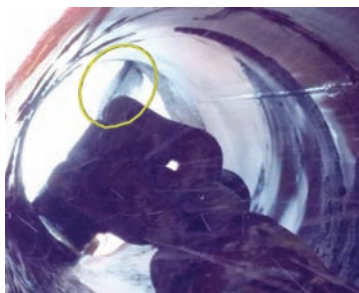
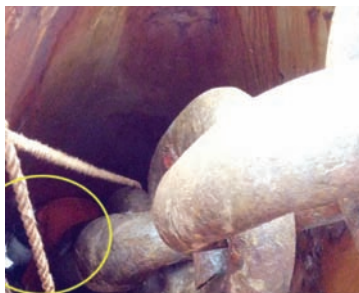
➔ A bulk carrier in ballast weighed the port anchor and departed the anchorage for a sea passage. As the anchor came into view, it was discovered that the flukes were not positioned properly. Heaving was stopped, but not before one of the flukes entered the hawsepipe and became stuck. The anchor was secured in that position and the vessel left the anchorage for the sea passage.

Top: stuck fluke
Bottom: Crew member pinned in hawsepipe

The next day, a support was welded inside the hawsepipe so that a hydraulic jack could be used to move the chain in the hope of dislodging the anchor fluke. A crew member entered the hawsepipe to position the hydraulic jack against the anchor chain and started operating the jack to move the anchor chain. Suddenly, the anchor chain moved with a jerk and pinned the man against the wall of the hawsepipe.

- The early plan of sending a crew member over the side at the bow while underway was a clear signal that improvisational and unsafe practices were being employed.
- Stand your ground. In this case the chief mate was not in agreement with the practices used and refused to participate. The Master, uninhibited by the chief mate's warnings, continued the various attempts that eventually cost the life of a crew member.
- When a new challenge arises it is best to use cool heads to analyse all risks and benefits. In this instance it would have been evident that sending a man over the side at the bow while underway or having someone enter the hawsepipe were dangerous acts that could not be justified.

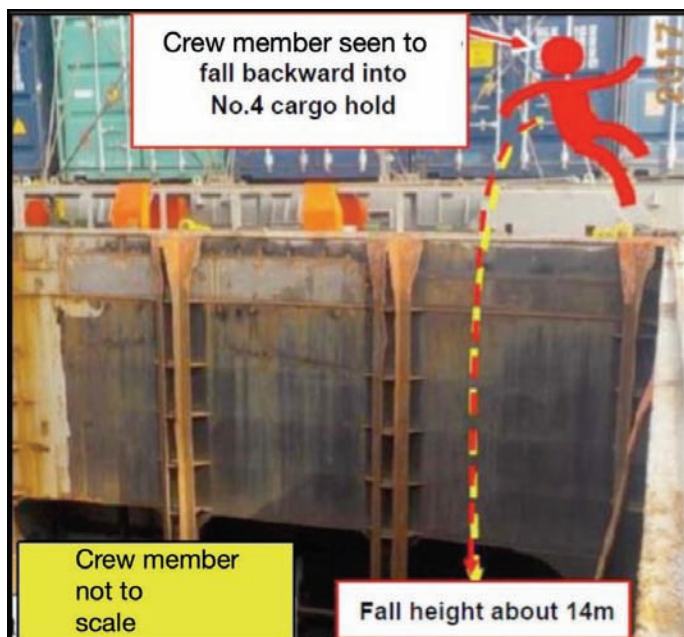
Suddenly, the crew member was seen to trip backward and fall into the empty hold number 4, a distance of about 14m. He remained motionless at the bottom of the hold and an evacuation procedure was initiated. Later that day he was pronounced dead at the shore hospital.

The ensuing investigation was unable to establish why the crew member was walking on the raised catwalk near the open hold. However, it was found that there were no barriers to prevent falling and that the narrow (70cm) catwalk was littered with loose securing gear that made walking on that surface hazardous.

- A combination of wet and cluttered surfaces and a lack of fall barriers resulted in a very hazardous work area. Then, the crew member made his fatal decision to enter that area without fall-arrest equipment.
- We do not always make the best and safest 'on-the-spot' decisions. This is why strong procedural integrity and a robust safety culture are important safeguards against negative outcomes.

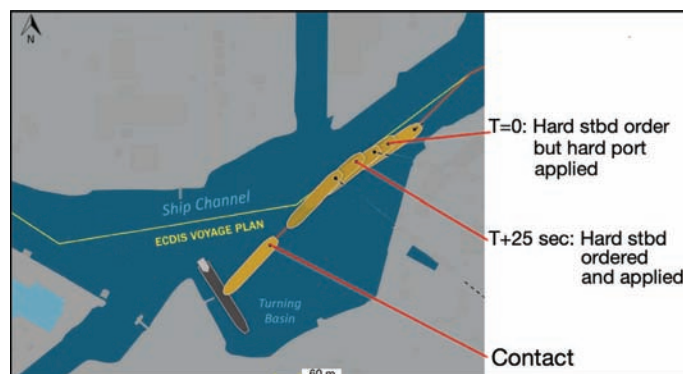
right, 24 seconds later, was 'hard starboard'. The helmsman repeated the pilot's order but instead put the rudder hard to port.

With the port anchor and two shots of chain deployed, the vessel nonetheless collided with the port side of a berthed tank barge while making almost 4 knots.

The investigation found, among other things, that the helmsman had probably been fatigued by carrying out extra duties the day before and that this contributed to the accident.

- When in restricted waterways the helmsman's actions should always be verified by same-time sighting of the rudder angle indicator. A wrong rudder application may be irrecoverable if left for even 10 seconds.

- The OOW was apparently not sighting the indicator at all and, if he was, he did not indicate the wrong rudder application to the pilot. The pilot was sighting the rudder indicator but only after a 10- or 11-second delay. In the first instance they were able to recover, but not in the second.

- The work-rest log did not indicate the helmsman's extra duties the day before. When collecting data for fatigue, investigators should not restrict themselves to looking at the work-rest logbooks, but should also question each person in detail about their previous 72-hour, or preferably 96-hour, work-rest routine.
