Mariners' Alerting and Reporting Scheme

MARS Report No 340 February 2021

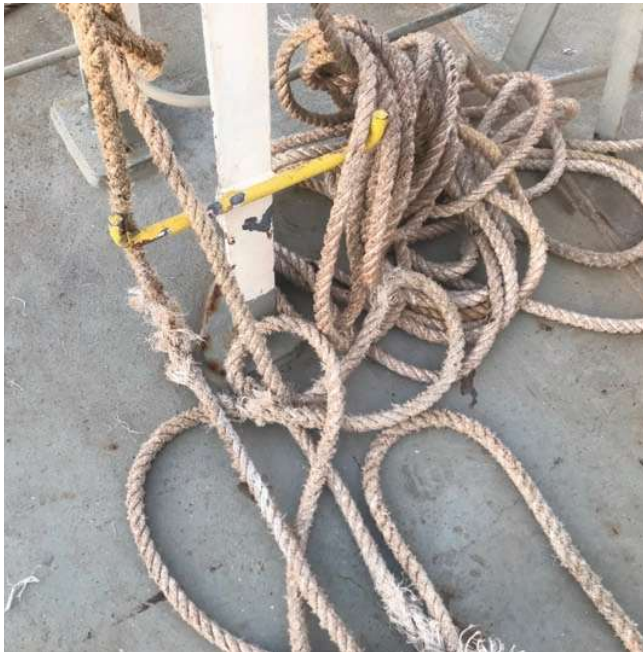
→ A pilot brought a large bulk carrier alongside. Once berthed, he descended to the main deck for disembarkation. The crew were in the process of rigging the gangway which was now swung out and some 15 metres above the wharf. The pilot saw two crew members on the gangway with safety harnesses on, but the safety lines from the harnesses to the ship were not secured to a strong point. Instead, they were being held in the hands of other crew members on deck. All of the safety lines appeared in poor condition (see photo) and would probably have failed if any load had come on the line.

The pilot immediately protested to the chief officer and Master and corrections were made. The issue was reported to the local maritime safety authority as a safety and crew competence issue.

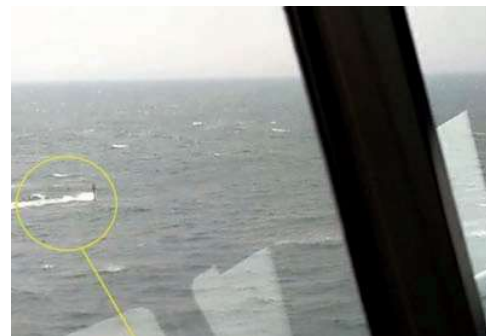
Submarine periscope as seen from ferry

As it turned out, the submarine's command team had made several errors that each contributed to the close quarters situation. The approach speed of the ferry was under-estimated (taken as 15 knots instead of 21) and the ferry's range was overestimated. Both of these errors contributed to another critical error on the part the submarine's command team to remain at periscope depth instead of deep diving out of harm's way.

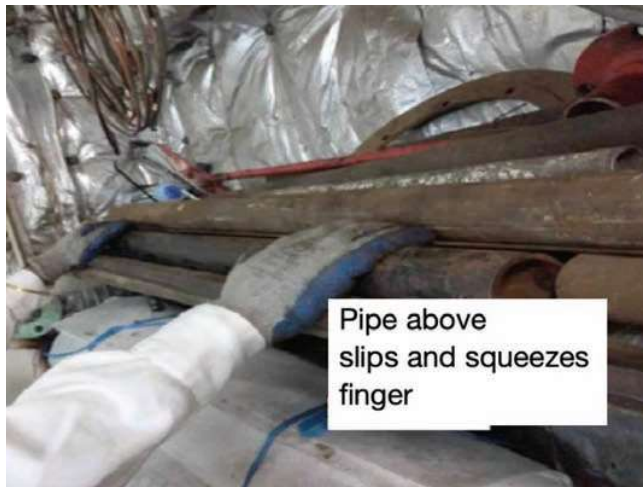
→ An engine room crew member was in the vessel's workshop when he spotted an unsafe condition. One of the pipes stowed against the workshop bulkhead was protruding out sideways from the storage support.

He attempted to rearrange the misplaced pipe, but as he was doing so, another pipe stowed above slipped from the pile and crushed his index finger against the pipes below. Upon removing his gloves, the crew member found the fingernail had sheared off along with the skin from the index finger. He received first aid and was put on rest routine.

- It should be second nature for crew to carry out on-site risk assessments to avoid unnecessary injury while accomplishing tasks: the mundane as well as the extraordinary.
- Seek assistance from fellow crew members for tasks involving lifting or shifting of heavy weights.

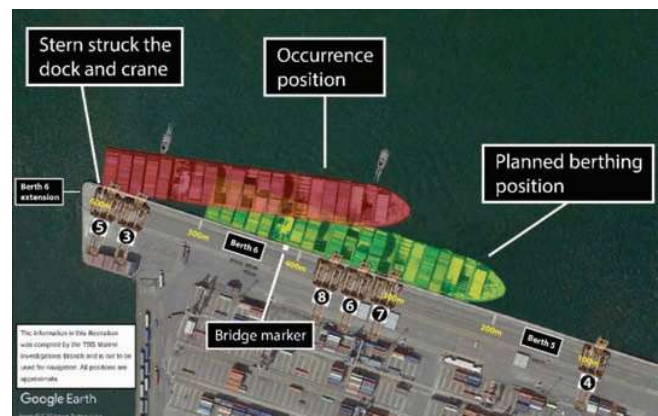
The Master attempted to alert the pilot to what was going on. At the same time, the pilot ordered the bow thrusters full to starboard, the engines dead slow ahead, and the helm hard to starboard. However, with the tugs still operating at maximum power in the wrong direction there could be no stopping the pivot. With the vessel now at an angle of about 10 degrees with the berth, the flared stern struck the quay and made contact with one of the shore cranes which collapsed inwards toward the terminal, the boom falling onto the vessel.

Although ultimately the collision was caused by human error, the investigation also found that there has been an increase in the size of container vessels berthing at the port over the last decade, and no corresponding upgrades to the terminal such as more appropriate fenders.

- If effective bridge resource management (BRM) is not maintained by bridge teams, including pilots and tug Masters, there is a risk that errors will go uncorrected and cause unwanted consequences.
- Some port infrastructure has not kept up with increases in vessel size and mariners should be aware of these inconsistencies.

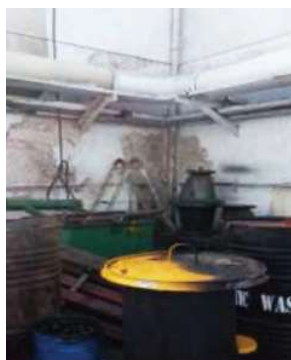
➔ A vessel had just left dry dock and was underway to another port for bunkering. In the late afternoon, a fire broke out on the poop deck in the area used for garbage collection. Within minutes the fire party mustered and was able to extinguish the fire without further incident.

The company investigation found that a quantity of combustible material, such as craft papers and plastic covers used to protect the ship's alleyways while in dry dock, had been left on deck and not secured in closed containers. A soot-blowing procedure was undertaken while underway, and it is probable that hot embers ignited the loose garbage.

- Loose garbage is always a hazard, for fires but also for safety and cleanliness.
- Certain activities, such as dry dock, can leave inordinate amounts of waste on board. Proper planning can alleviate this hazard.
- Soot blowing can introduce fire hazards on deck and company procedures should take this into account.

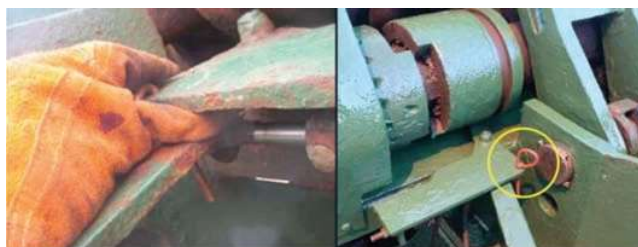
➔ A vessel was proceeding to anchor and some deck crew were forward at the windlass. One of the deck crew was removing the gear lever pin while another crew operated the hydraulic lever. Unfortunately, the victim's fingers were not clear of the lever pin as he withdrew it, and a finger got trapped in the space between the gear and frame, requiring first aid.

Finger crushed

The company subsequently re-engineered the pin with a simple eye on top, enabling the pin to be removed from top of the lever without the operator putting their fingers between the lever and frame. This improvement was applied to all similarly equipped ships in the fleet.

New Pin
