Mariners' Alerting and Reporting Scheme

MARS Report No 341 March 2021

In this issue of MARS, we would like to highlight some of the risks posed by fires and firefighting on vessels. It is hard to imagine another trade or industry where workers are expected not only to do their regular work but also to be expert firemen too – yet as seafarers our lives may depend on it!

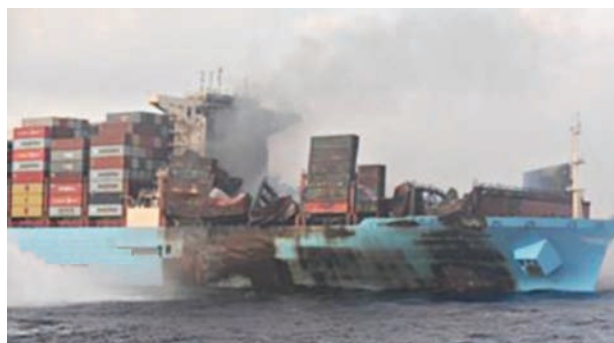
The official investigation found, among other things, that no. 3 cargo hold contained a block stowage of 55 containers of sodium dichloroisocyanurate dihydrate (SDID). It is possible that the cargo in one or more of these containers underwent self-decomposition. The block stowage exacerbated the rate of reaction and heat production which resulted in the uncontrollable spread of the fire.

- The complexities and interconnected risks of large modern container ships, including loading of certain dangerous cargoes below deck, may have outstripped the current accepted best practices and fire fighting arrangements, not to mention fire fighting training of crews on these ships.
- One example of the above: how are the crew to safely close all of the ventilation flaps manually when heat and smoke are present? In this case it was not possible. Although this arrangement conforms to class rules, maybe it is no longer suitable.

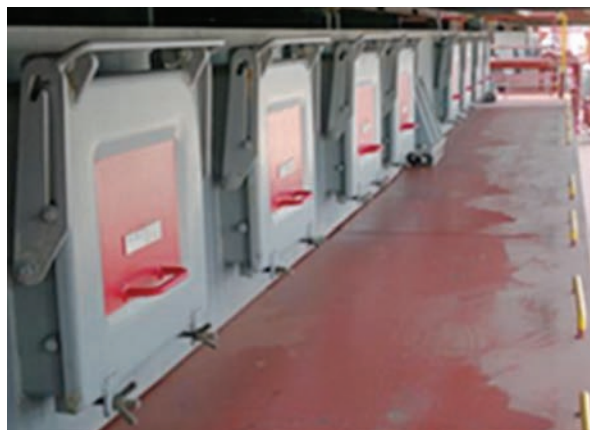
On the starboard side main deck, crew closed all 16 natural ventilation flaps for hold 3, but were unable to complete this task on the port side due to heavy smoke and heat. Some of the crew reported a strong chlorine-like smell while closing the ventilation flaps on the cross deck, and suffered some breathlessness with itchy burning sensations.

Natural ventilation flaps (Sister ship)

- It is important to close the ventilator flaps/dampers in the accommodation and machinery spaces for the protection of the crew, even for an under-deck cargo fire.

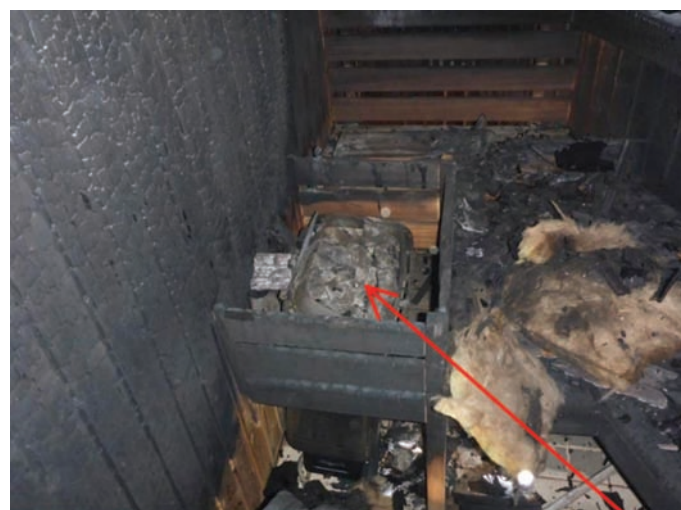
By approximately 1745, the heat and smoke from the fire was dissipating. It was considered likely that the fire was contained within the sauna and smouldering. Once the fire was fully extinguished, burned pieces of a wooden footrest were found below the sauna's electric heater, indicating that the footrest may have been on the heater when it was turned on. With the heater left unattended, the heat likely ignited the footrest, starting the fire.

Burned sauna and heater

- Regular fire drills, using varied and realistic scenarios, are critical to confirm that firefighting equipment is in working order and to reinforce crew's knowledge of how to use the equipment and of their assigned emergency duties.
- Post-drill evaluations in a round-table discussion with all involved are a valuable tool for quality assurance and continued improvement.
- While hindsight can be said to be 20:20, in this case it remains debatable whether the first intervention of opening the door and emptying a fire extinguisher in the general direction of the fire was effective or only gave the fire more air. Normal procedures would have put boundary cooling in effect, followed by properly dressed and equipped firefighters attacking the fire in an organised manner with a pressurised hose for full effect and safety.

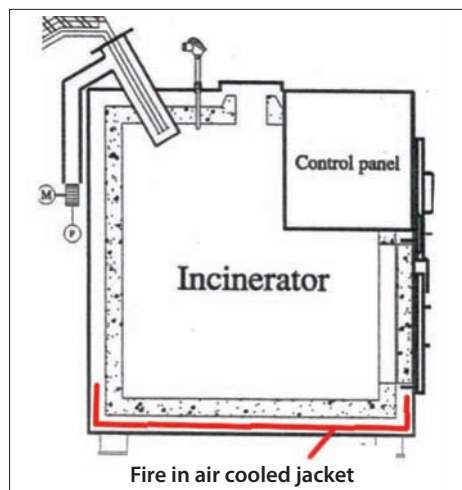
During the investigation it was found that the fire had started in the air-cooled incinerator chamber jacket. Later, it was found that refractory and outside body plates were intact. Traces of oil were found between the sludge dosing door and the combustion chamber, which was an indication that oil had accumulated in the double shell refractory lining.

- Even during the cool off period, an incinerator must be attended to and regularly checked.
- Boundary cooling and cool heads are a great asset when fighting a shipboard fire.
