# Mariners' Alerting and Reporting Scheme

MARS Report No 342 April 2021

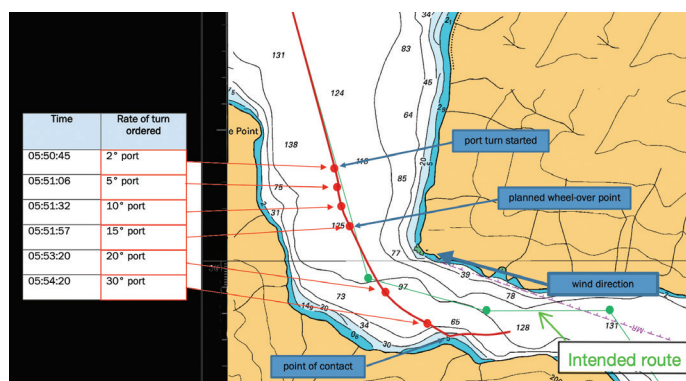
The vessel was brought to the middle of the channel while the Master and the remainder of the bridge team followed a vessel-grounding checklist. While this was happening the pilot continued to con the vessel to a safe anchorage. Inspections confirmed that the hull had not been breached although the dive survey revealed that the vessel's hull was indented along the starboard side for about 65 metres.

The investigation found, among others, that although the tracks were clearly displayed on all of the bridge equipment, at no time was a challenge voiced to the pilot until it was too late. Also, it is likely that the pilot became overly focused on the ROT thus losing situational awareness of where the ship was, where it was heading, and what other factors were influencing its progress.

- Darkness changes everything! Ask yourself, would this event have happened in daylight and good visibility?
- Correctly executed blind pilotage means using all instruments at your disposal as well as all senses. Why wasn't a parallel index used here as a backup check on the adherence to the planned track?
- Rate of turn is an excellent manoeuvring tool but under certain circumstances it is not a substitute for helm orders.

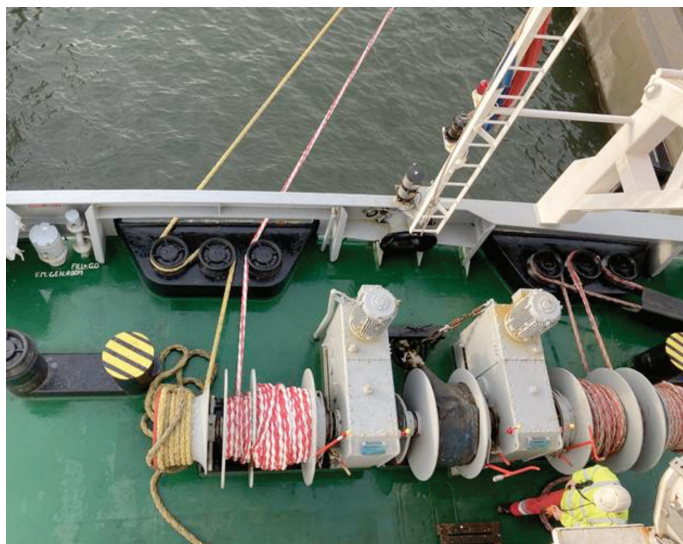
➔ A vessel was at berth and a MARS reporter who was not a member of the crew noticed some possible mooring arrangement problems. Below is a photo taken at the time.

- Improper leads of the mooring ropes around rollers including full turns and chafing situations.
- Ropes left on warping drum ends instead of being transferred onto mooring bits.
- Too many turns on the working part of the split drum winch.
- No SWL marking on mooring bits.
- Different types of ropes (so different breaking limit) working in same direction.

- Once again, new eyes can see hazards that may not be apparent to crew who are desensitised to the hazard.
- Unfortunately, poor design is also often at the basis of improper mooring patterns; something which is often overlooked during building.

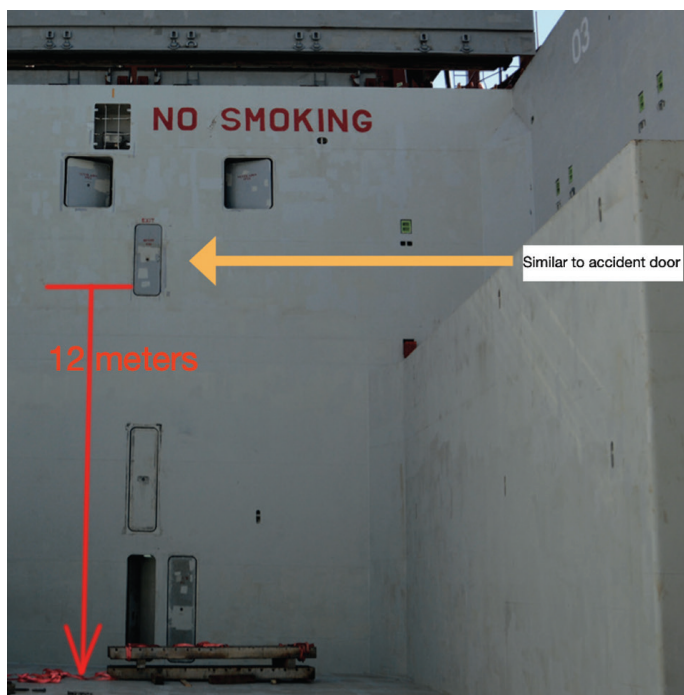
The investigation found, among others, that the victim had entered through one of the door openings in place for use with the tweendecks – even though he knew that hold 1 was now without a tween-deck. Because there was no tween-deck, he fell about 12 metres into the hold. At the moment of the accident, the lighting in the hold was not switched on and, because the hatches were closed, hold 1 was in complete darkness. The lighting in the stairwell was also not switched on and the victim was using a small torch light.

- On ships with multiple hold configurations, great care and failsafe precautions must be taken with doors leading to the hold. If these are not fully closed and locked prior to the removal of the pontoon decks, then grave accidents can occur, even to crew who are aware of the danger.
- We often become preoccupied with the task at hand. In this case the victim walked through (or fell through) a door that he knew was unsafe but had probably not stopped to think, too engrossed in his present task of search for stacking cones.
- Working in dark areas presents extra risks; always have local lighting illuminated for your work area if possible.

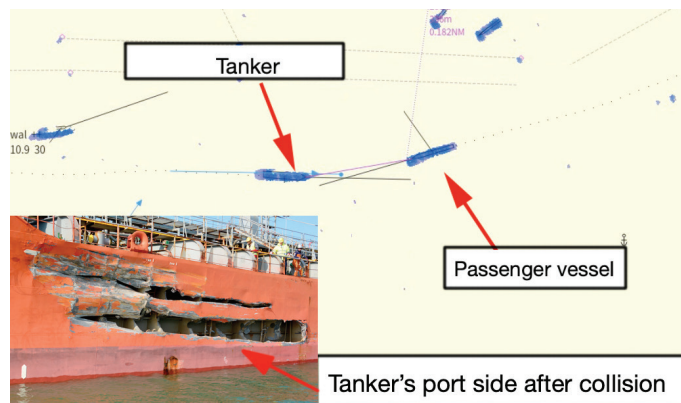
About 30 seconds before the collision (time of diagram), the pilot on the tanker issued a warning via the VHF and shortly afterwards ordered the helmsman to turn hard to starboard so that the tanker would not hit the river cruise ship amidships, which might cause catastrophic damage. In the meantime, VTS called the passenger vessel twice to turn to starboard, but without effect. Shortly afterwards, the passenger ship and tanker collided.

The investigation revealed that the crew of the passenger vessel had seen the tanker, but that based on their understanding of the communication, they believed that vessel would make a turn to port ('red side turn') resulting in a green to green passage. They had not understood that this plan had been refused earlier by VTS. The investigation also found that the English communication skills of the passenger vessel's bridge team were quite rudimentary. This may have contributed to their miscomprehension of the situation.

- Good communication is critical for safety.
- Meeting arrangements should ideally be made in good time and directly between the two vessels concerned, not through a third party.
- When in doubt, slow down.

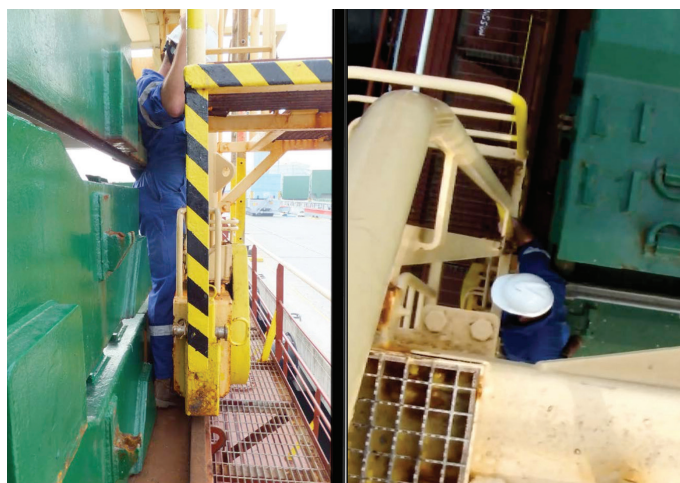
Simulation

- The victim was crushed because he attempted to walk between the vessel's gantry crane and a stack of cargo hold hatch covers. The C/O did not know that the victim was under the crane or what his intentions were because he was focused on raising the crane's lifting bar.
- The toxicology report showed that the victim had more than twice the legal limit of alcohol in his bloodstream. Almost certainly the consumption of alcohol was a significant contributory factor in this accident.

- Severe accidents involving gantry cranes are unfortunately not uncommon. The lessons learned from the past can be reviewed in MARS 201525, 201460 and 98058 for example.
- It goes without saying that alcohol consumption above the limits set for all mariners via STCW is to be condemned. Many companies have now adopted 'dry-ship' practice in order to help in the practical management of this norm.
- A strong safety culture is not a guarantee of zero accidents, but it is a bulwark against many potential bad outcomes.
- In this instance it was found that emergency stops for the gantry crane were not in sufficient number and those that were installed were badly positioned.
