Mariners' Alerting and Reporting Scheme

MARS Report No 343 May 2021

Aground, then punctured, a vessel turns sideways

Enclosed space: Deadly H₂S goes undetected and rescue attempts are haphazard

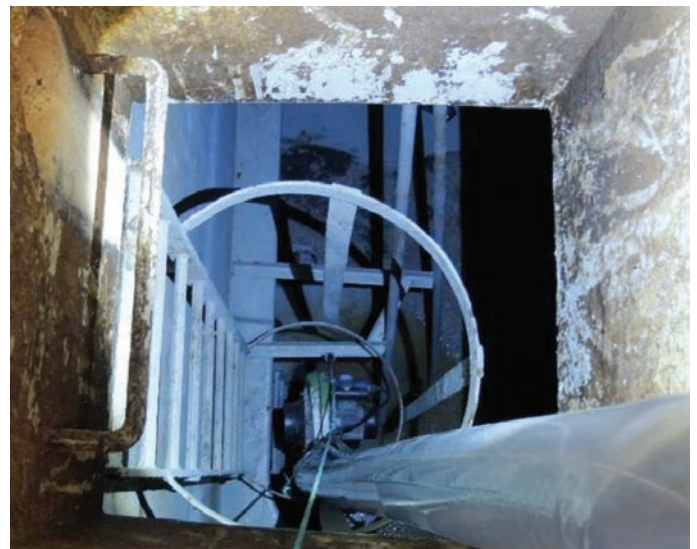
Access to silage tank

→ A factory trawler was underway and being made ready for fishing. Crew had finished cleaning the factory and were preparing the silage tanks for cleaning. Silage tanks are special compartments that contain unused fish parts that are processed into silage and later pumped ashore (used to make oil and protein concentrate used in feed for farmed fish). The tanks had last been cleaned about five weeks earlier and there was still silage residue at the bottom of the tanks. Cleaning these tanks included preparatory work such as flushing the tanks by filling them with seawater and emptying them several times and then lowering a fan into the tank to ventilate. The usual method was to lower the fan into the tank using a rope.

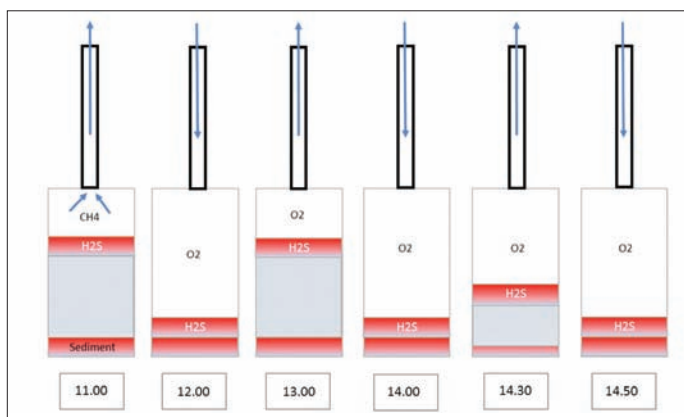
Flushing was accomplished as per the below diagram (not to scale). For the ventilation, a plastic hose was attached to the blower to channel the gases out into the open air. It had previously been a challenge to prevent the hose getting twisted when the fan was lowered, and it was decided to send someone into the hold to position the fan correctly, if safe. The oxygen level in the tank was measured by lowering an oxygen detector on a string, but it is not known how far down the tank it was lowered. The oxygen detector did not sound an alarm, and therefore it was deemed safe to enter the tank.

- The gas detector in use measured only the level of oxygen present. It was therefore not possible to determine whether the atmosphere was safe from other deadly gases such as hydrogen sulphide (H₂S) which is produced by bacterial decomposition of organic compounds containing sulphur such as, for example, the fish and fish waste in the silage tanks.

- The fisherman was probably exposed to a fatal dose (one or two breaths) of toxic hydrogen sulphide gas as he climbed down to the bottom of the tank.
- Efforts to rescue the victim from the tank were stymied by the lack of suitable equipment and training.

- SOLAS requires testing enclosed spaces with a multi-gas detector which includes H₂S prior to entry. Testing for O₂ content alone is not enough to allow safe entry into many confined spaces.

- For deep tanks, tests should be made and recorded for several levels including at the bottom.
- Another best practice is to have BA equipment ready for use at the enclosed space entrance before anyone enters that space.

- Although ventilation is more efficient using a positive pressure approach (fan pushing fresh air into the compartment), when circumstances dictate, a negative pressure approach can be used by extracting contaminated gases from the space.

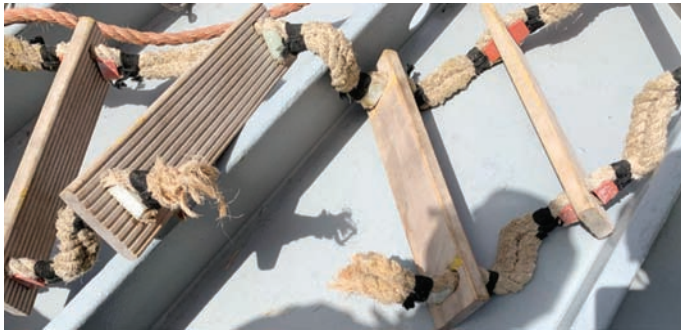
A vessel had been discharged and was ready to depart. A pilot had been ordered and had arrived via a small boat, boarding the vessel from the sea side. As the pilot stepped from the last rung of the pilot ladder onto the deck, one of the side ropes suddenly broke. Luckily, due to the fact the pilot had his weight and leg on the main deck, he did not fall.

Pilot ladder defects are, unfortunately, a fairly common problem even today. The lives of persons using such ladders depend on a reliable, safe equipment. Ladders should be scrupulously inspected at regular intervals and any hint of defect corrected or the ladder taken out of service.

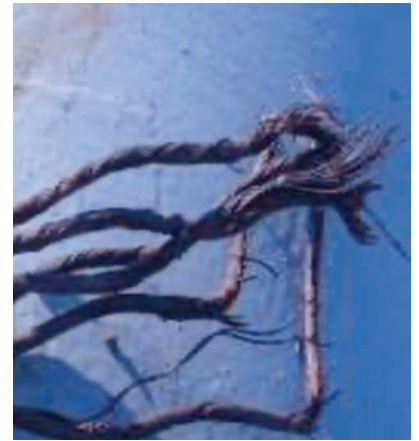
The vessel had finished berthing and the deck crew were deploying the starboard accommodation ladder for shore access. As the ladder was being lowered from its stowed position, the wire rope parted about two metres from its inboard end near of the outrigger's outboard guide sheave. The gangway fell and hung vertically along the ship's side. Fortunately, no one was injured and the ladder was recovered and secured. The wire had been installed 29 months earlier and had recently been inspected with no defects found. It was also reported that all rollers and moving fittings were able to turn freely without any signs of defects.

The company's post-incident investigation found that the wire's external condition appeared good. However, its internal condition was found to be poor, with corrosion evident.

- Inspecting wire rope for internal defects is especially difficult but can be achieved in many cases by opening the strands with a marlin spike.
- Particular attention should be given to splices and any 'hidden' points of the wire ropes, such as in the rollers, especially at points where little or no movement takes place under normal usage.
