Mariners' Alerting and Reporting Scheme

MARS Report No 344 June 2021

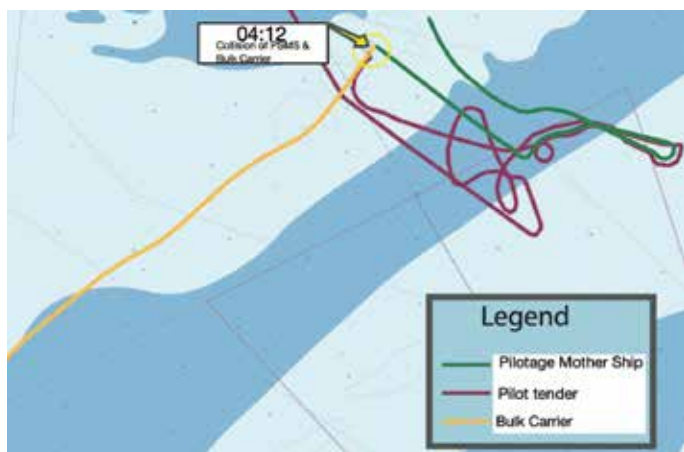
At this time the mother ship continued on autopilot. The captain was still preoccupied with administrative tasks. At 04.12, the mother ship collided with the starboard bow of the bulk carrier. Several crew members suffered minor injuries; there were no injuries aboard the bulk carrier.

The official investigation mentioned that both the pilot and the crew of the bulk carrier assumed that the mother ship was involved in the pilotage operation. They therefore assumed, somewhat justifiably, that it would not hinder their movements.

- As mentioned in many past MARS lessons learned, darkness changes everything! It is hard to imagine this accident happening in daylight and good visibility. When in darkness, re-double your attention.
- As also mentioned in many past MARS lessons learned, being preoccupied with other tasks instead of navigating your vessel changes everything. Put distractions and other tasks away when navigating your ship.
- Making assumptions about the movements of other vessels, even in apparently clear-cut circumstances, can have negative consequences. In this case, the bulk carrier’s crew and pilot assumed the PSMS would stay clear, but at no time did they confirm this with the PSMS via VHF communication.
