# Mariners' Alerting and Reporting Scheme

MARS Report No 345 July 2021

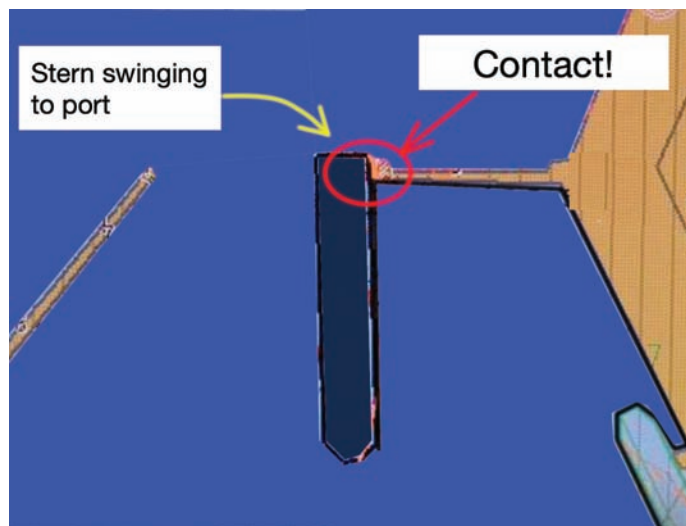
Because of this developing situation, it was not possible to carry out a Master/pilot information exchange with the second pilot. When the vessel's bow entered the basin and the forward tug was pushing the bow to starboard, the Master realised that the vessel's stern was not going to clear the breakwater. He immediately ordered engines full ahead and helm hard to port, but these actions were too late to avoid contact on the vessel's port quarter.

Since this breakwater was without fenders, the vessel suffered some minor hull damage on contact. The company investigation found that, among other things, the change of pilots at a critical stage of the manoeuvre did not allow the docking pilot enough time to become accustomed to the prevailing conditions, position, speed, rate of turn, and position/status of the tugs.

The company investigation also found that the tug orders were given by the pilots in a language other than English. This had the effect of excluding the Master, making him less aware of the developing situation. Due to this communication gap, the Master could not effectively use tugs to control the vessel's swing.

- In this case, the company decided to reinforce their navigational audits for compliance with docking procedures by using remote VDR audits and onboard navigational audits by independent third-party auditors.

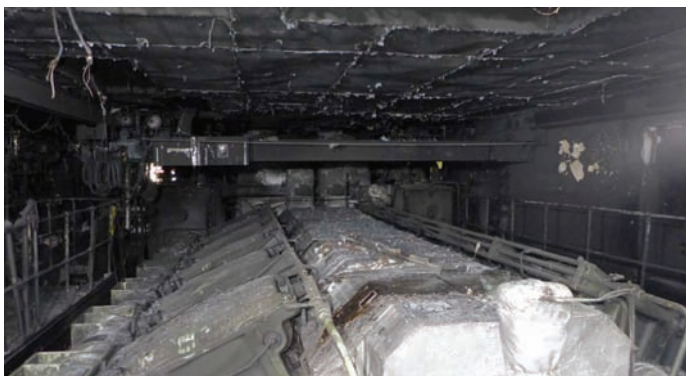
Now that all crew and passengers were accounted for, the fire flaps closed and the engine room fuel supply isolated, the engine room's CO<sub>2</sub> system was activated. Boundary cooling was initiated. The fire was declared extinguished about 3 hours and 40 minutes after it had begun.

- The fire was the consequence of a sudden major engine component failure, which led to the ejection of heavy engine parts from the crankcase and release of hot oil vapours into the engine room.
- Although the crew were confident the CO<sub>2</sub> had been released, there was no information in the bottle room to identify easily which spaces were protected by which CO<sub>2</sub> bottles. There were no visible means of identifying whether the gas bottle operating valves were open or closed.
- The accident demonstrates that more consideration could have been given to the number and location of EEBDs in this vessel's engine room even though the required number had been fitted. For example, an additional EEBD at the secondary escape ladder on the tween deck level would be a sensible addition.

- Every fixed gas fire-extinguishing system control station should have clear instructions for the operation of the system and means to identify which bottles have been spent.
- EEBDs are not an onerous expense. Proper consideration should be given to fitting all escape routes on vessels with EEBDs, even at the cost of going over the number of EEBDs required by class.

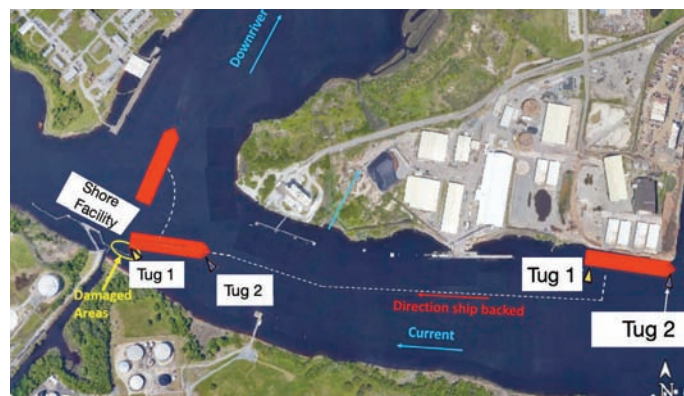
As the manoeuvre progressed, the backing speed increased to about 2.9 knots. The aft tug (tug 1 in the diagram) was pushing at full power in an attempt to push the vessel's stern north, away from the shore facility. As the bulk carrier and tug approached the shore facility astern, the pilot requested that tug 1 stop pushing and that it be brought close by the bulk carrier. The tugmaster complied. By now the astern speed had reached 3.2 knots and the vessels were backing quickly into a shore facility. The pilot made several ahead engine orders to try to save the

situation in addition to hard starboard rudder. These actions did not prevent the bulk carrier from squeezing the tug on to the shore facility, striking a concrete pile for a mooring dolphin and then a walkway. Although damage to the tug was minimal, the shore facility suffered about \$1.47 million damage.

The official investigation found, among other things, that the speed at which the assisted vessel was being backed was too high for conventionally powered tugs to be used in an effective manner, resulting in contact with the shore facility. Another contributing factor was the less than adequate communication between the docking pilot and the bulk carrier's Master and also the tugmasters.

- Communication is key: everyone involved should have the same understanding of the manoeuvre.
- When undertaking familiar tasks with unaccustomed equipment it may be wise to step back and re-evaluate the risks and procedures.
