# Mariners' Alerting and Reporting Scheme

MARS Report No 346 August 2021

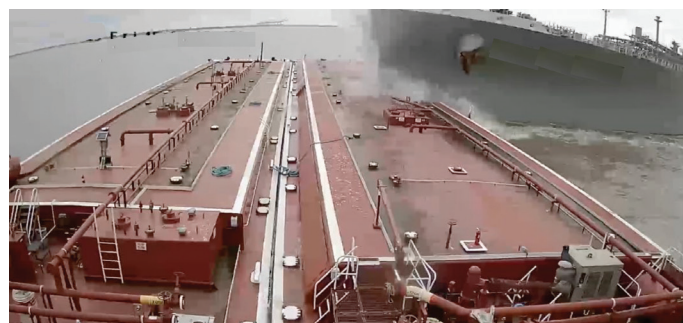
The tug Master complied and gave full port rudder, but within minutes the LPG vessel's bow struck one of the barges midship on the starboard side, penetrating the double hull and breaching two cargo tanks in that barge. The force of the collision capsized the second barge although no tanks were breached.

The official investigation found, among other things, that the combined effect of the speed of the LPG vessel passing another large vessel in the asymmetrically shaped channel resulted in an uncontrollable sheer to port by the LPG vessel, initiating the chain of events that led to the collision.

- Research on hydrodynamic interaction indicates that if the speed of the ship near a bank is too high, the rudder may be less able to cope with the forces induced and control will be lost.
- Proceeding at full sea speed in a restricted channel not only increases the risks of an uncontrolled shear due to hydrodynamic effects, but leaves the mariner with few options to mitigate or control the situation.

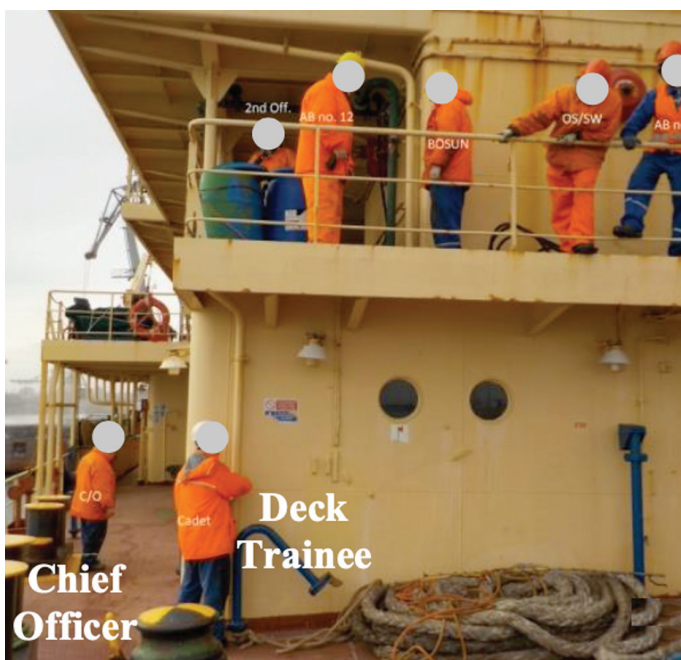
Simulation of the event

Three more deck crew arrived on deck 1 to assist. Some ropes were brought on board and untangled, with some crew working on deck 1 and the chief officer and a trainee on the poop deck. Suddenly, a large wave washed over the poop deck from starboard. Within seconds of the first wave, a second larger wave washed on board from the same direction. The two crew on the poop deck were swept overboard.

The official investigation found, among other things, that neither victim was secured to the vessel with a lifeline when the waves washed over the poop deck. Additionally, the crew members were not wearing lifejackets while working on the exposed deck in adverse weather conditions.

- Hindsight is always 20-20, but most vessels loaded to maximum draught are susceptible to breaking waves in heavy weather, even on the poop deck. Lifelines must always be considered for emergency deck work in heavy weather, as must lifejackets.
- Before undertaking an unusual or undocumented task, take a few minutes to do a risk assessment among the team members, even if only verbally.
